# PRE-PURCHASE INSPECTION REPORT

Independent vehicle condition assessment by SMGLR Auto Checks

Mazda3

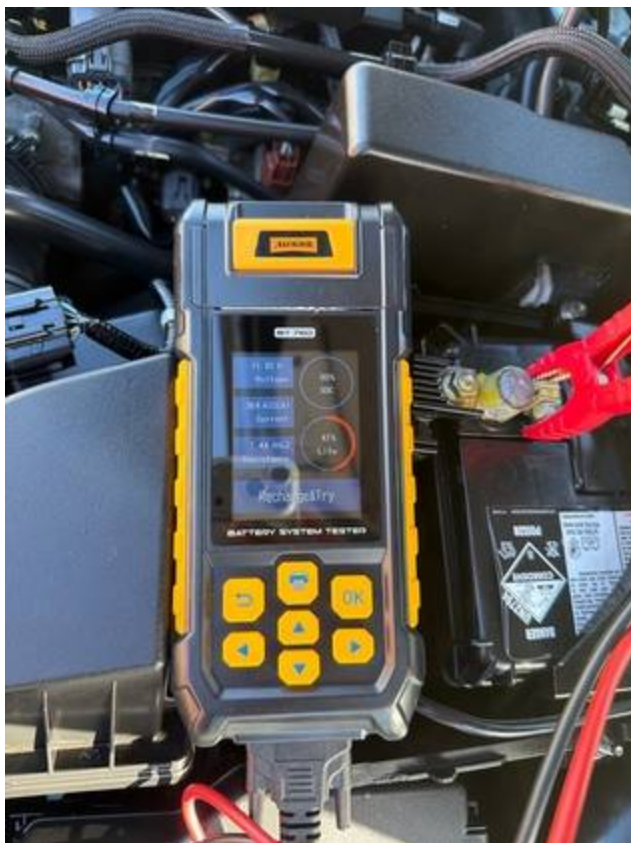
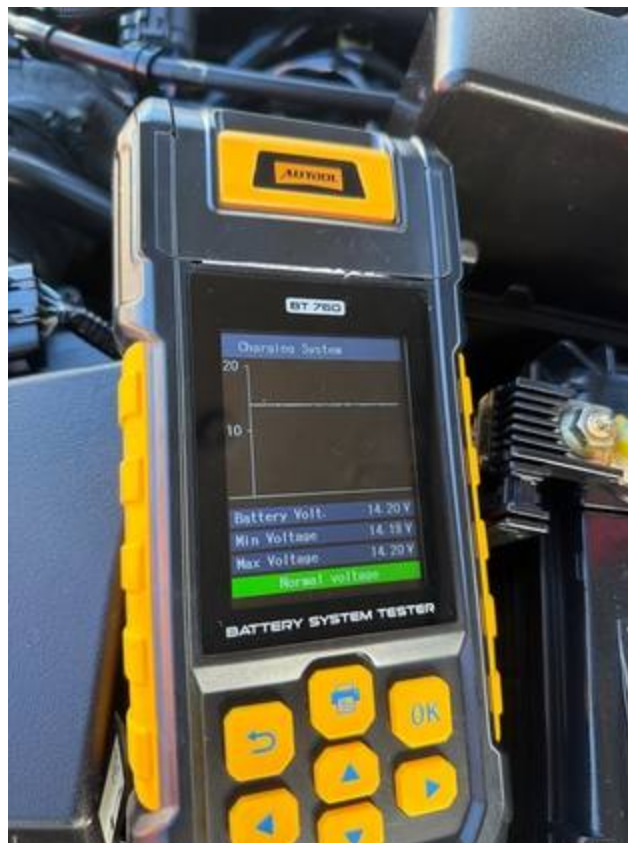
The 12V battery was found discharged; however, the charging system tested within specification. Recommend fully recharging the battery and retesting battery condition afterward.

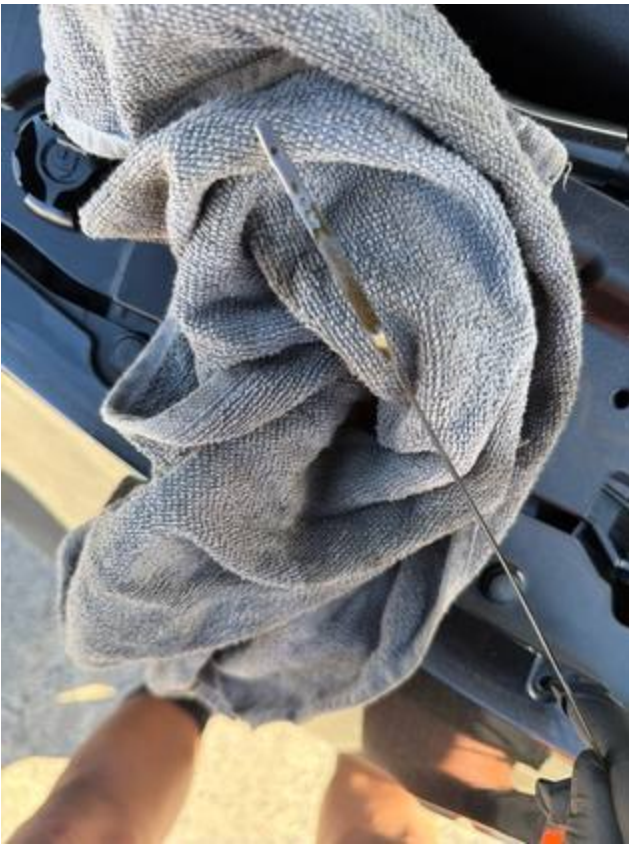
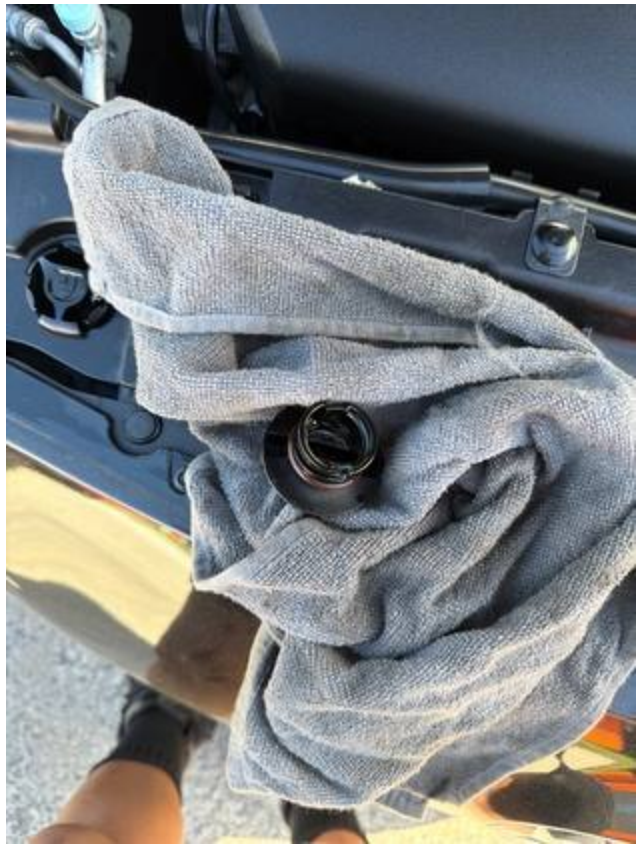
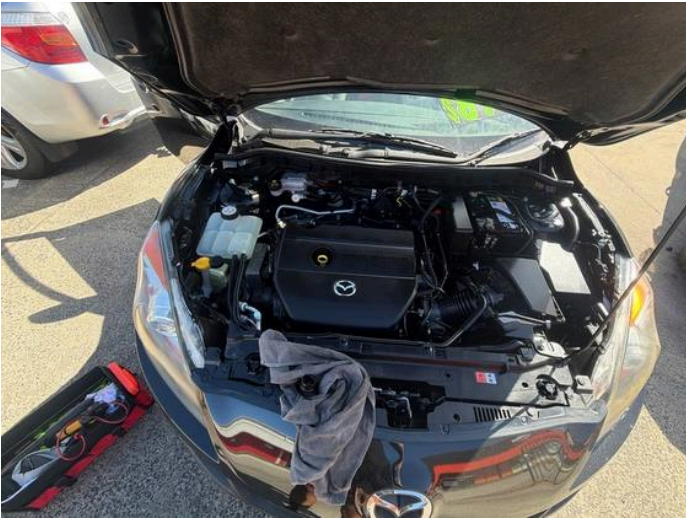
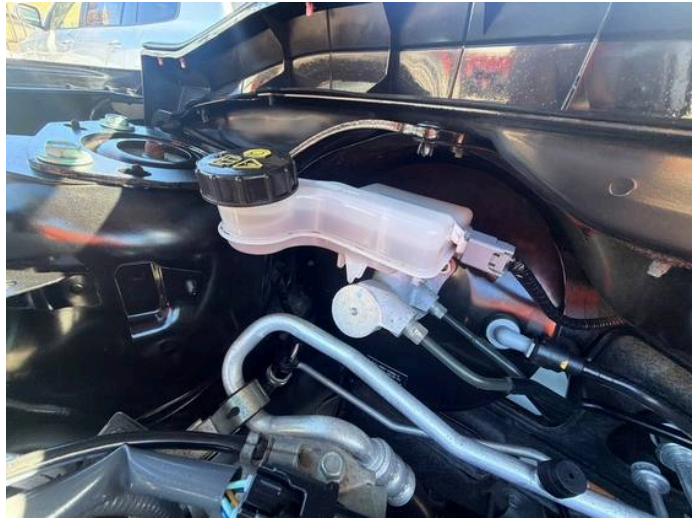
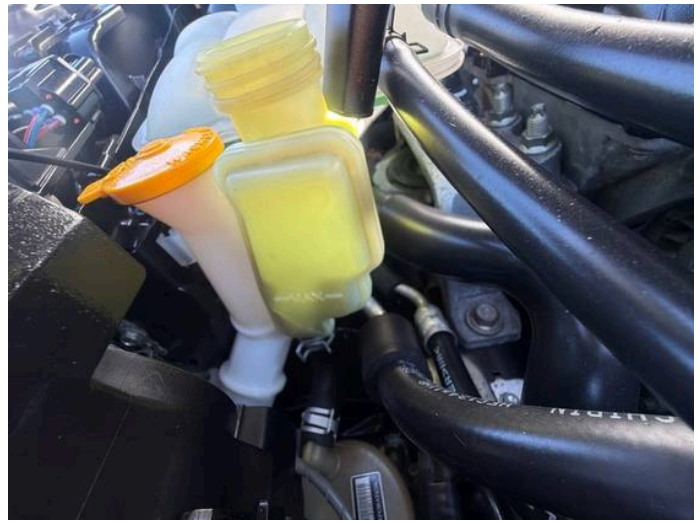
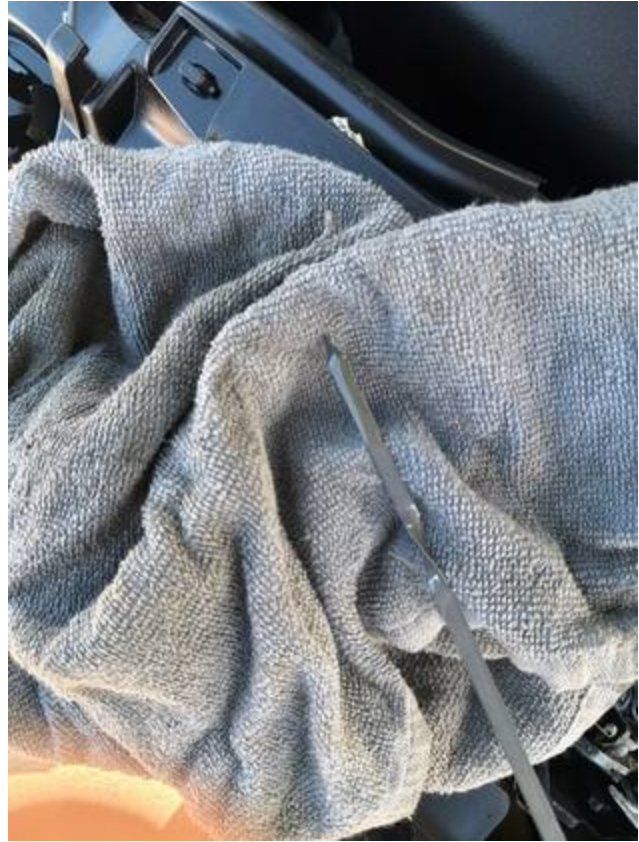
- \* Engine oil level satisfactory.
- \* Transmission fluid level satisfactory.
- \* Coolant level satisfactory.
- \* Brake fluid level satisfactory.
- \* Engine mounts appeared to be in decent condition.
- \* No active leaks detected around the engine bay.
- \* Oil residue noted around the power steering hoses.
- \* Power steering fluid reservoir found empty.
- \* Possible power steering fluid loss/leak requires further investigation.
- \* Seller was made aware of the issue.

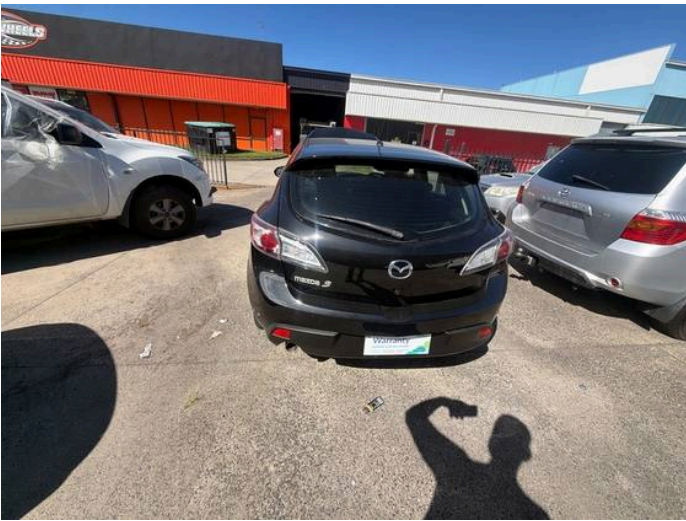
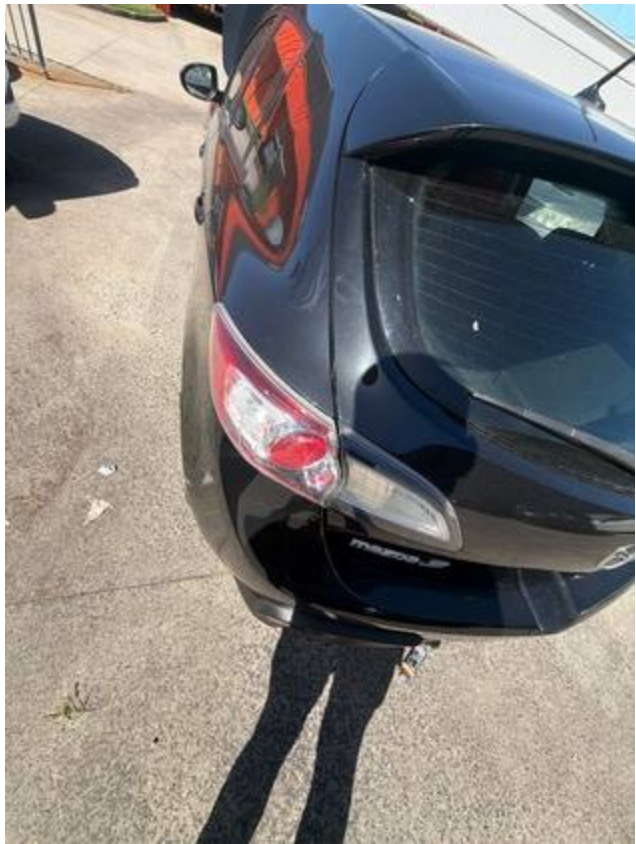
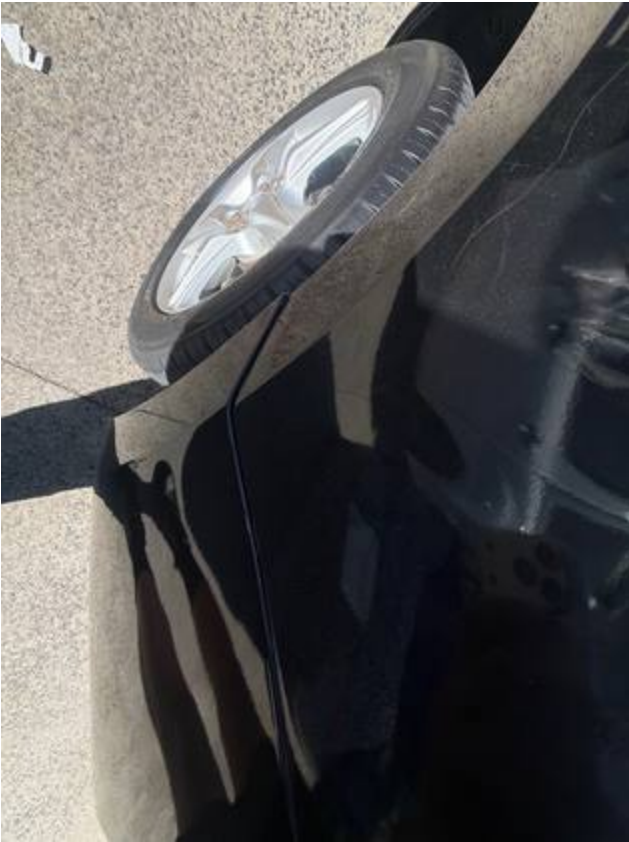
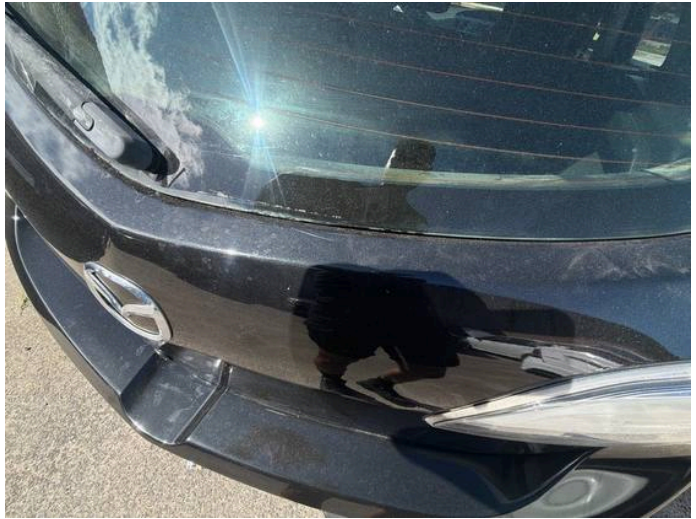
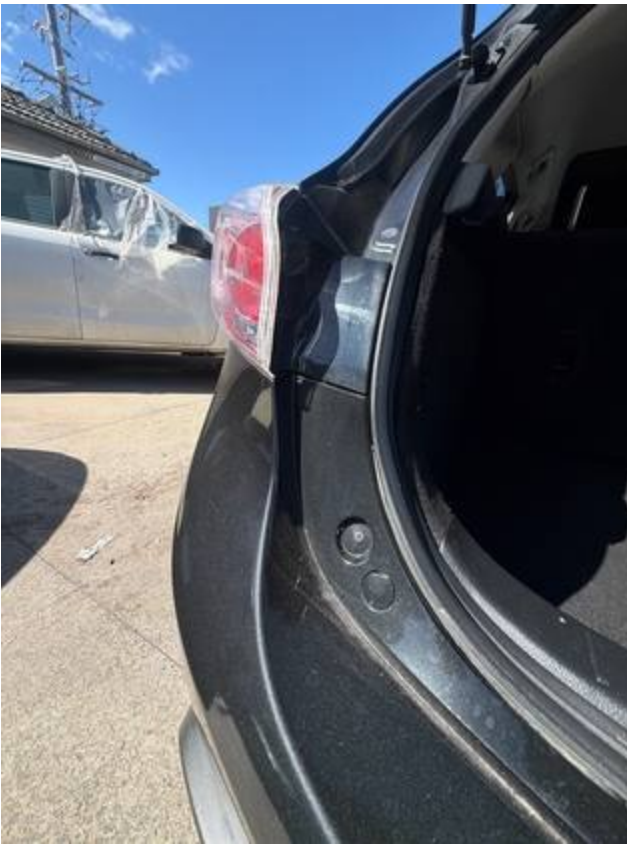
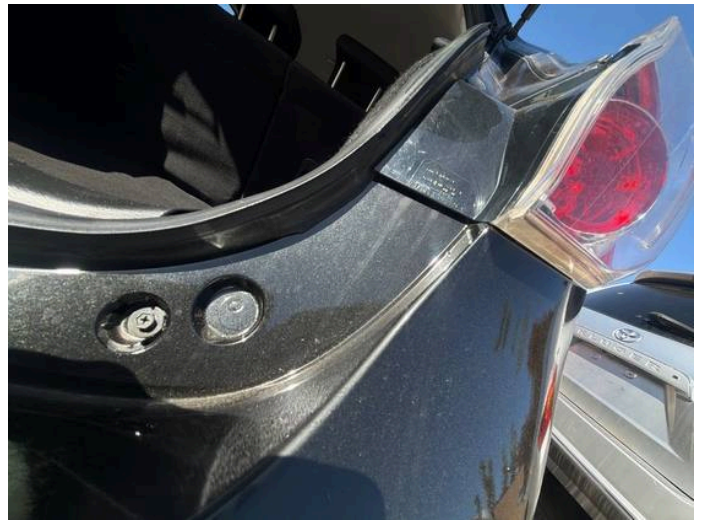
- \* Multiple scratches noted around the vehicle body.
- \* Several retaining clips were missing from the front and rear bumpers, indicating the bumpers had previously been removed.
- \* No obvious accident damage or repair work was detected during the visual inspection.
- \* PPSR check returned clear at the time of inspection.

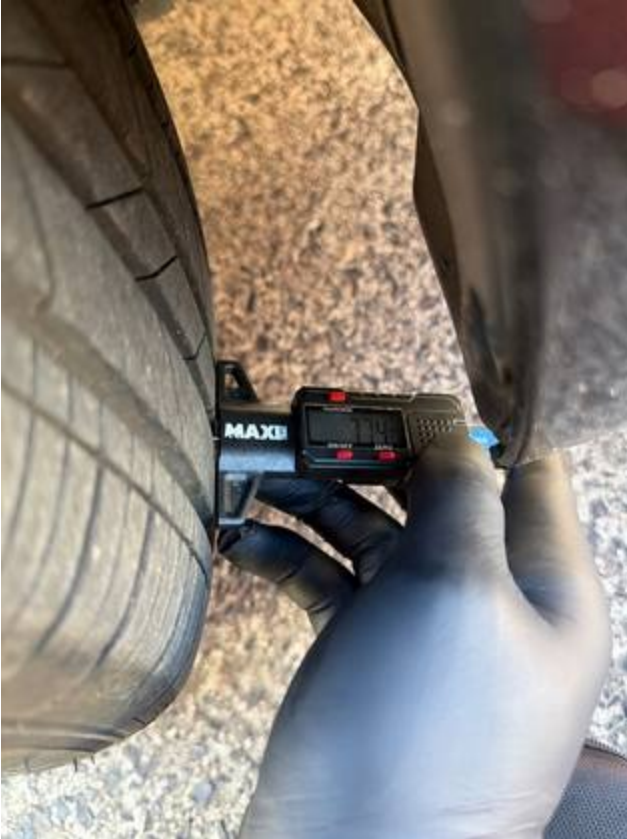
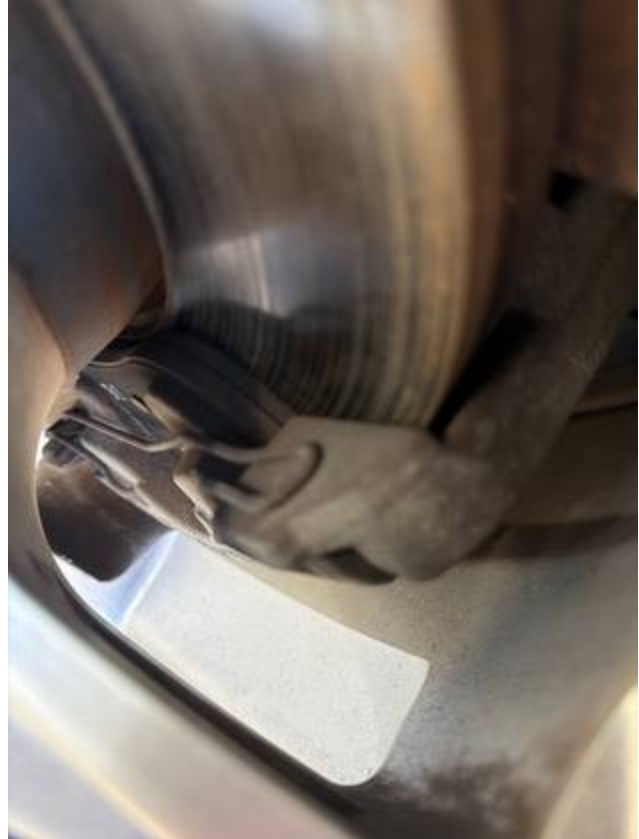
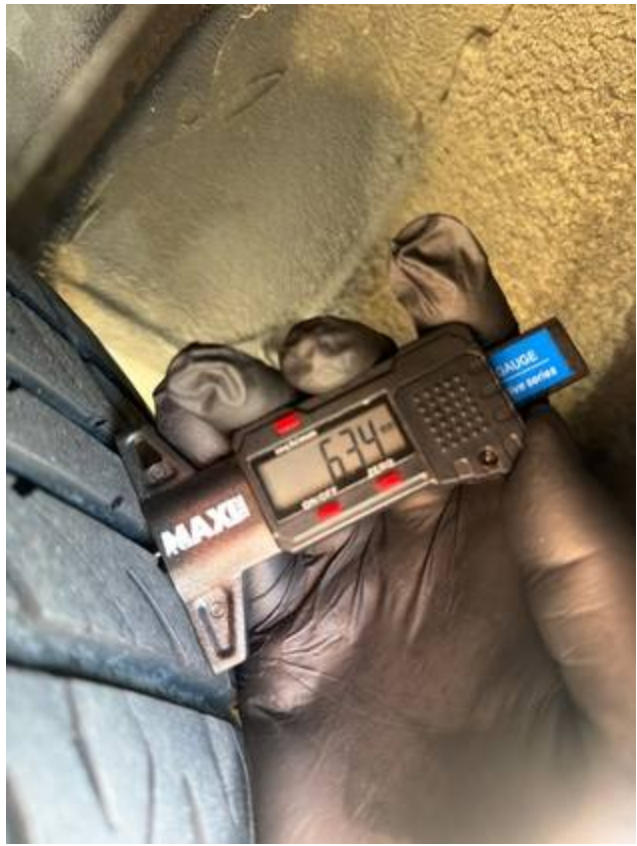
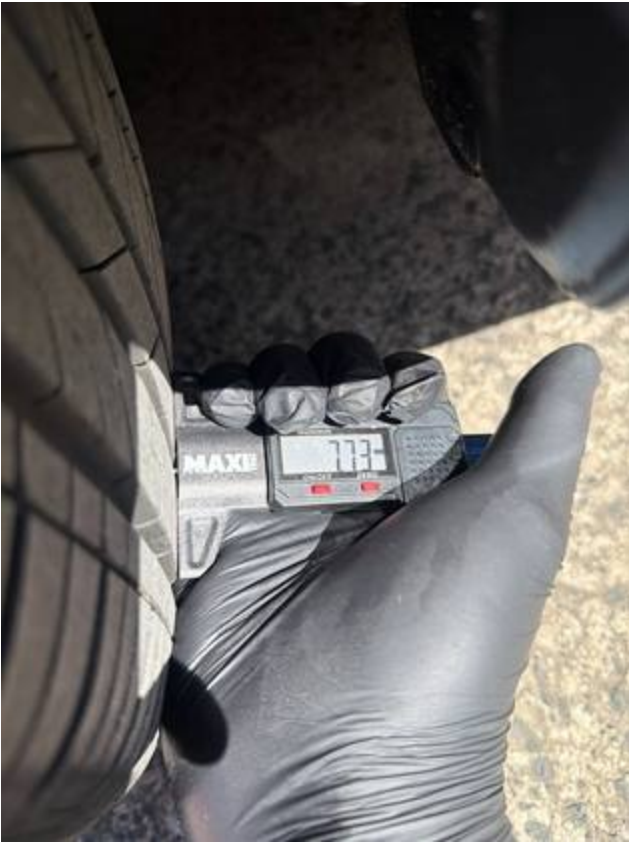
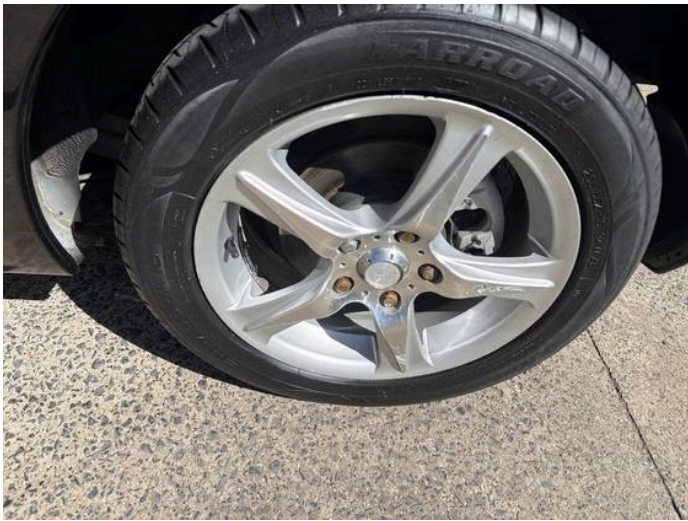
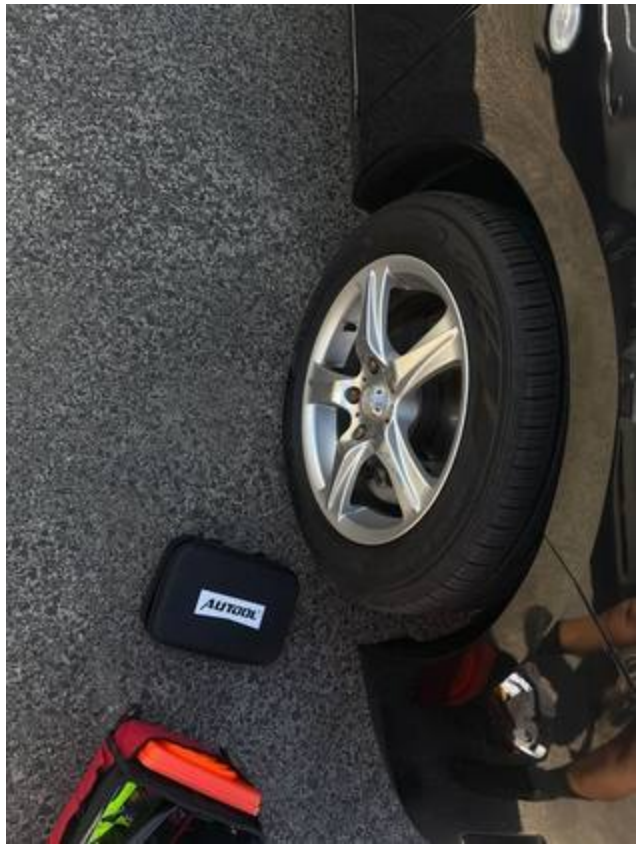
- \* Front tyres have around 90% tread remaining.
- \* Rear tyres have around 70% tread remaining and should still have good life left, depending on how much the vehicle is driven.
- \* Front brake pads are around 3.5 mm and may need replacing within the next few months.
- \* Rear brake pads are around 4 mm and are okay for now.
- \* All four wheels have some gutter rash, which is normal for the vehicle's age.
- \* Spare tyre was not secured properly and should be fastened correctly.

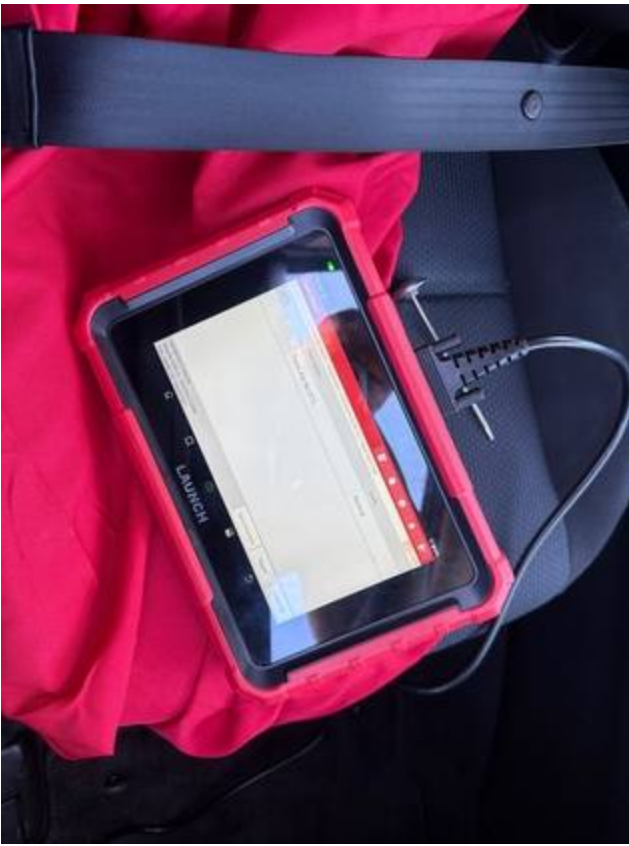
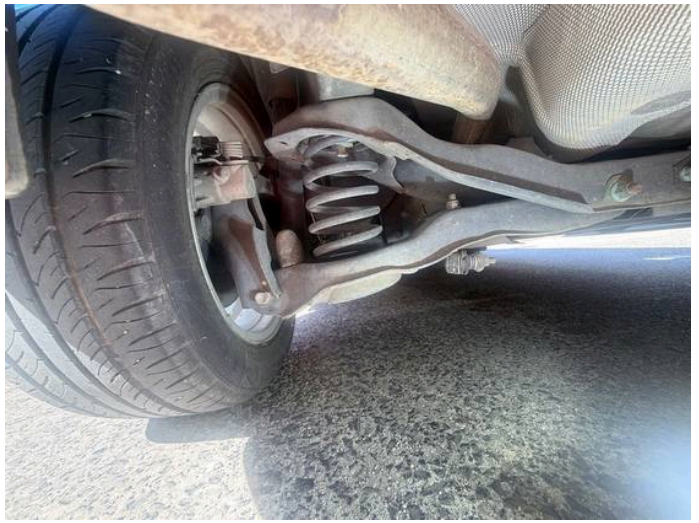
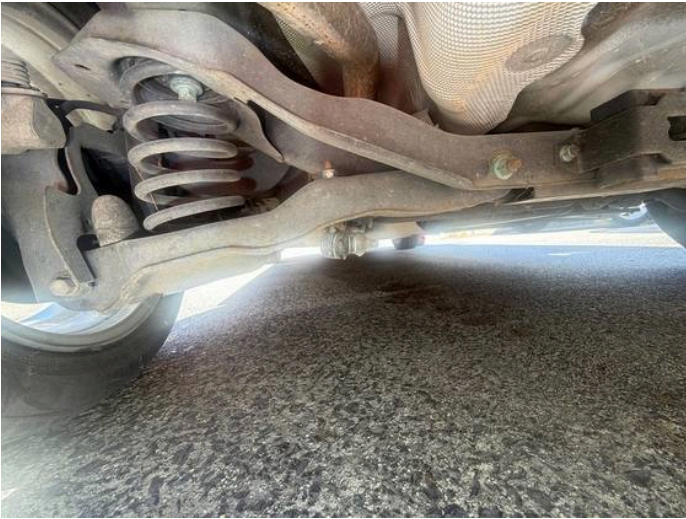
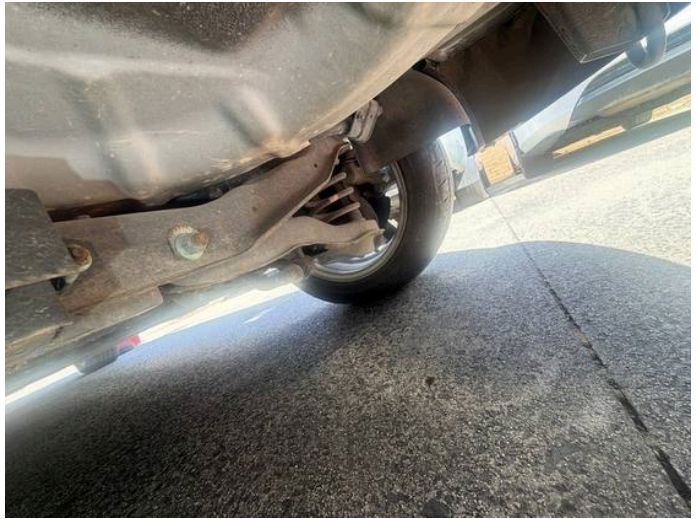
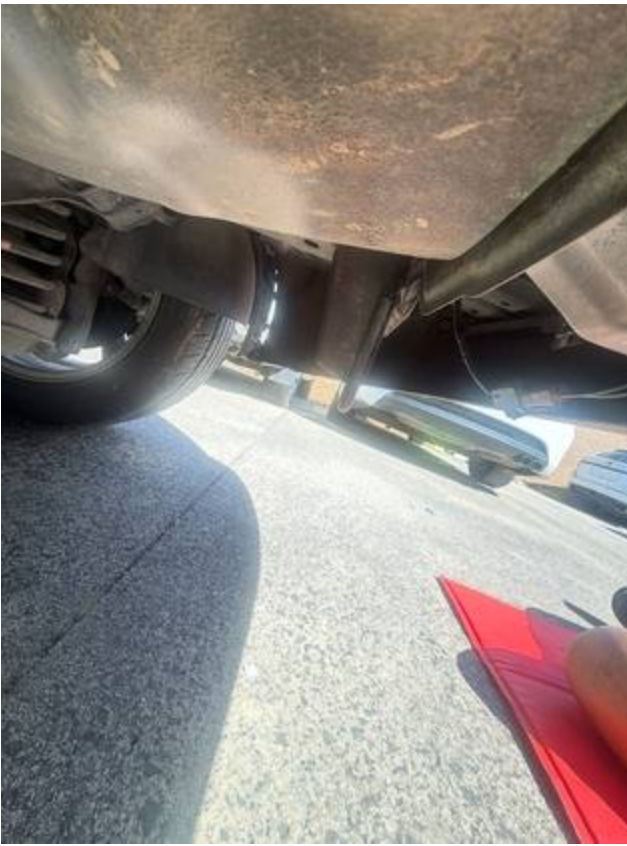
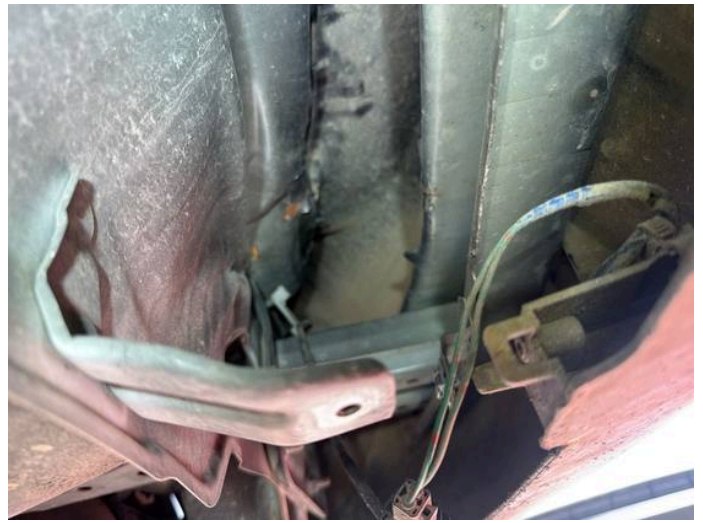
- \* Overall underbody condition was satisfactory at the time of inspection.
- \* Suspension components appeared normal, with no obvious leaks or signs of excessive wear.
- \* No active leaks were detected around the engine or transmission area at the time of inspection.
- \* No radiator or coolant leaks were detected at the time of inspection.
- \* Oil residue was noted around the power steering hoses and should be investigated further.
