## SMGLR Auto Checks -Pre-Purchase Inspection Report

### 1. Customer & Vehicle Details

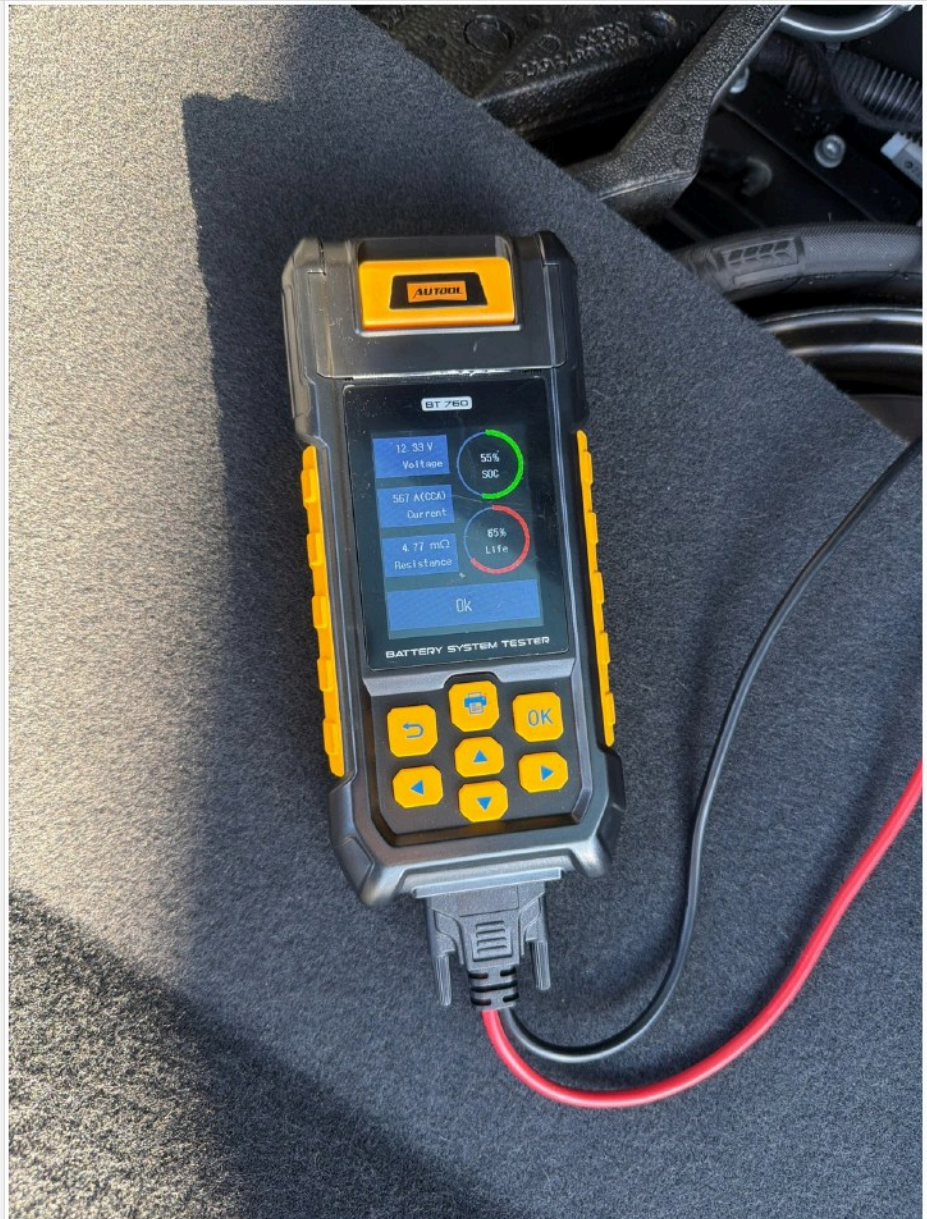
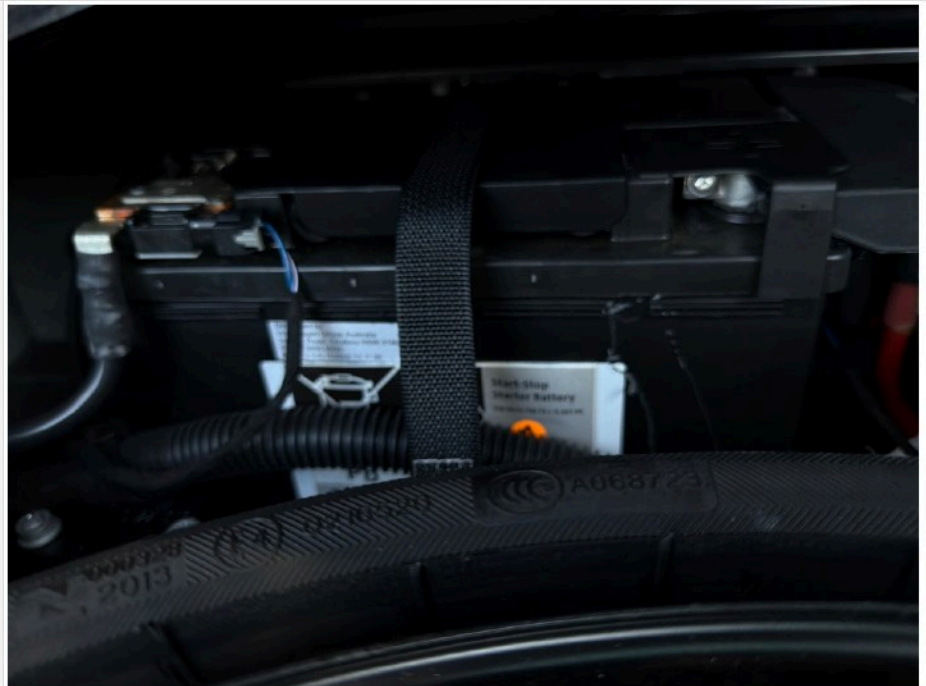
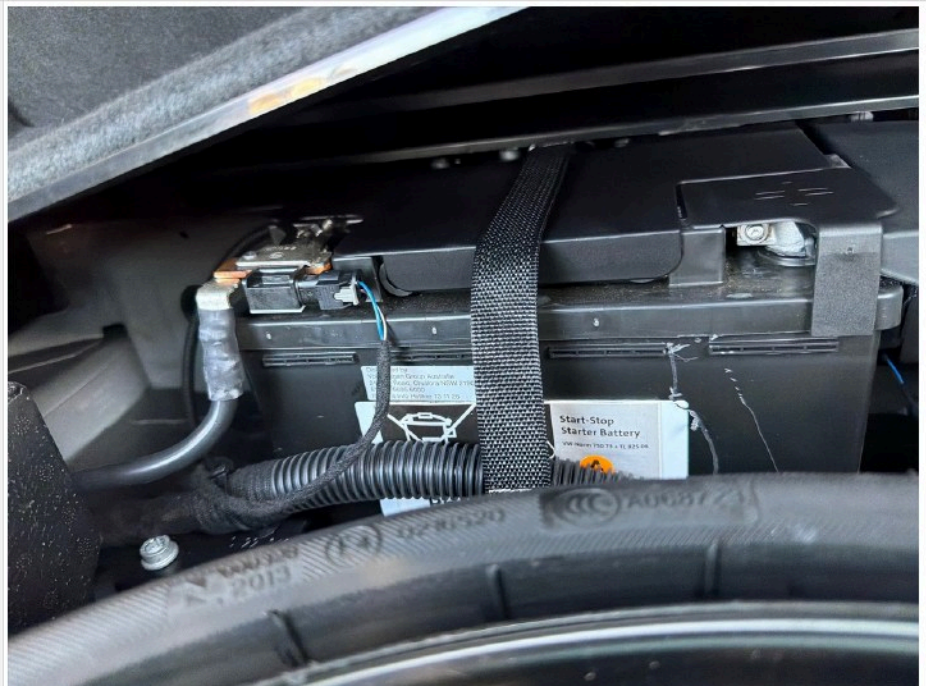
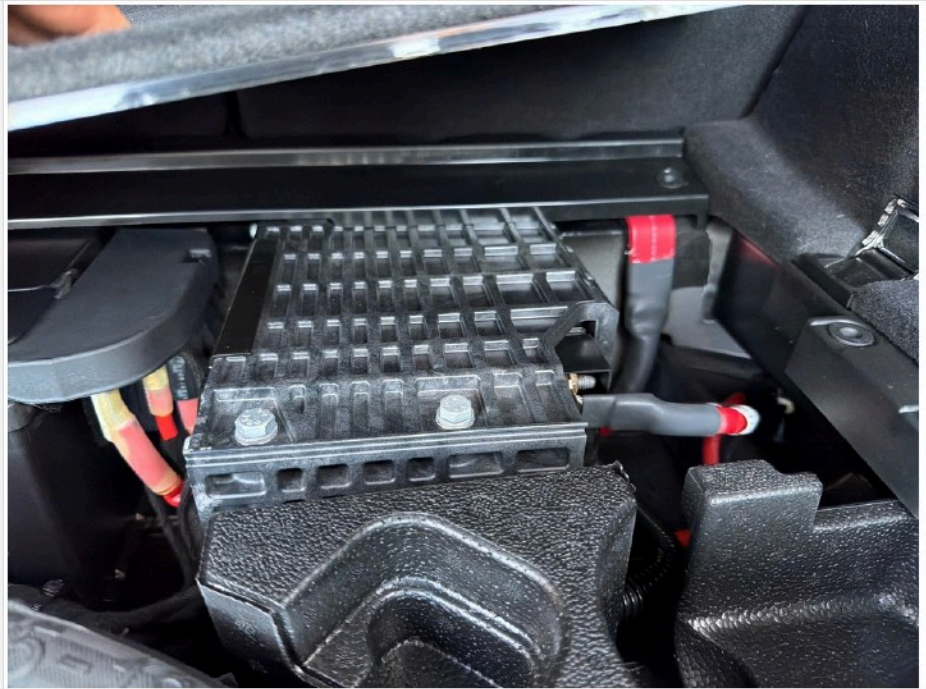
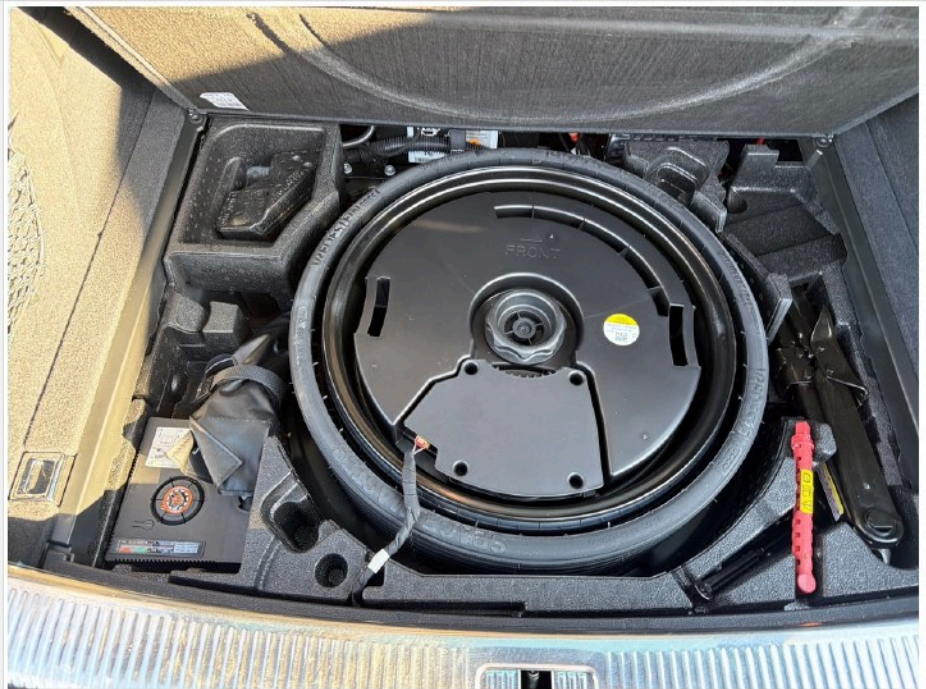
Section photos - Battery, Cranking  
& Charging

Engine battery and charging system is good. Passed the test.

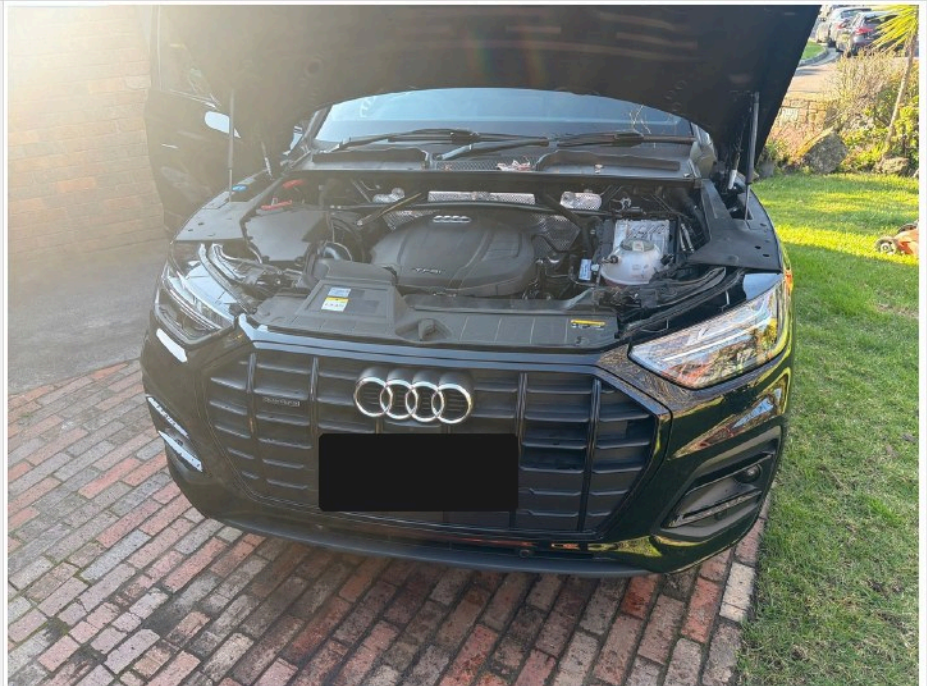
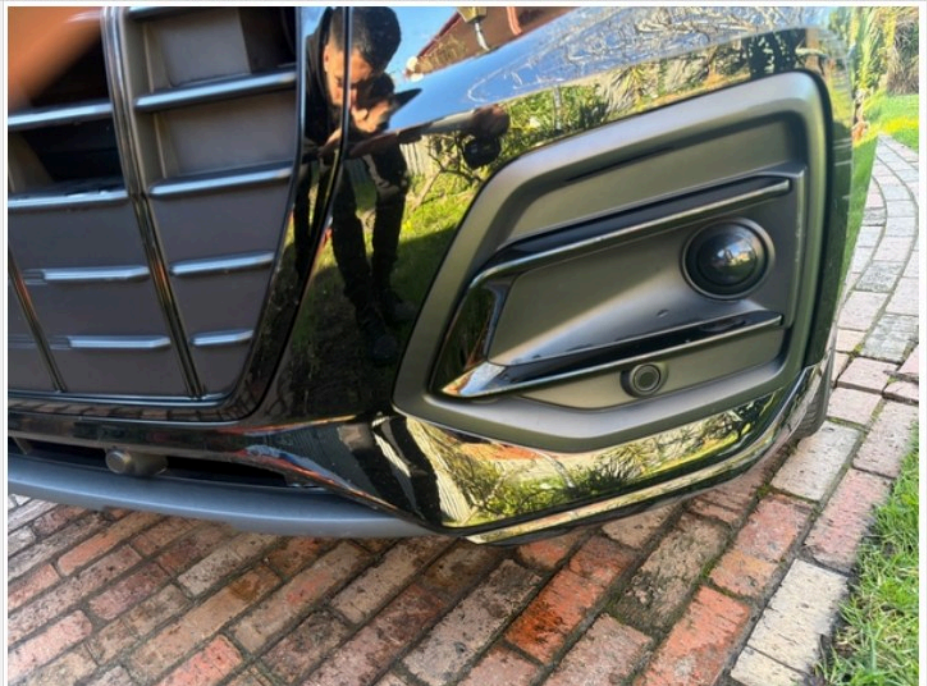
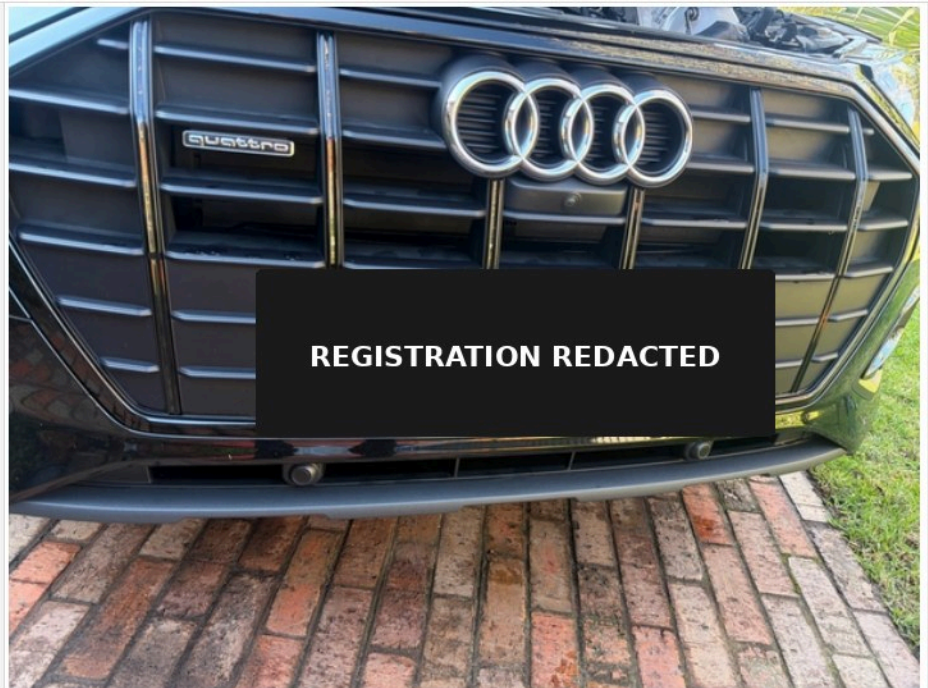
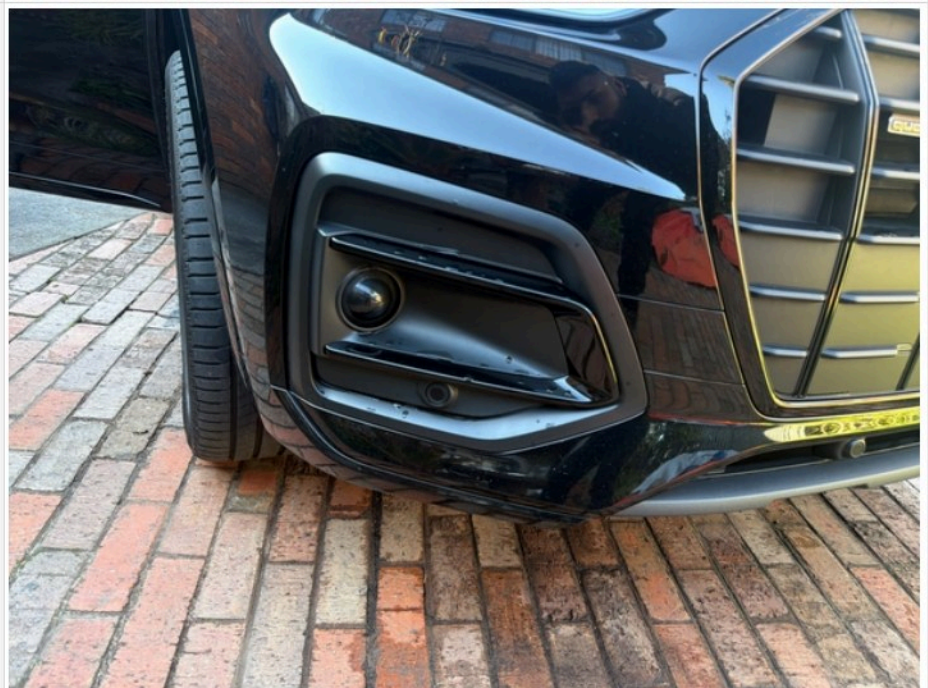
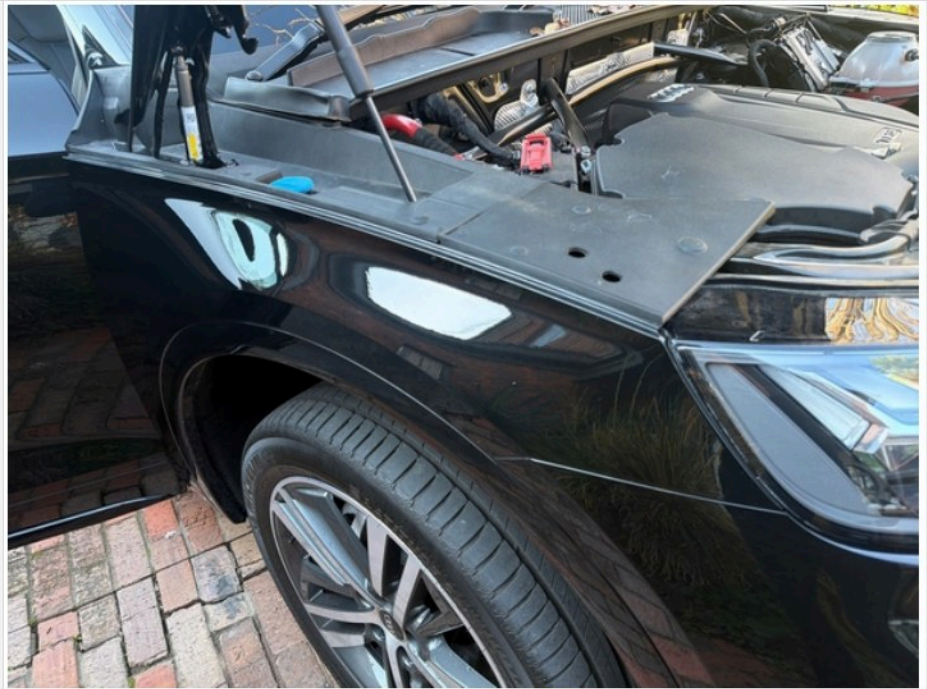
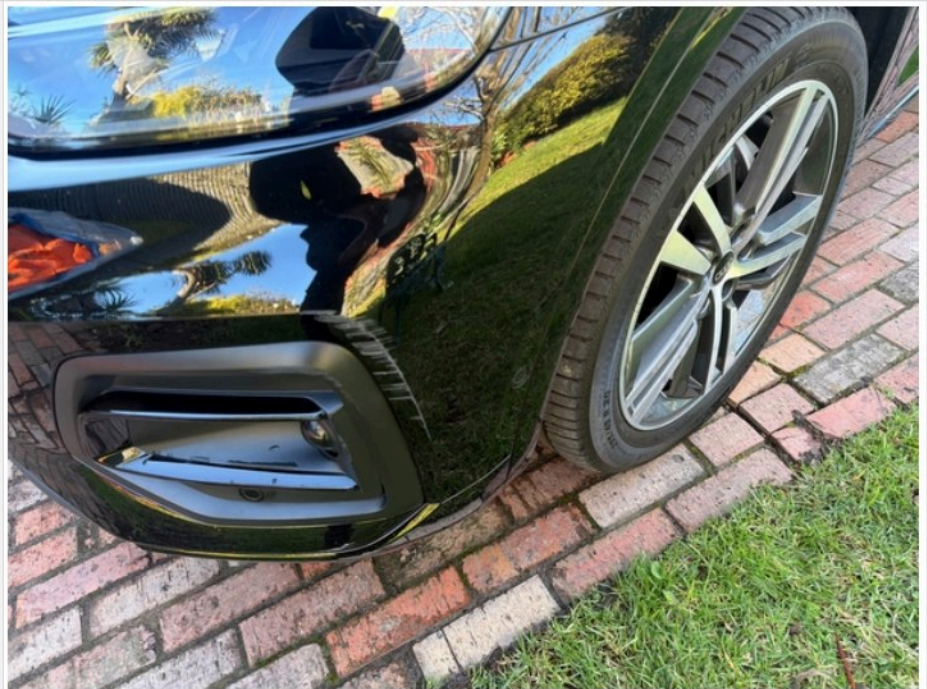
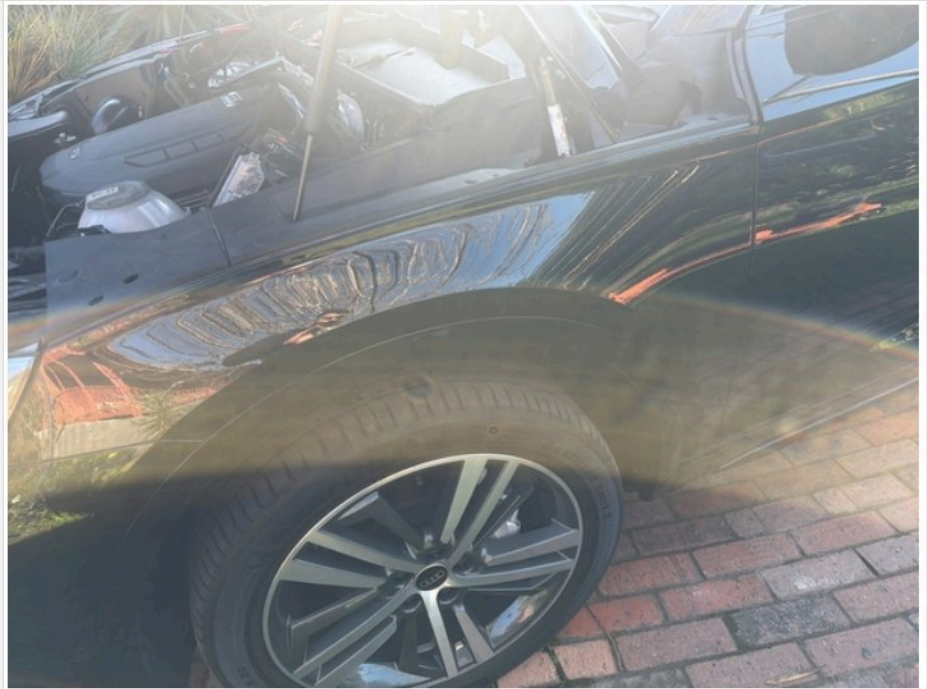
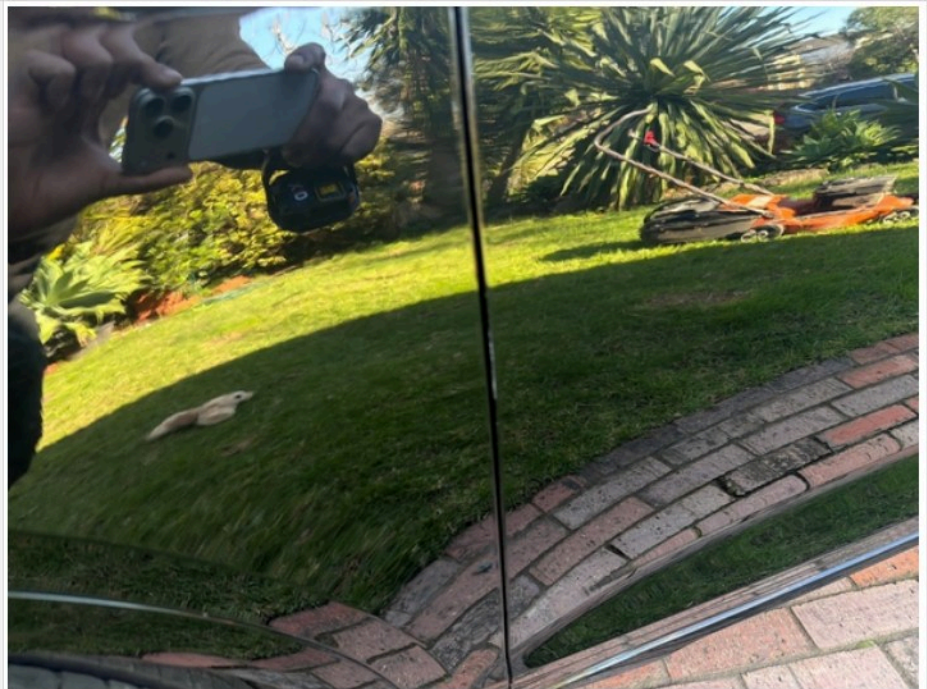
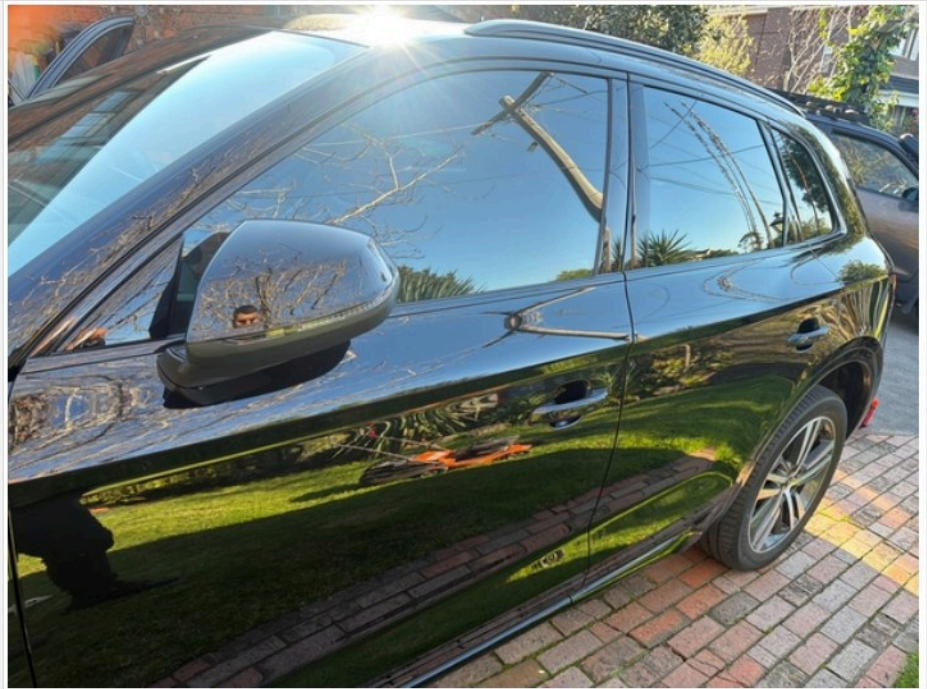
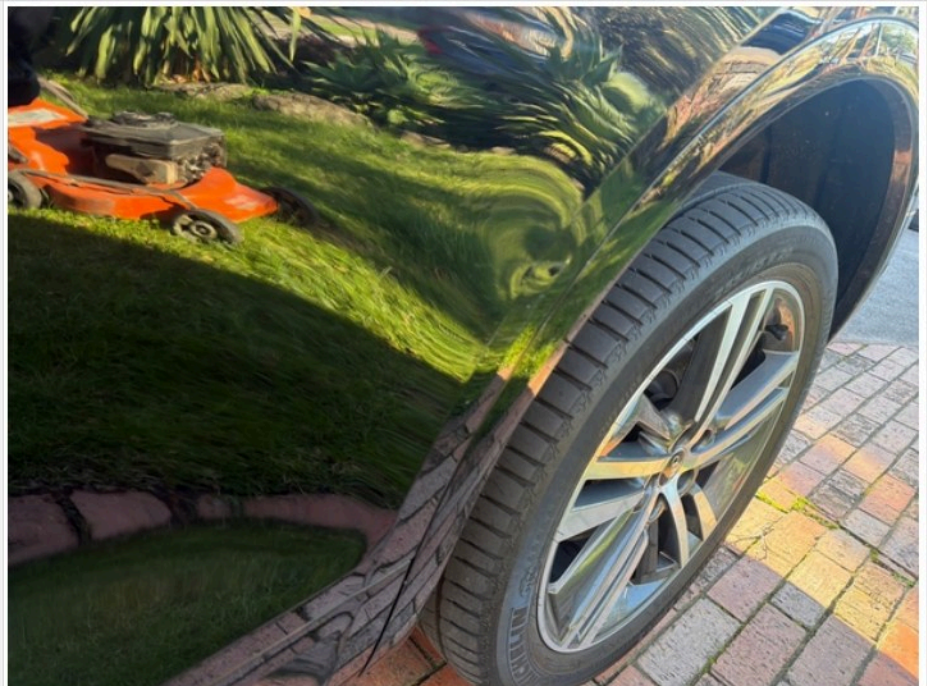
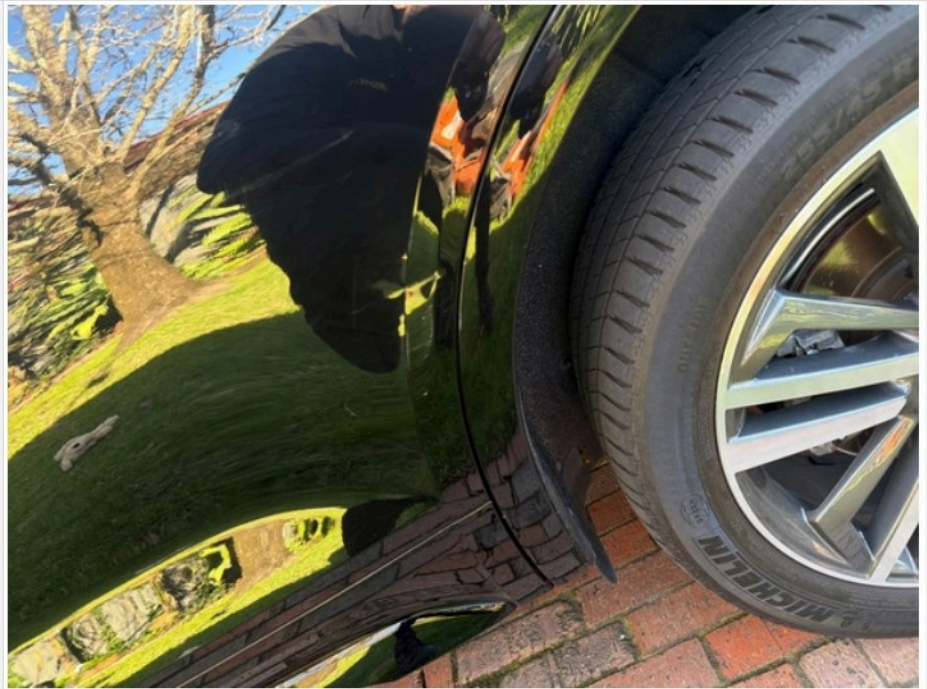
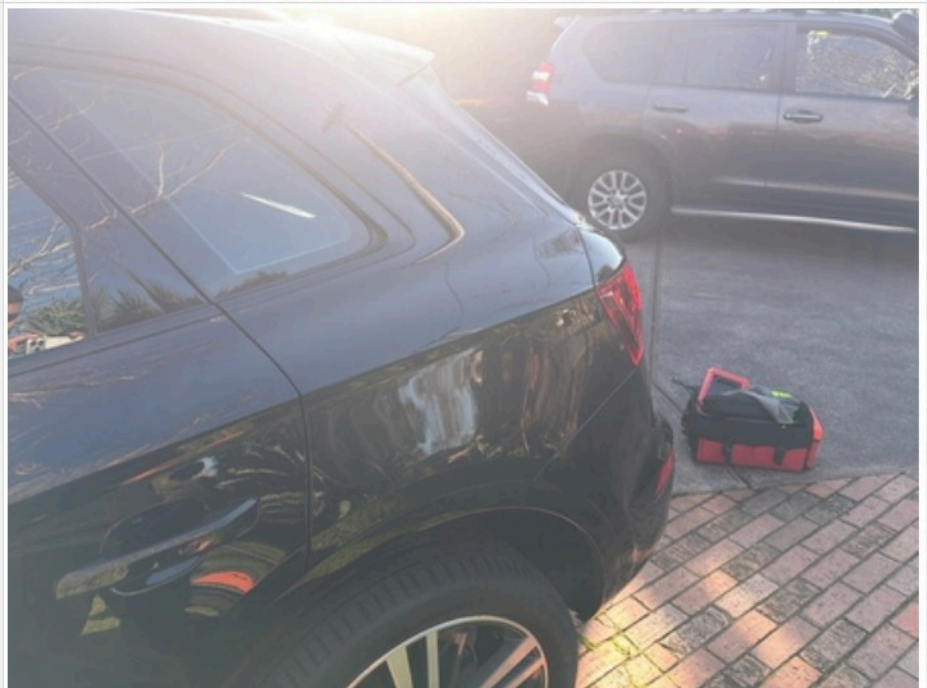
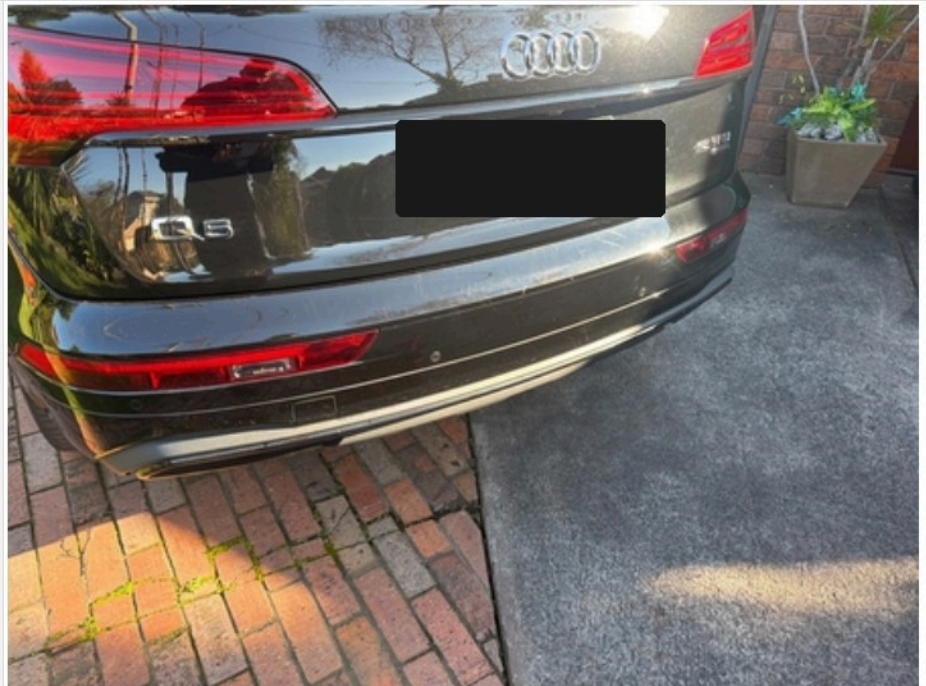
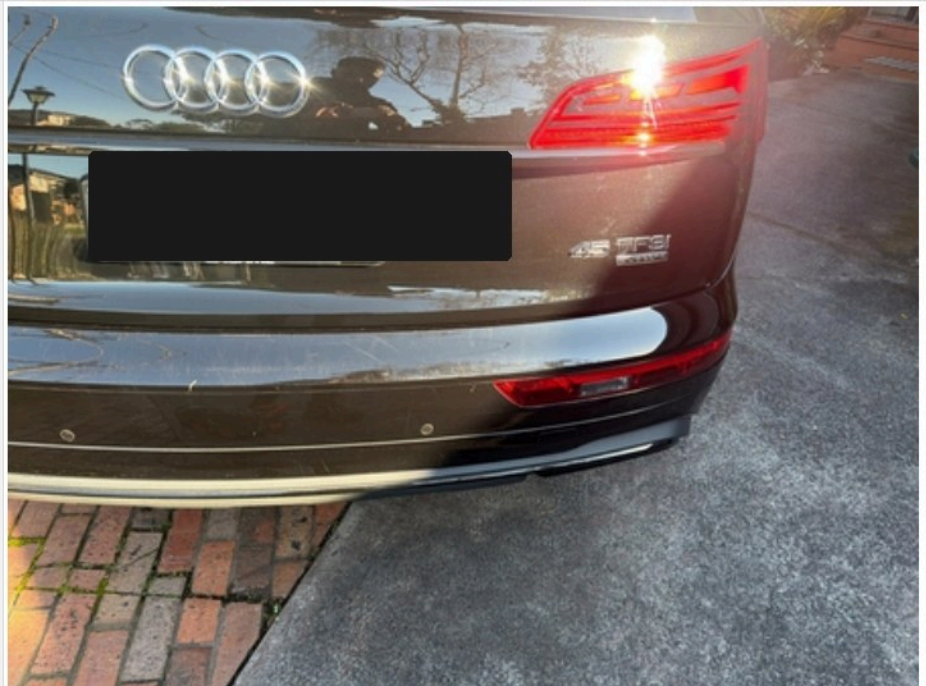
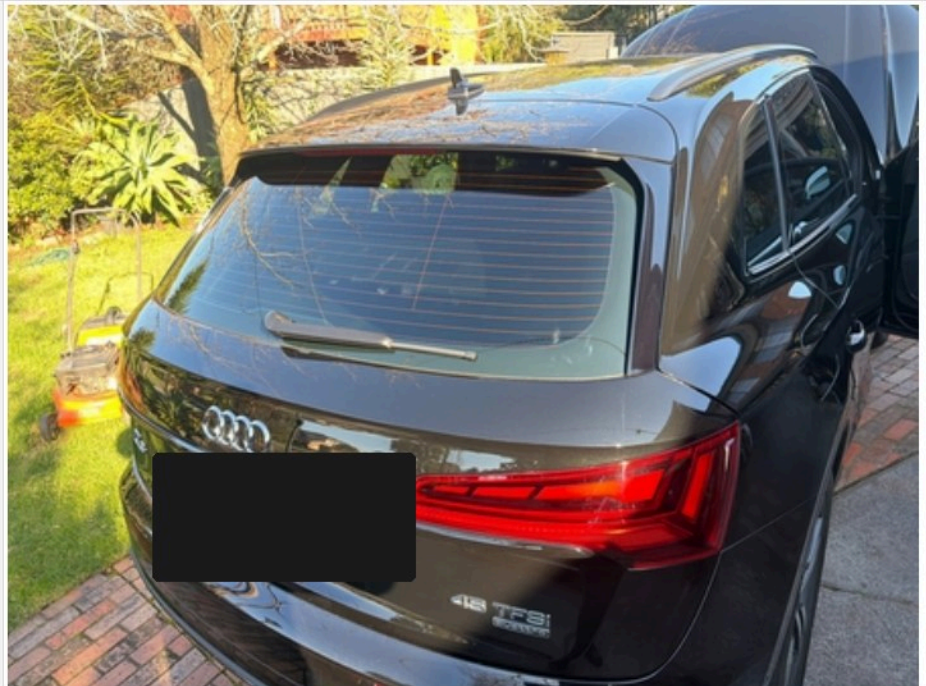
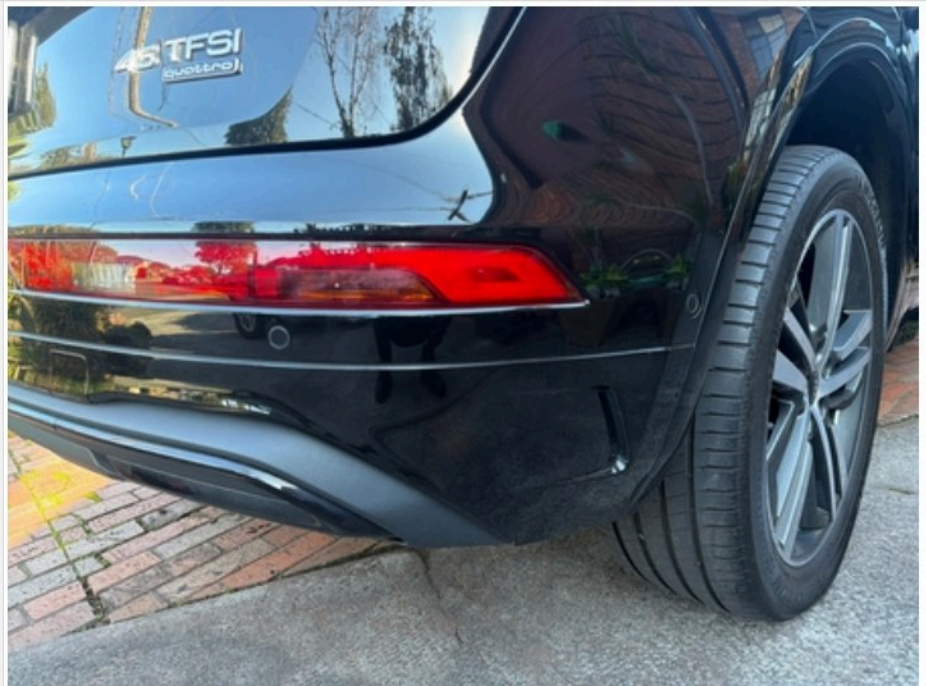
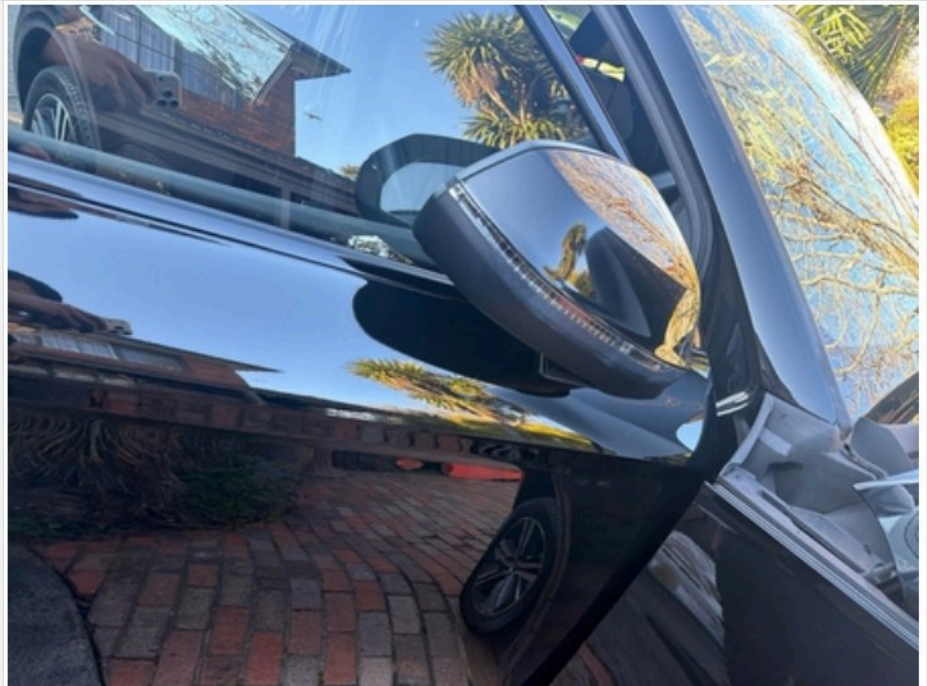
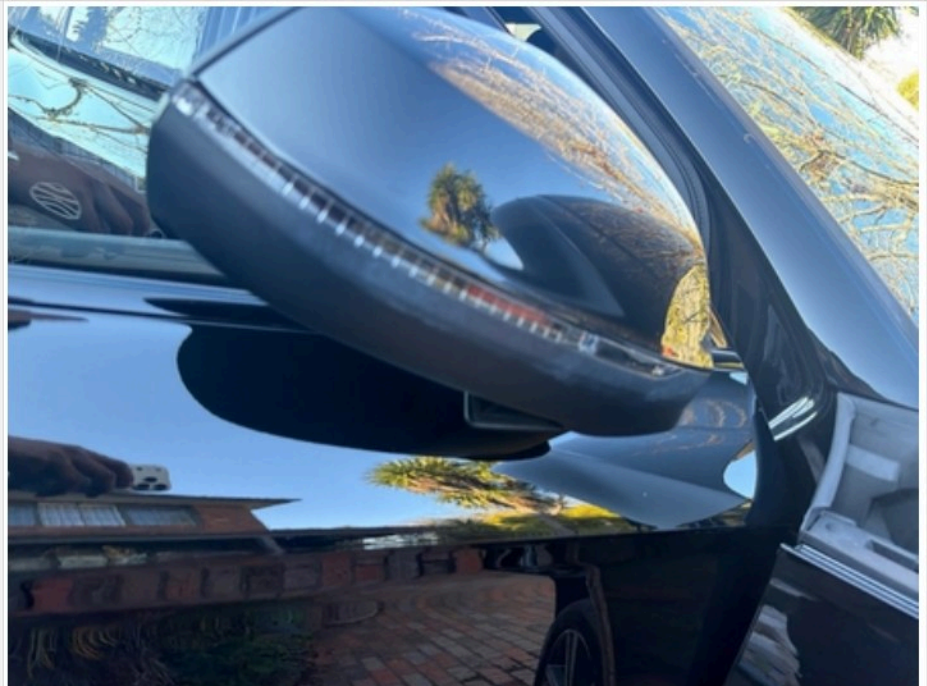
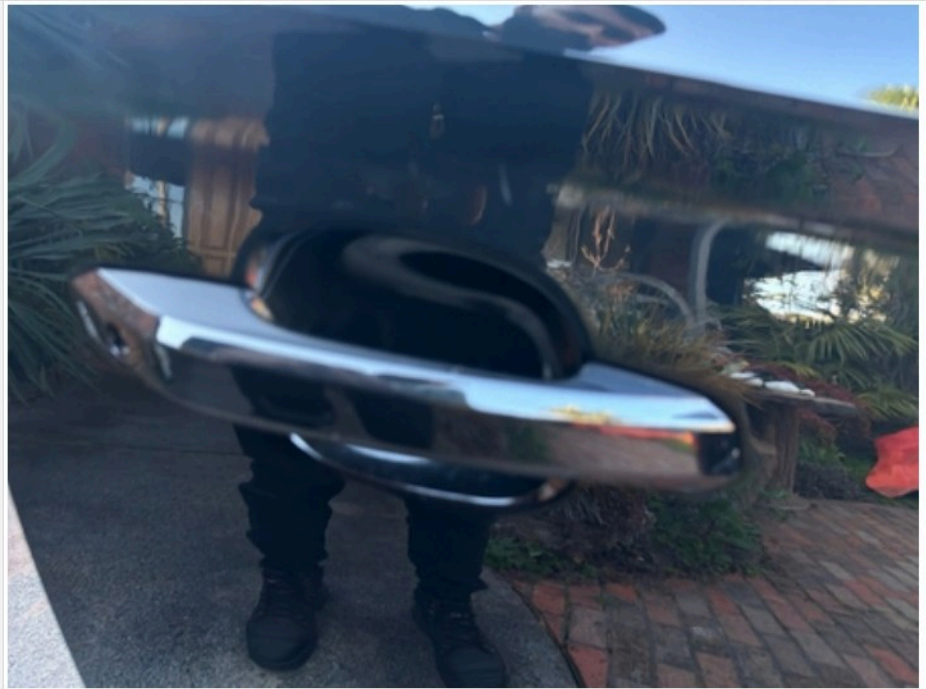
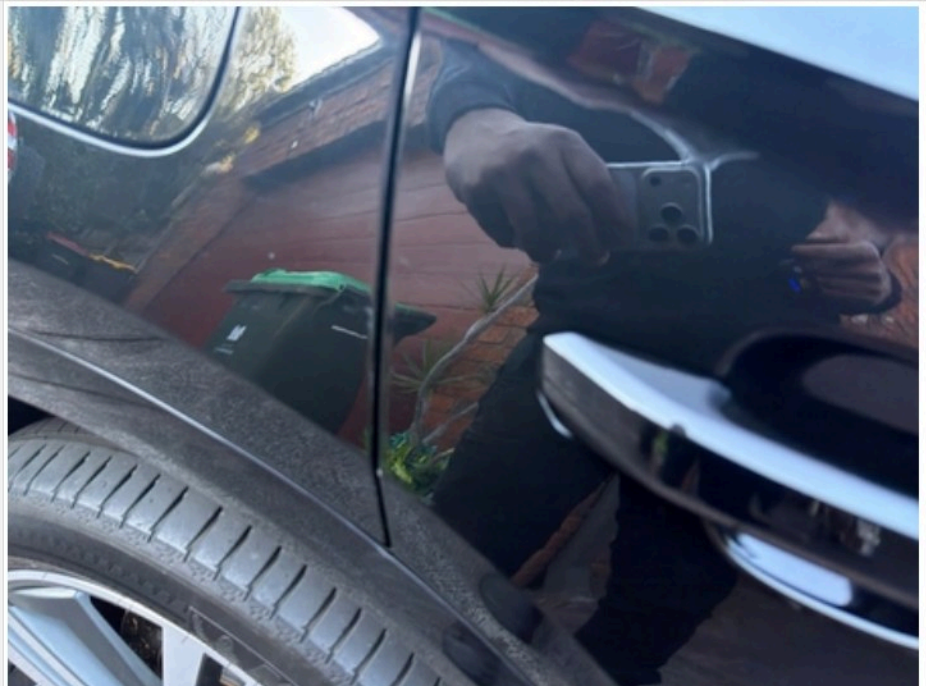
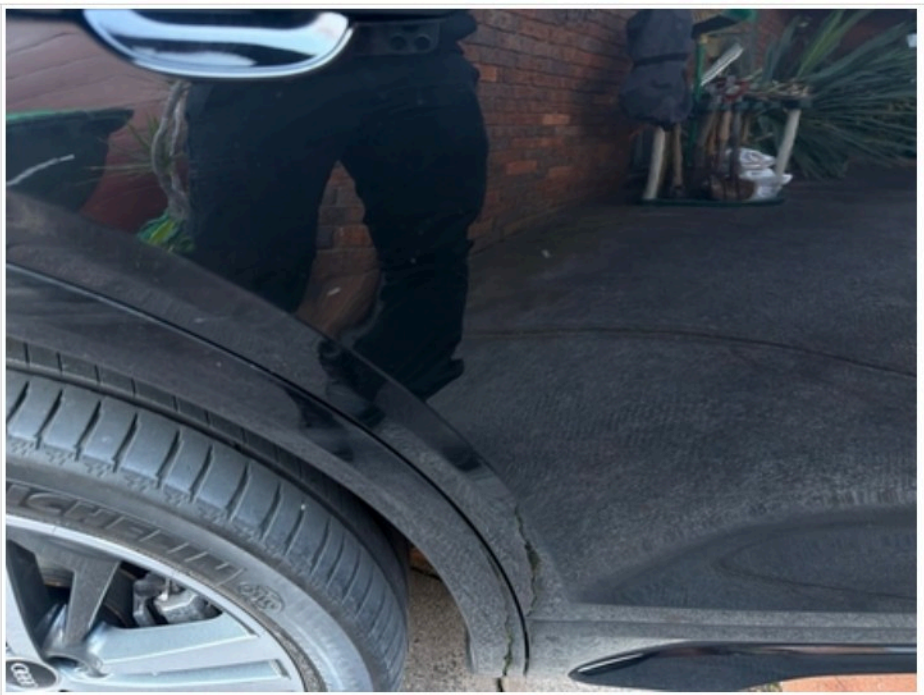
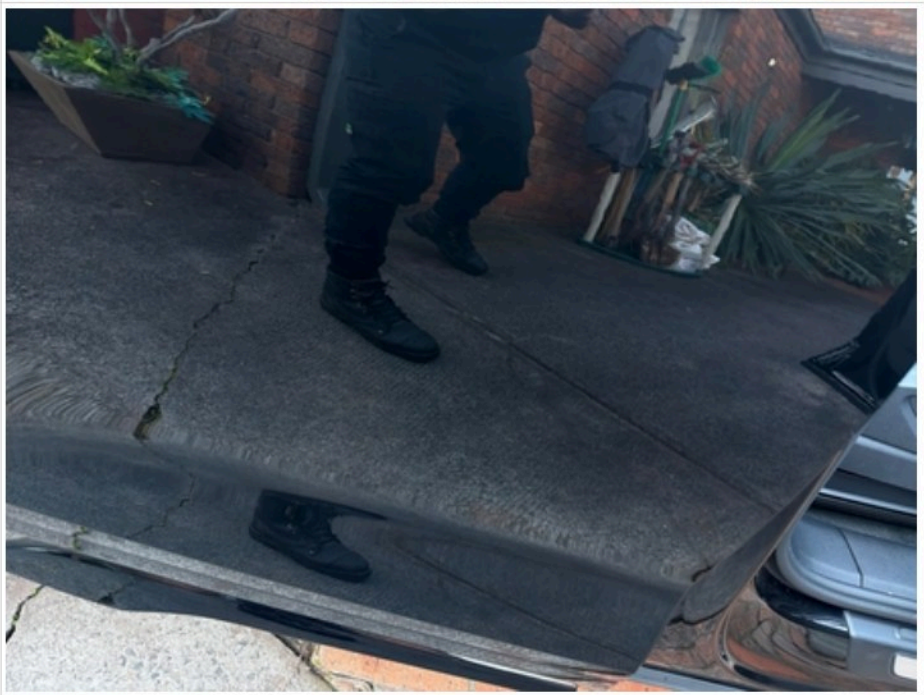
Section photos - Exterior, Body & Paint

| <p>Section notes - Exterior, Body &amp; Paint</p> | <p>Exterior is decent car do scratches all around the body please check photos.</p> |

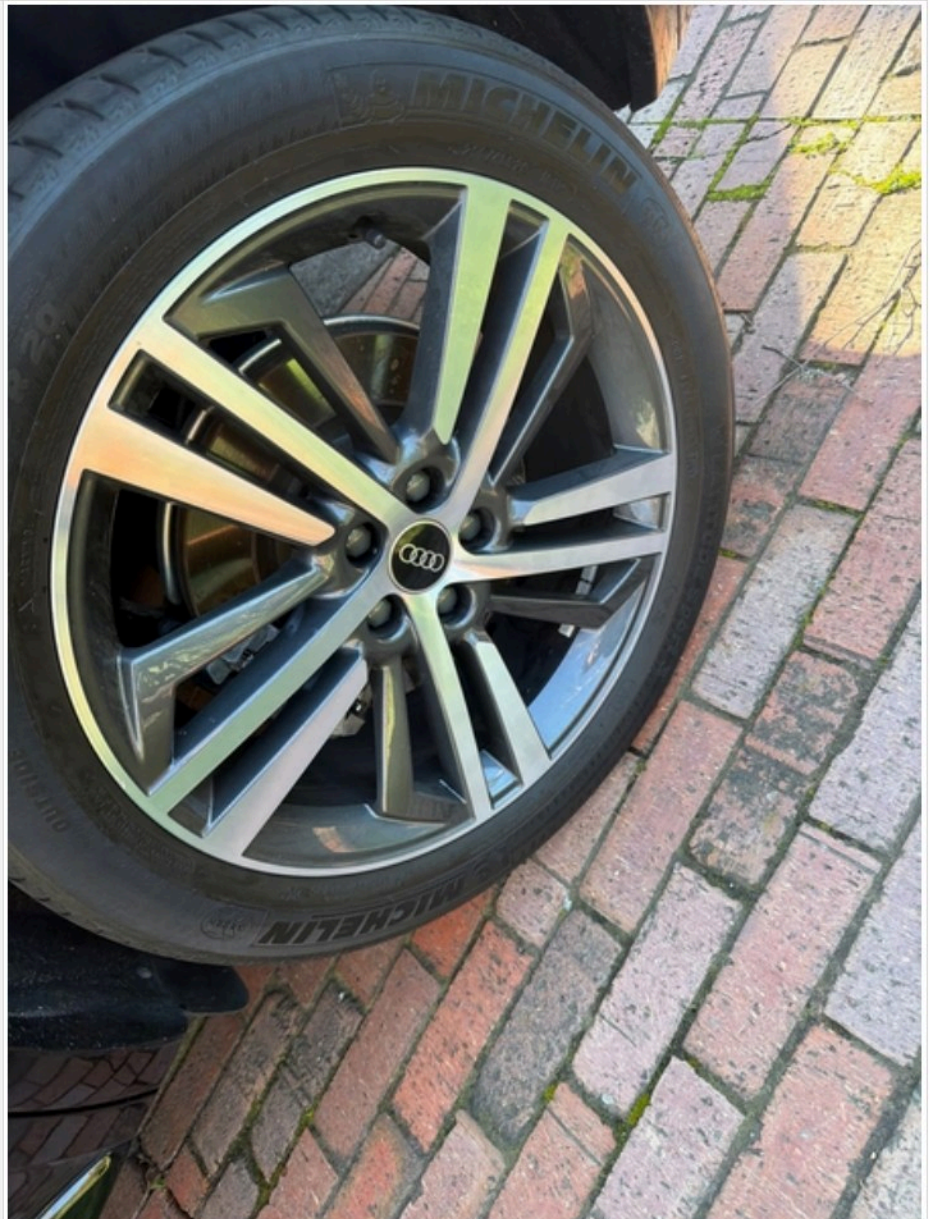
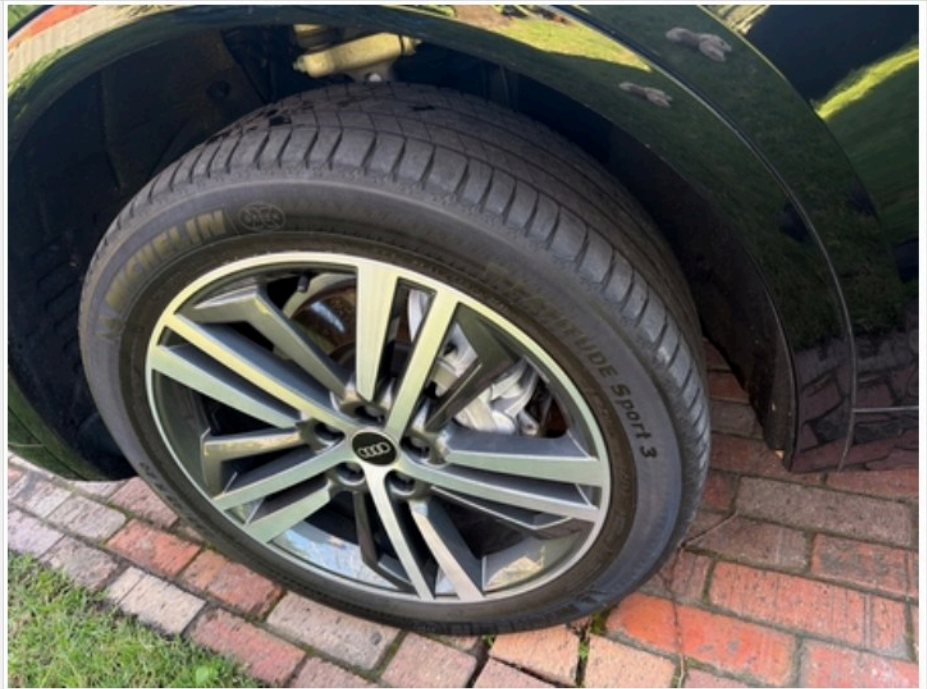
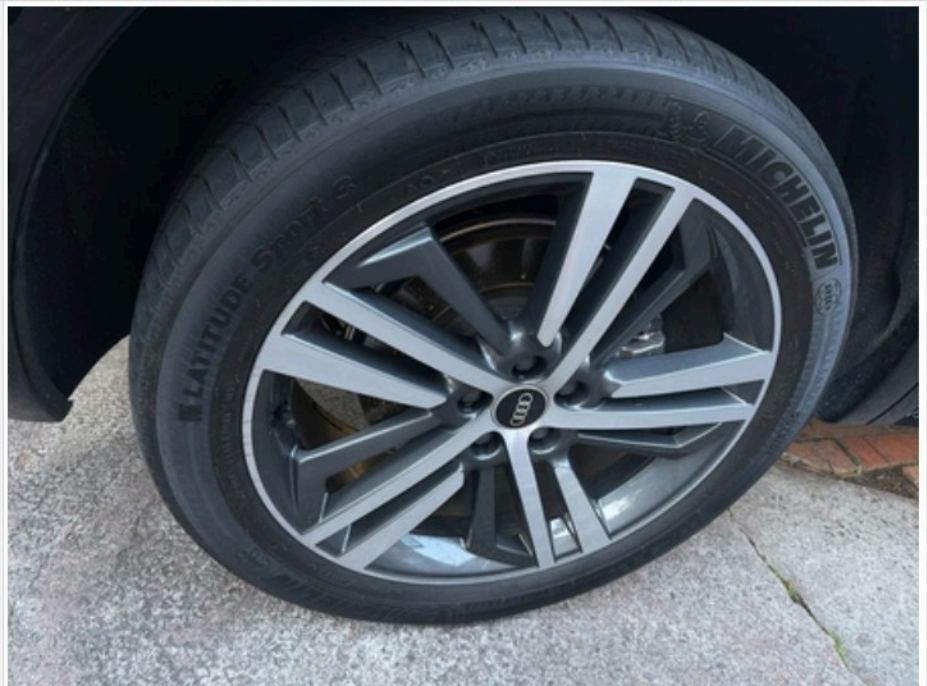
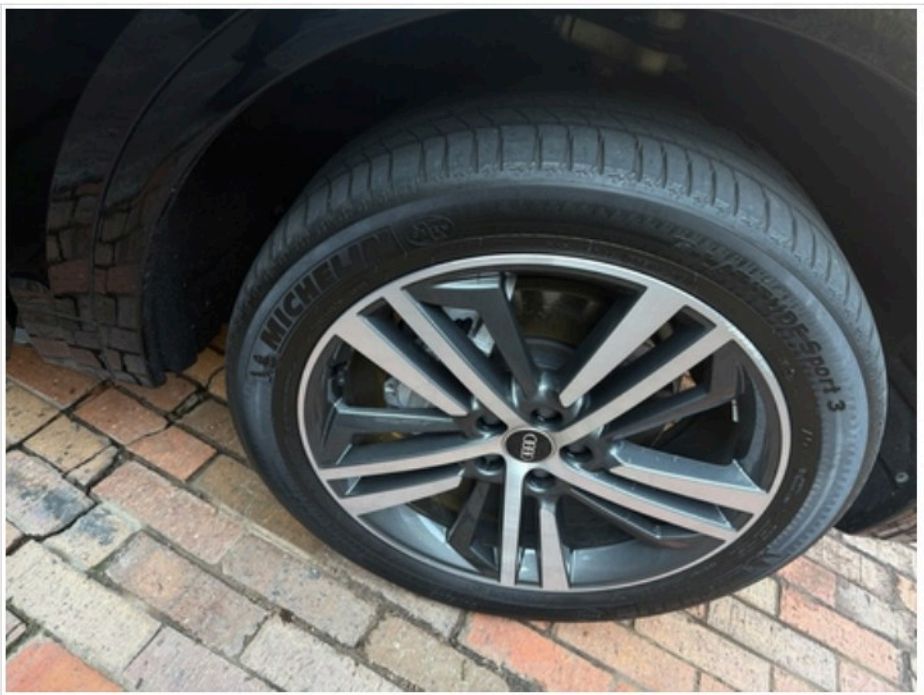
Section photos - Wheels, Tyres & Visible Brakes

| <b>Section notes - Wheels, Tyres &amp; Visible Brakes</b> | <p>All four brake pads are good 4-6 mm<br/>All four Tyres are have 60-70% left.<br/>All four wheels are pretty clean not many gutter rashes.</p> |

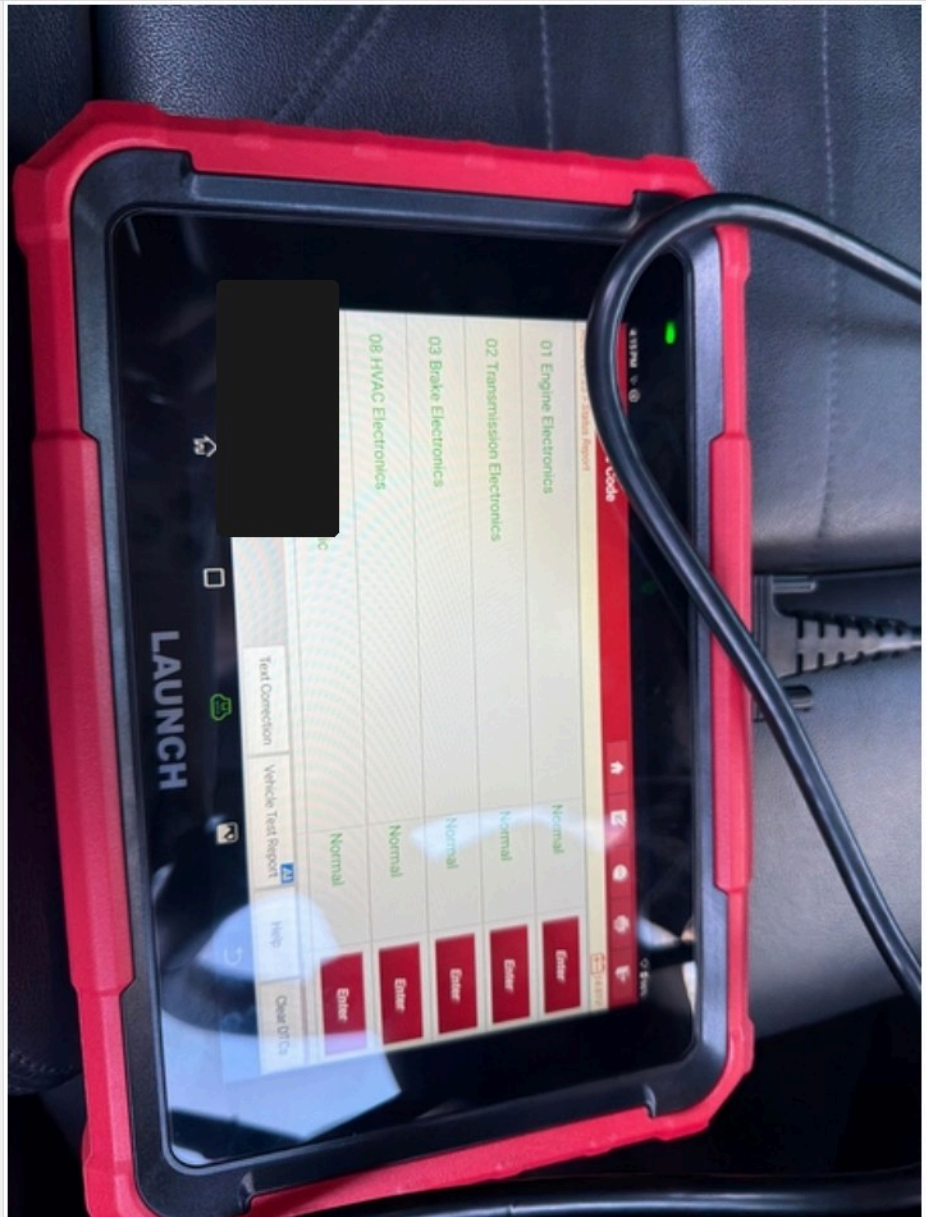
### Section photos - Diagnostic Scan

No active fault codes found.
