## SMGLR Auto Checks -Pre-Purchase Inspection Report

### 1. Customer & Vehicle Details

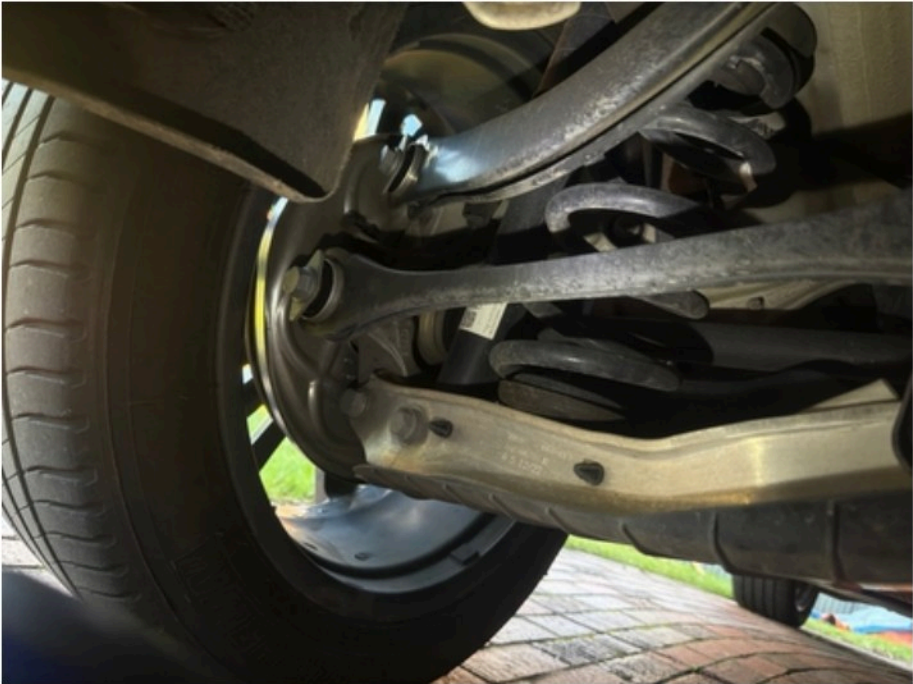
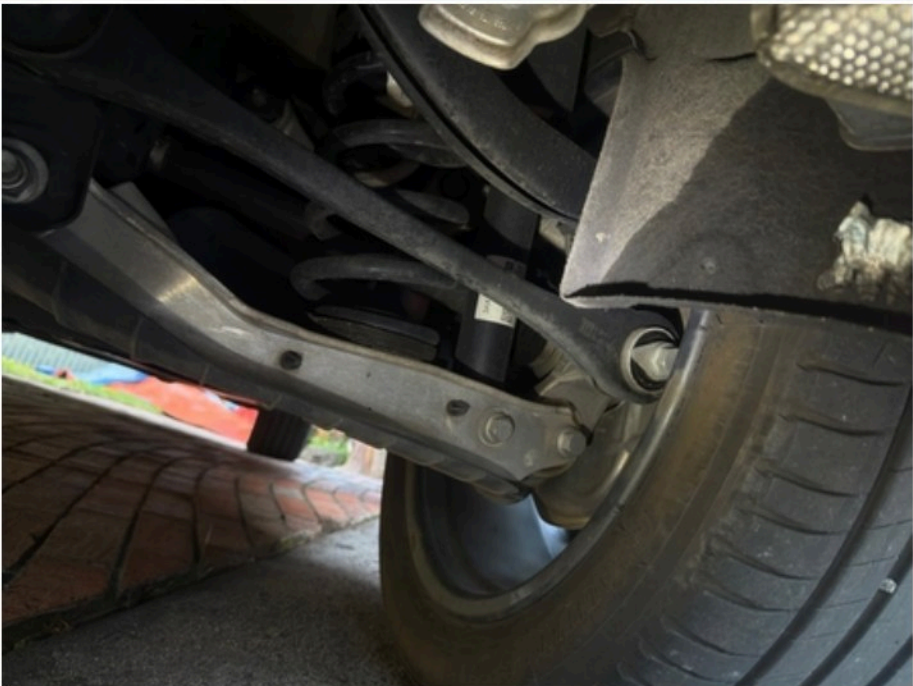
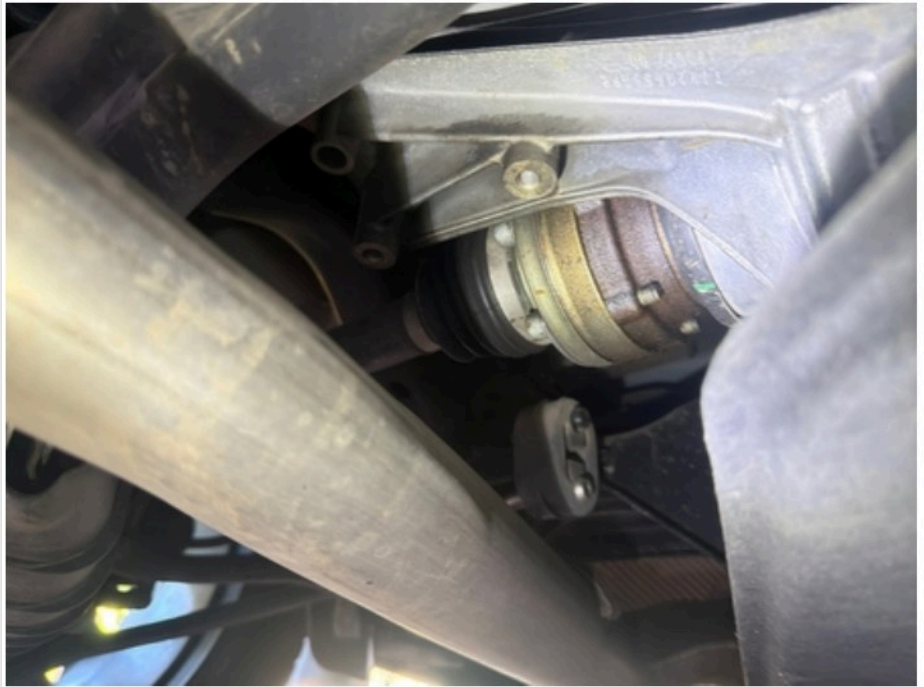
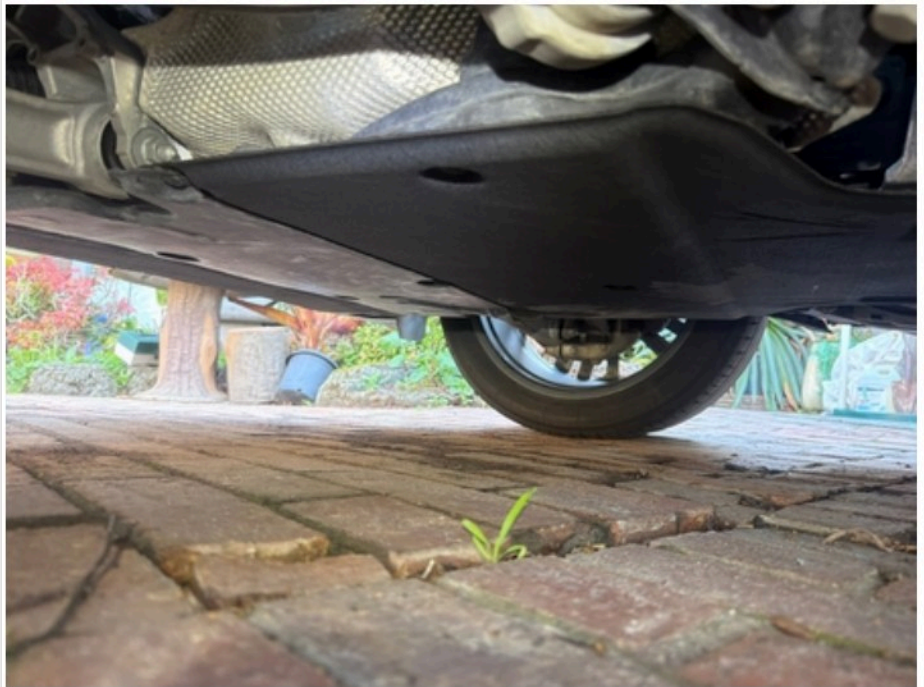
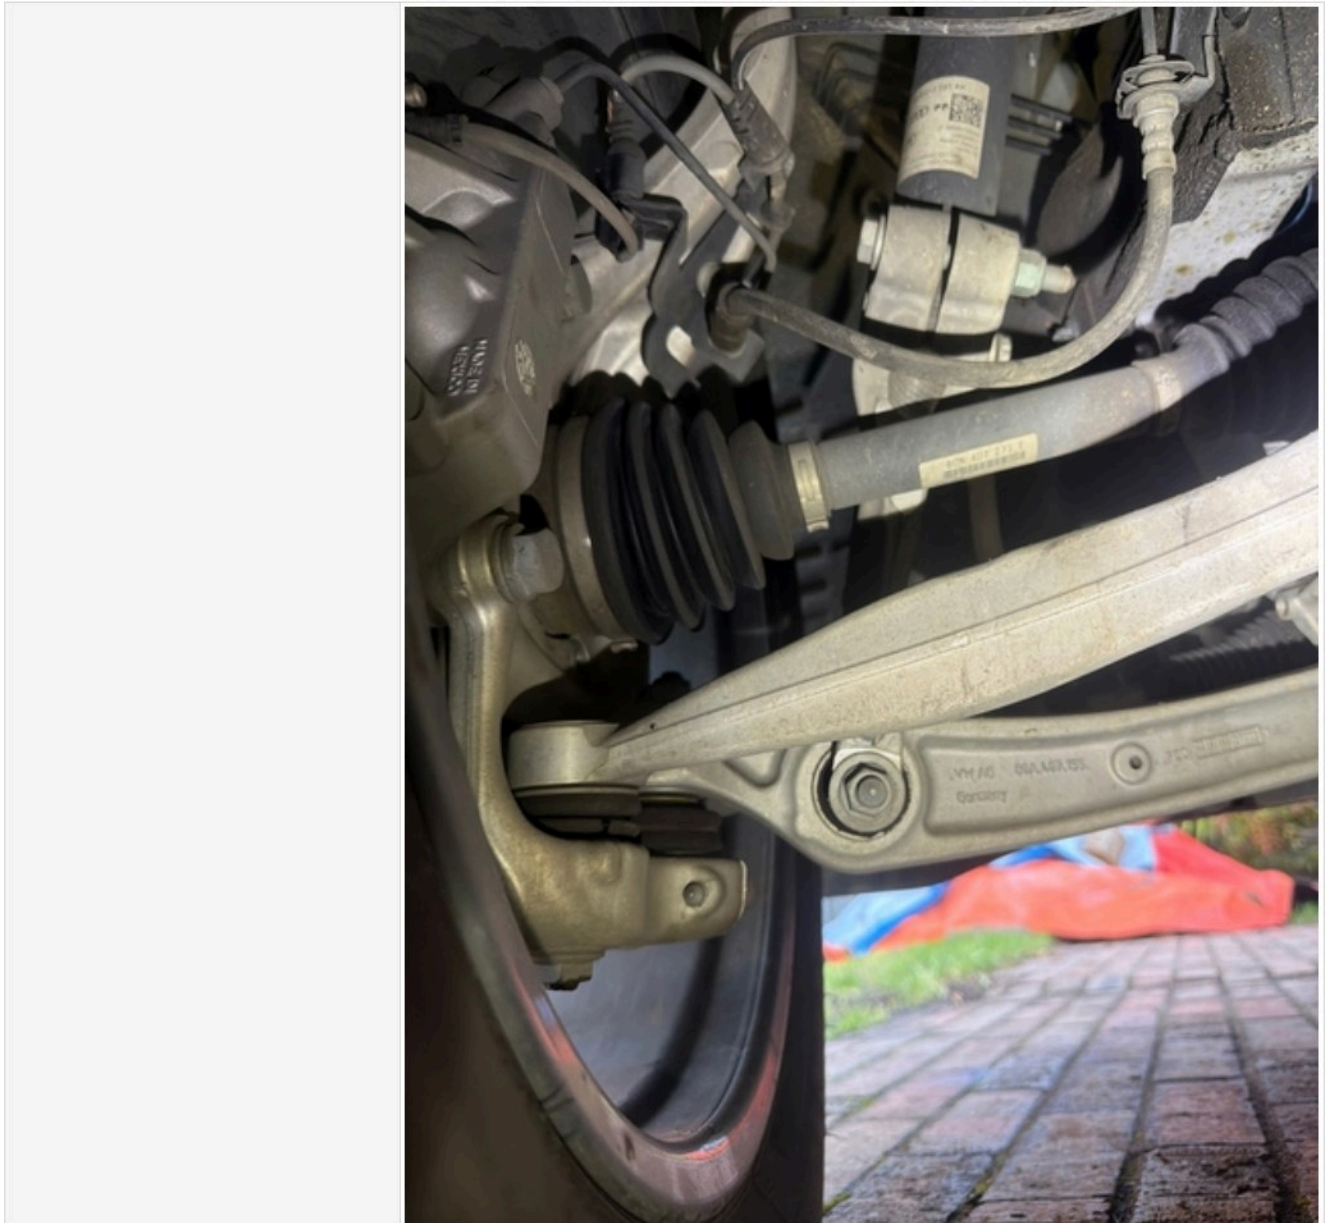
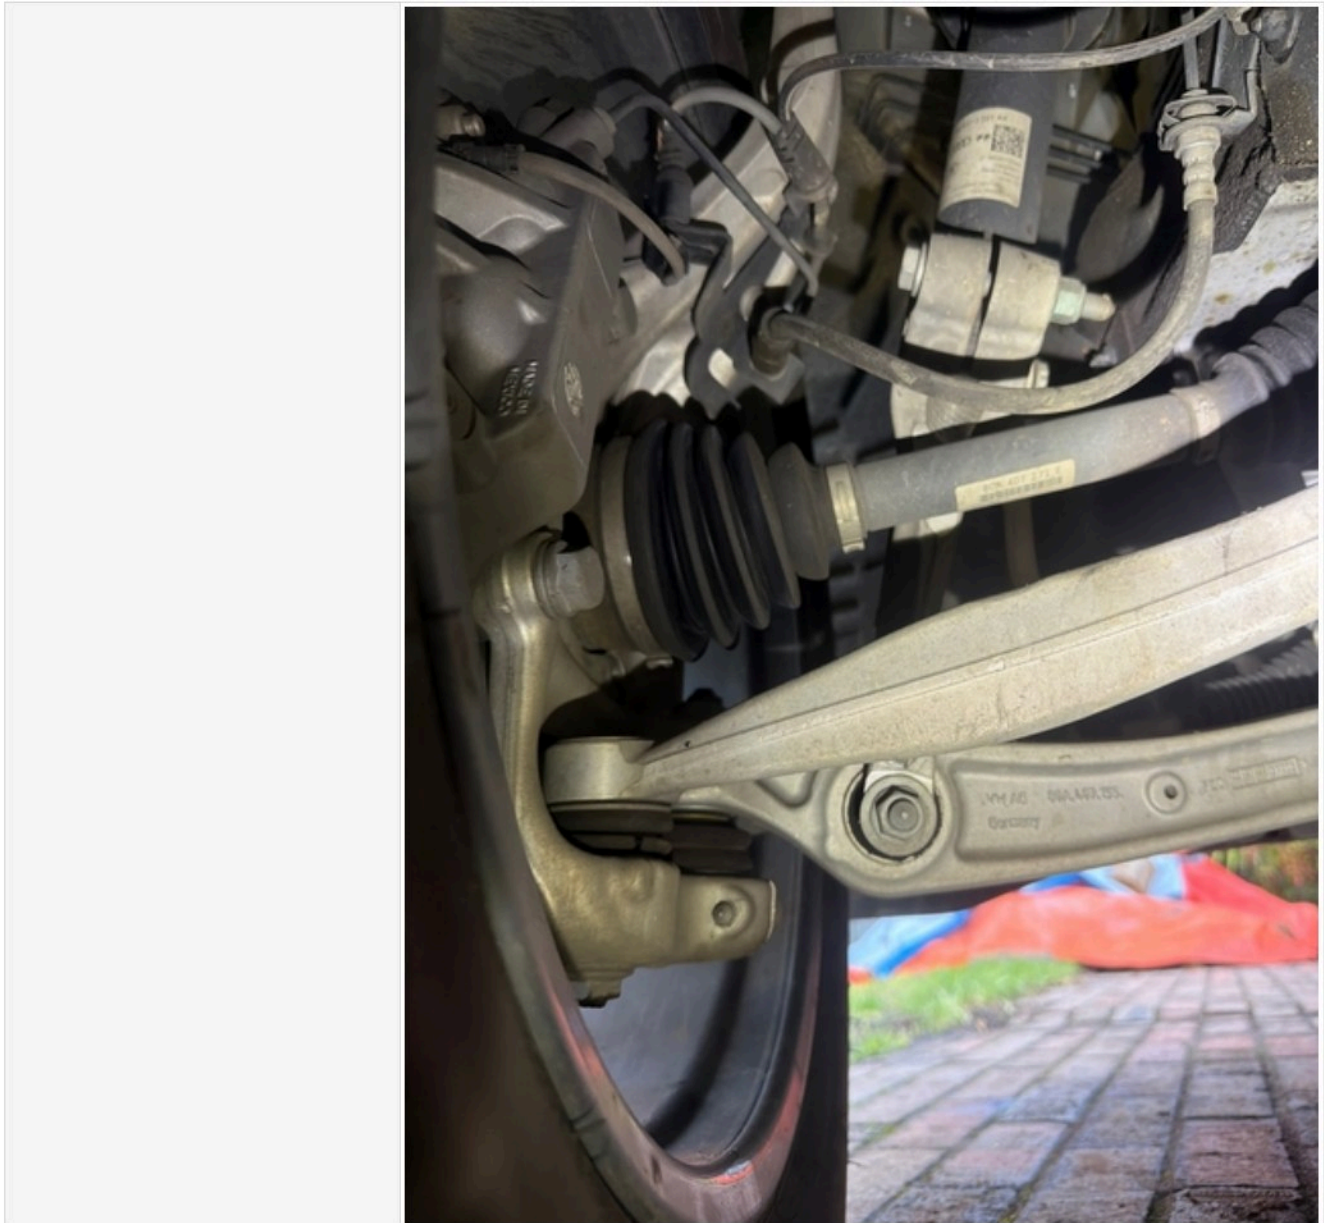
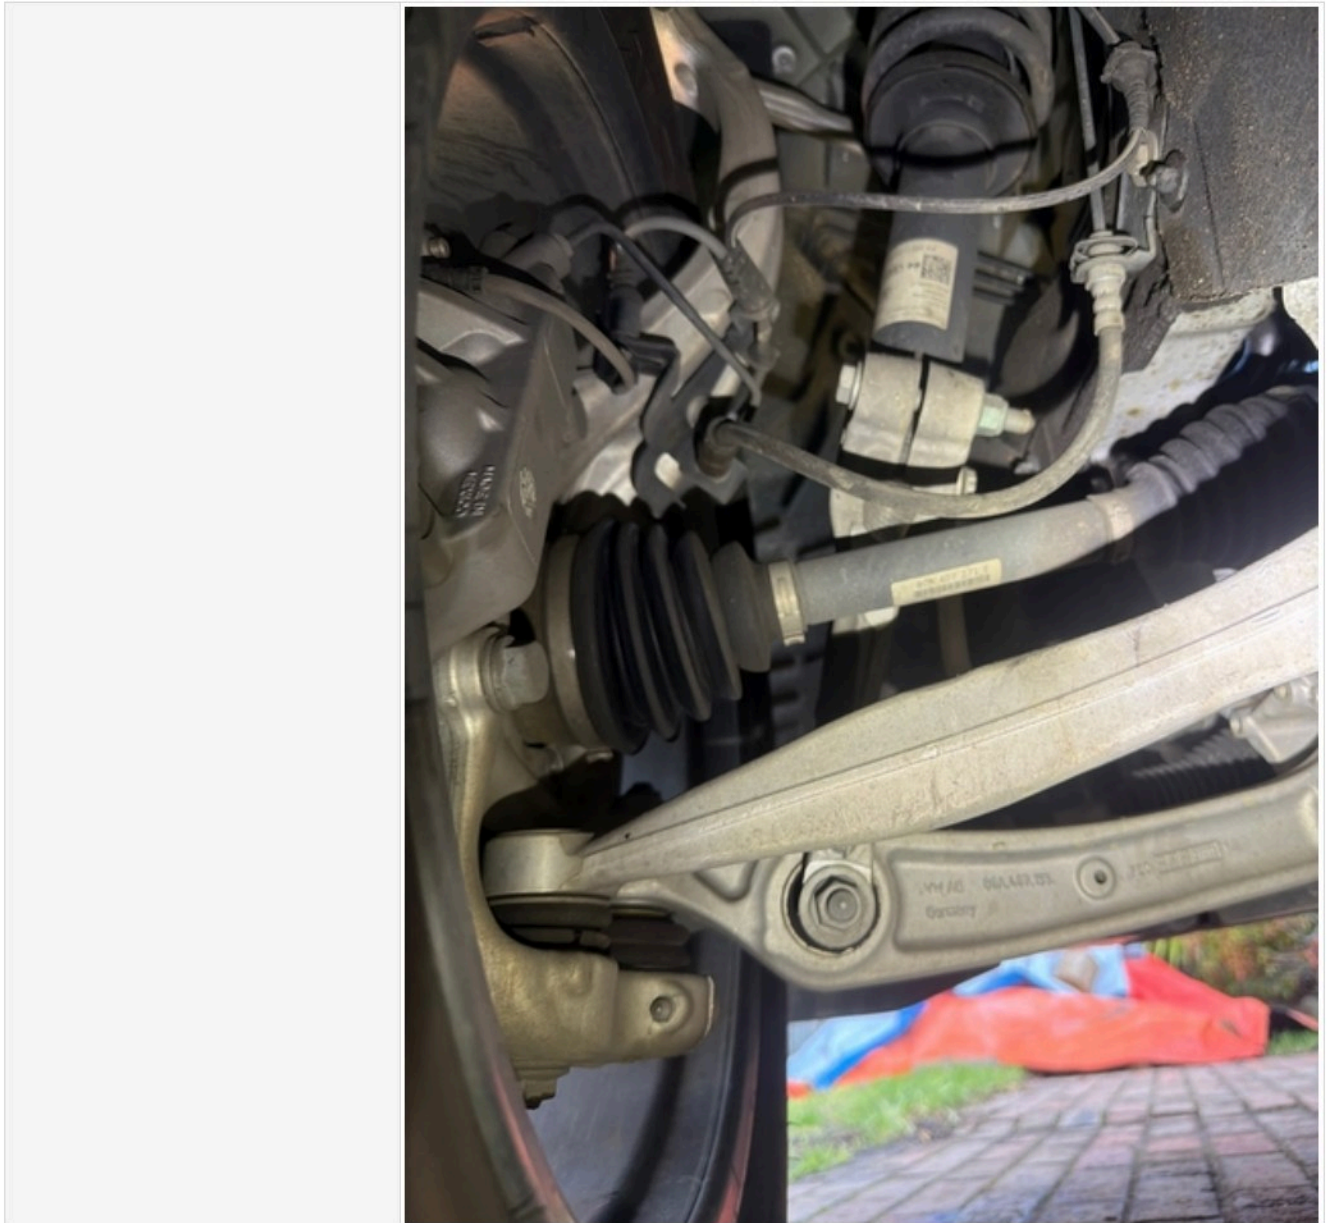
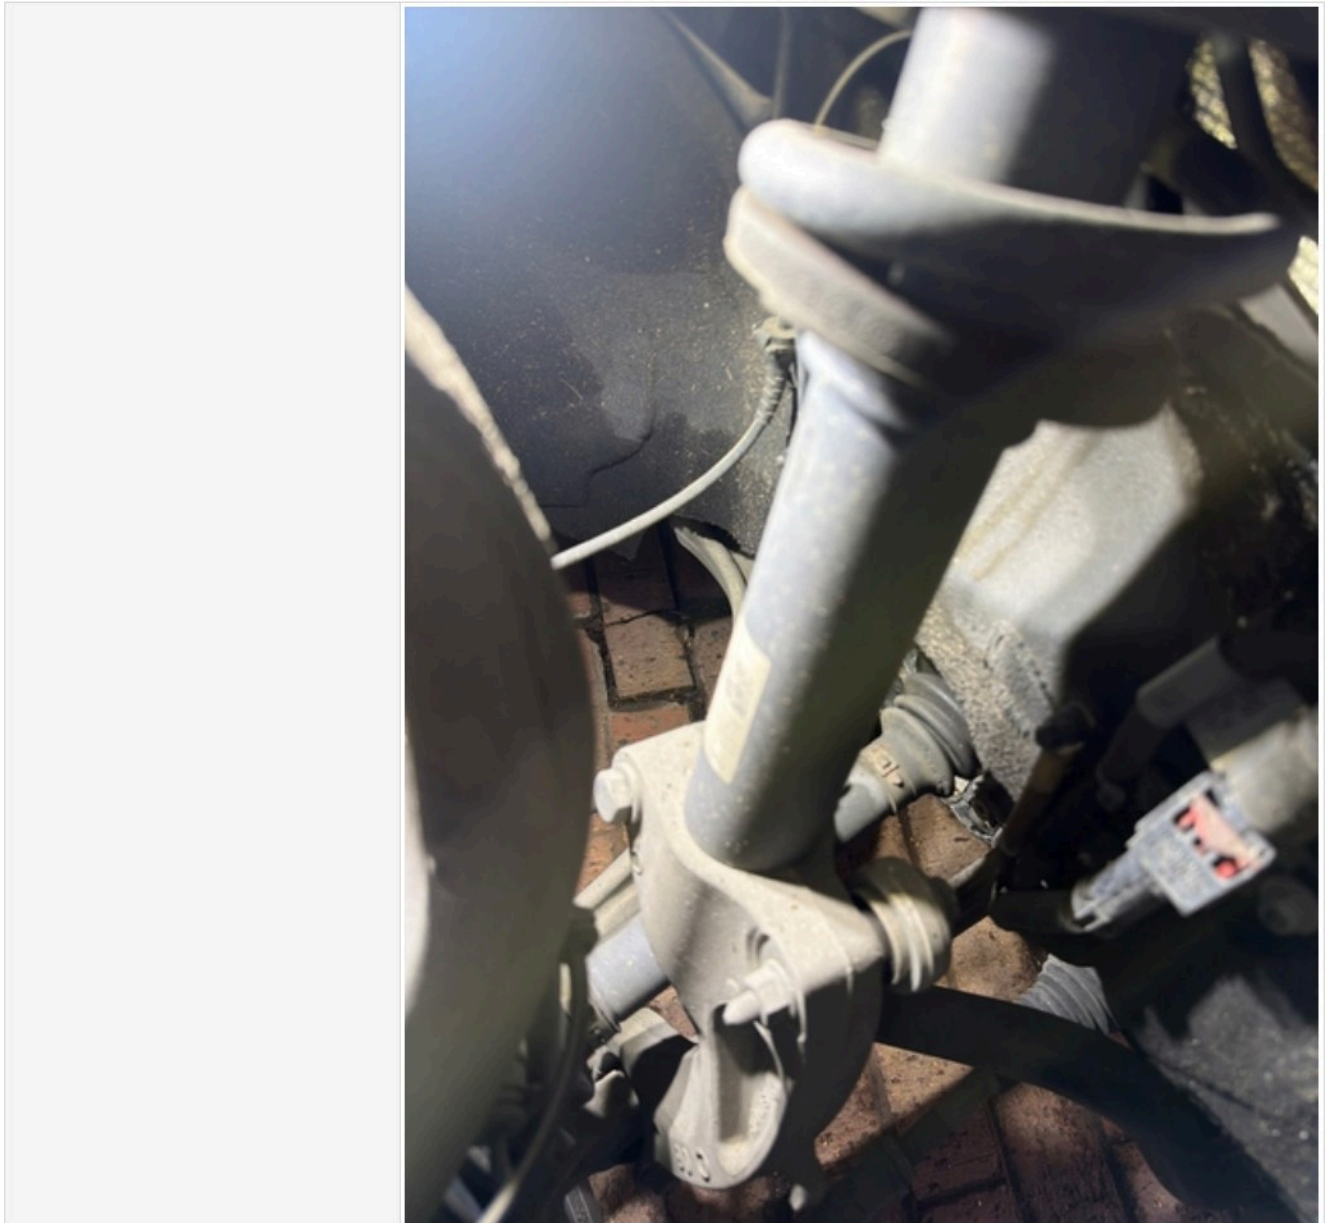
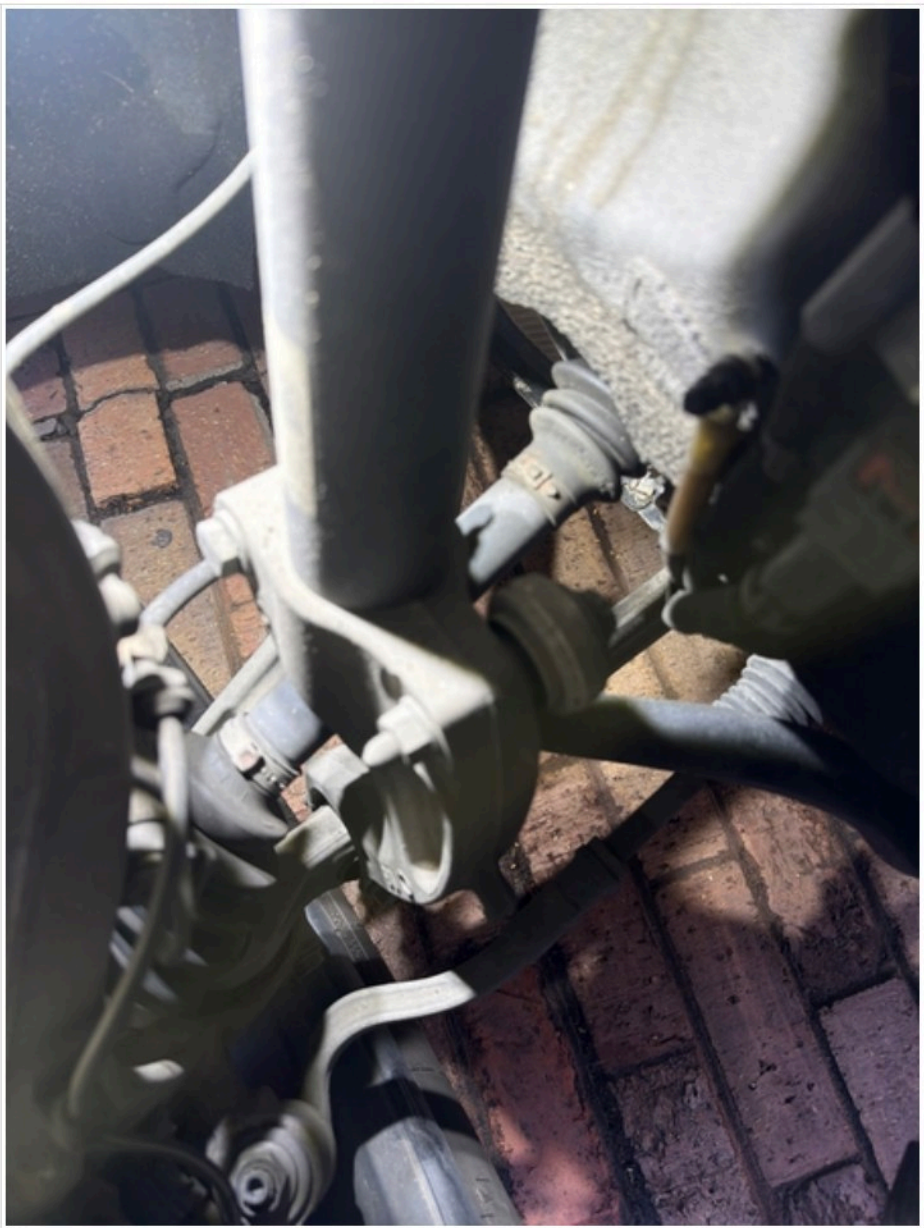
| <b>Section notes - Underbody &amp; Exhaust</b> | <p>Car had an under tray. Borescope has been used to check for the active oil leaks. At the time of the inspection no active leak has been found. Rear differential left hand axle had oil residue around it but no active leak.</p> |
