# PRE-PURCHASE INSPECTION REPORT

Independent vehicle condition assessment by SMGLR Auto Checks

Mazda3

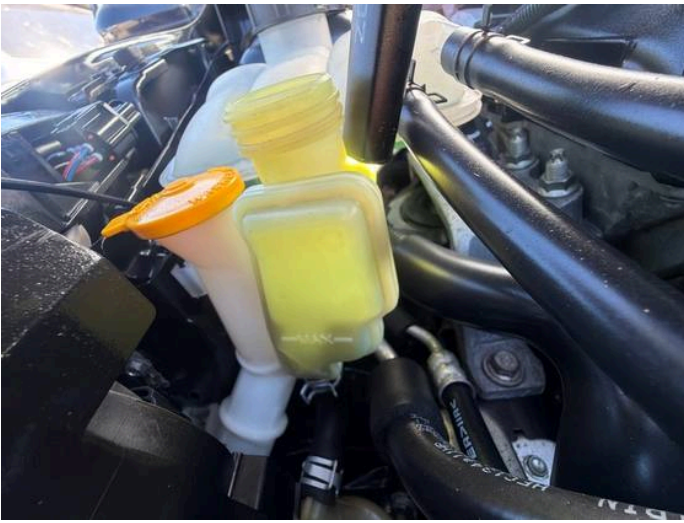
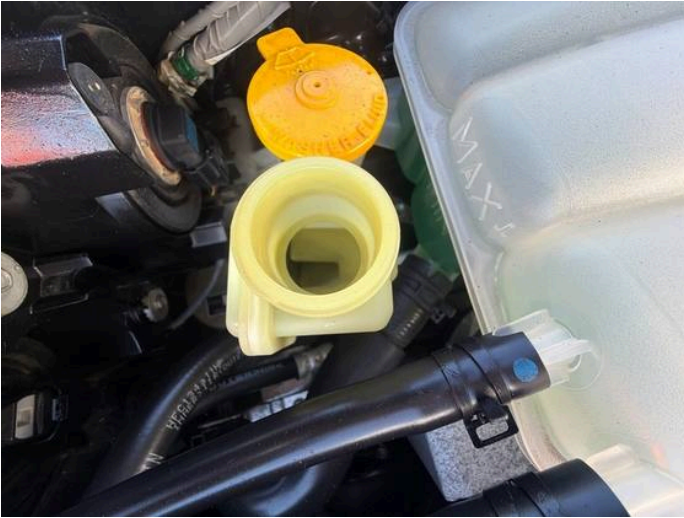
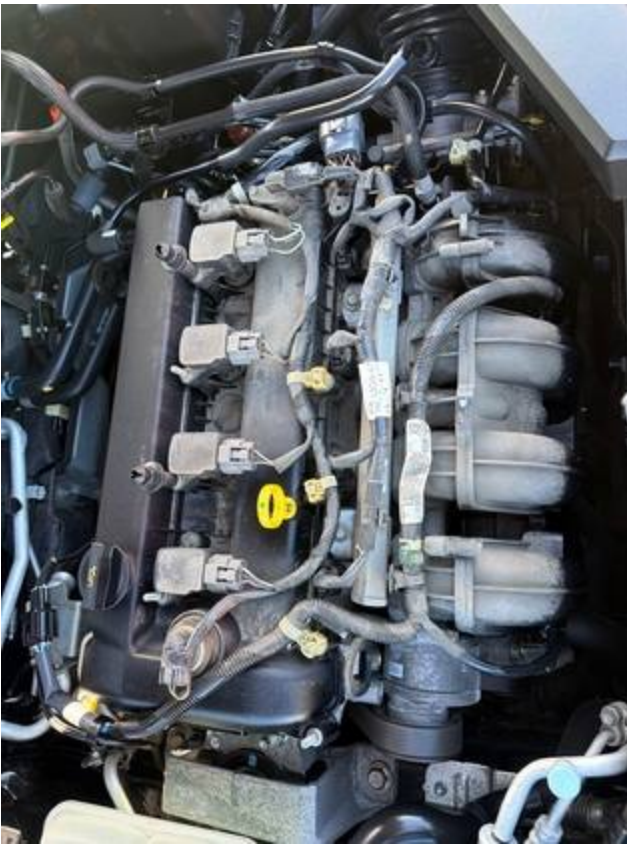
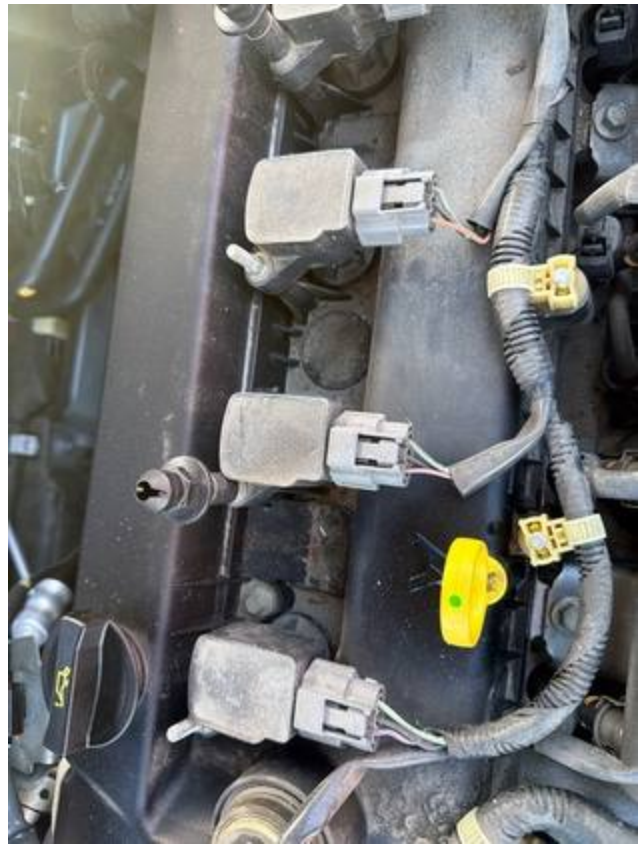
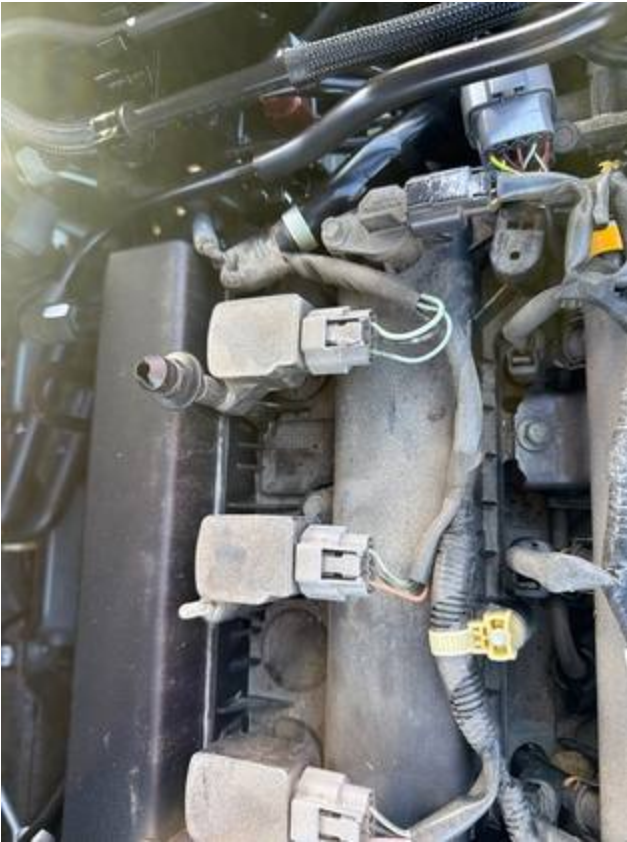
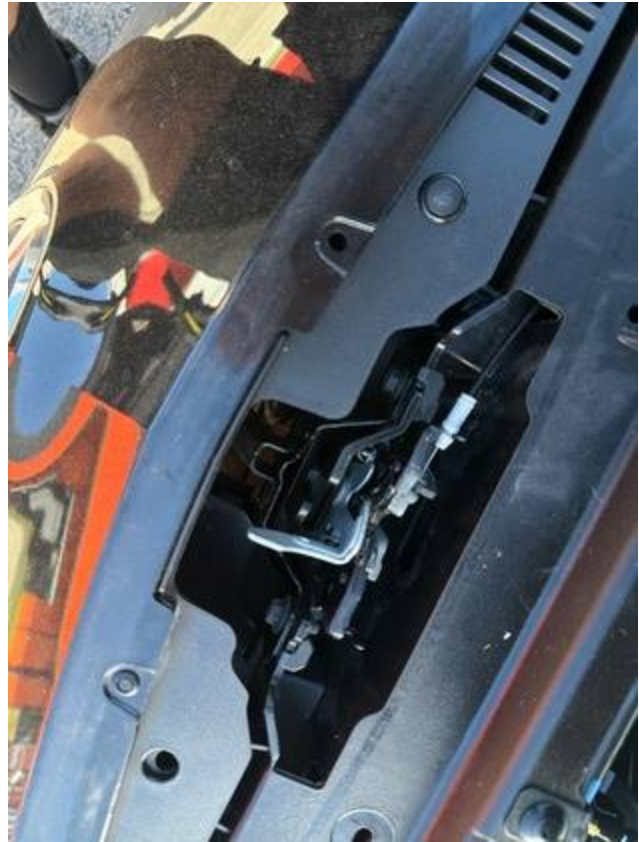
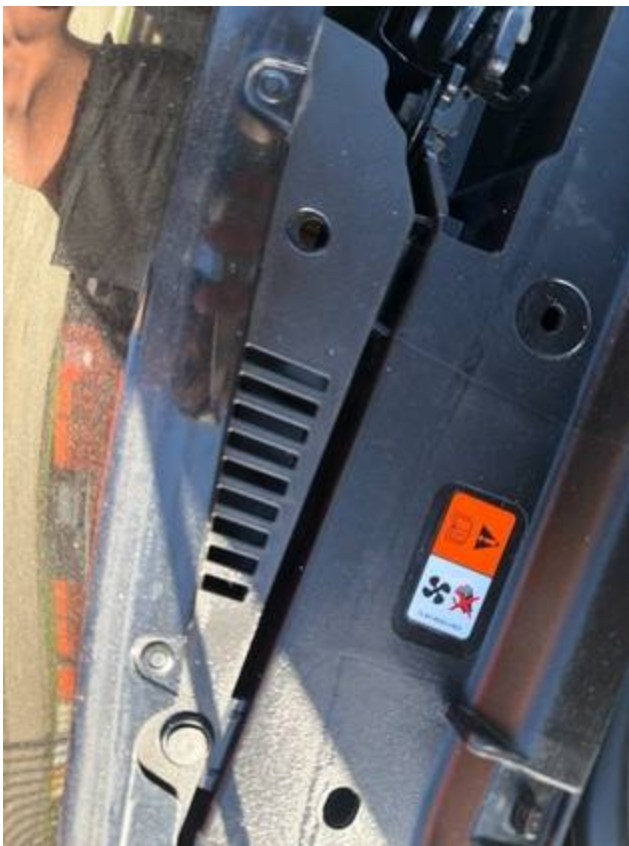
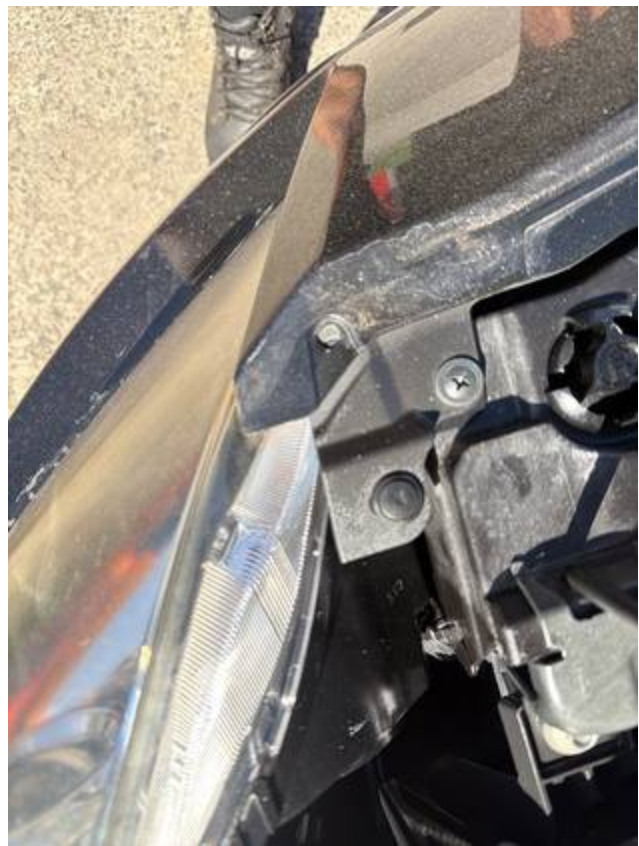
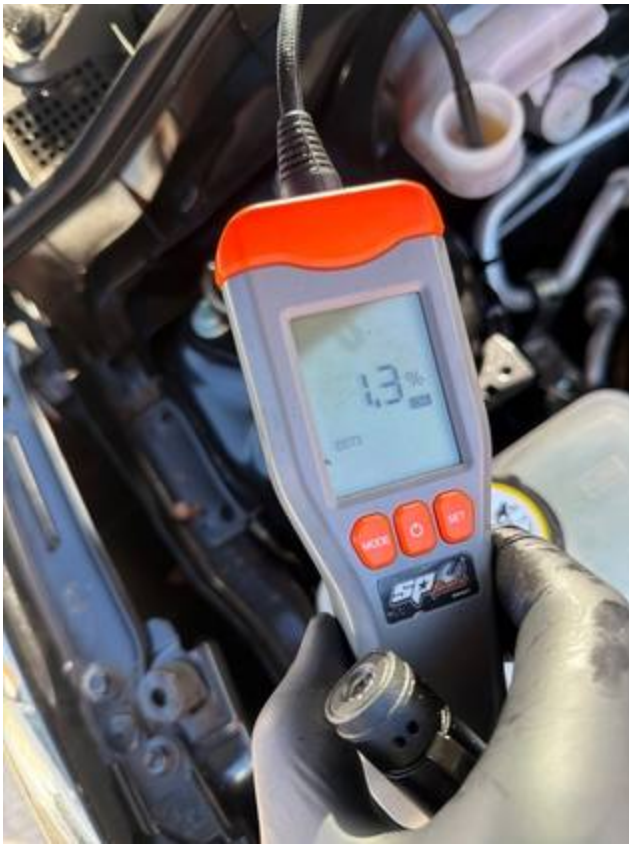
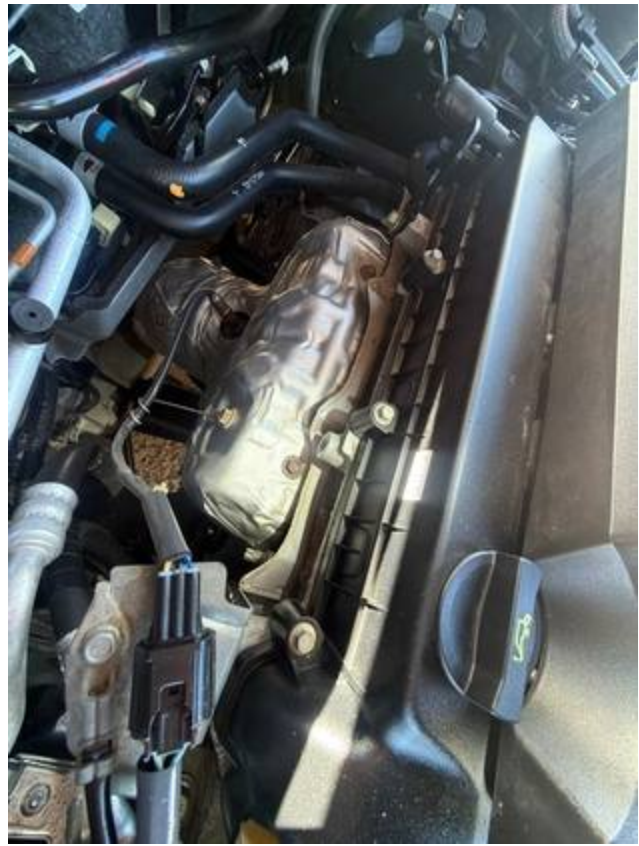
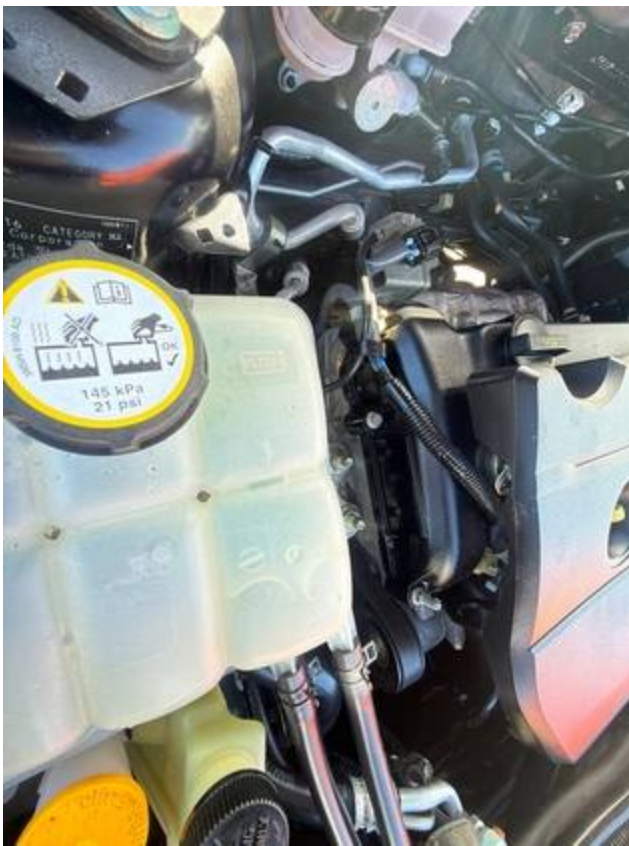
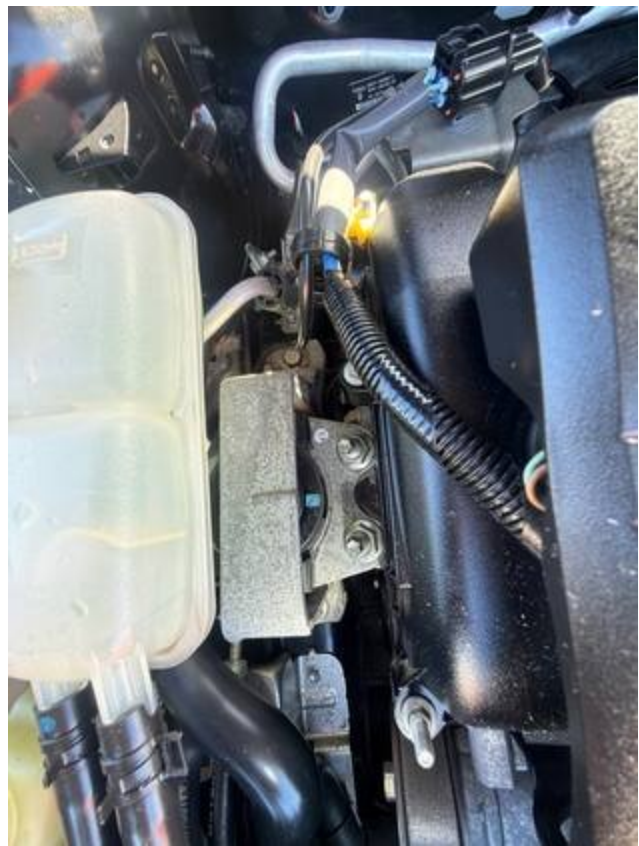
### Section photos – Engine Bay & Fluids

- \* Engine oil level satisfactory.
- \* Transmission fluid level satisfactory.
- \* Coolant level satisfactory.
- \* Brake fluid level satisfactory.
- \* Engine mounts appeared to be in decent condition.
- \* No active leaks detected around the engine bay.
- \* Oil residue noted around the power steering hoses.
- \* Power steering fluid reservoir found empty.
- \* Possible power steering fluid loss/leak requires further investigation.
- \* Seller was made aware of the issue.

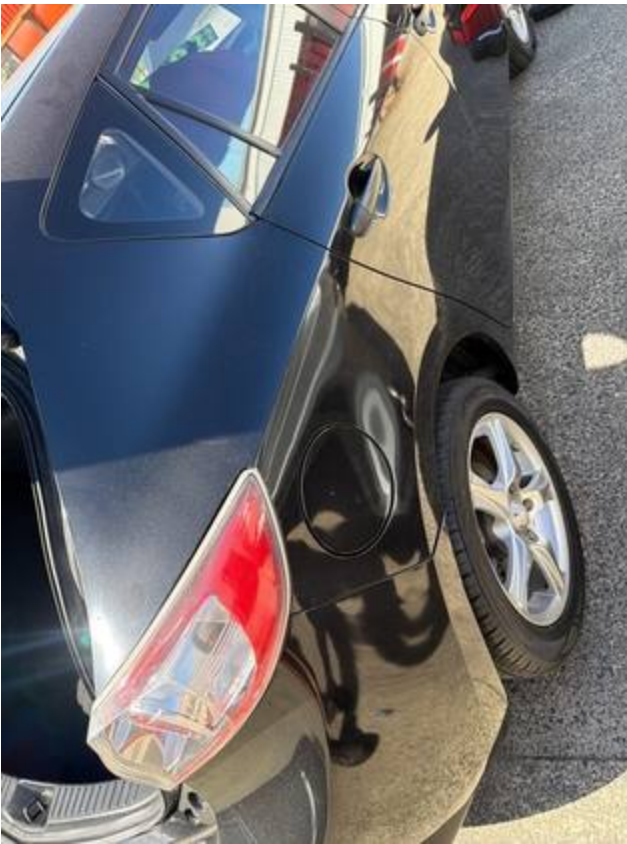
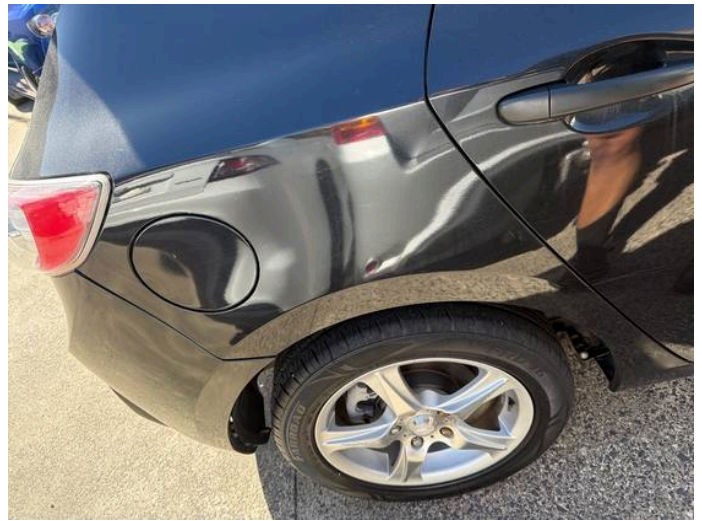
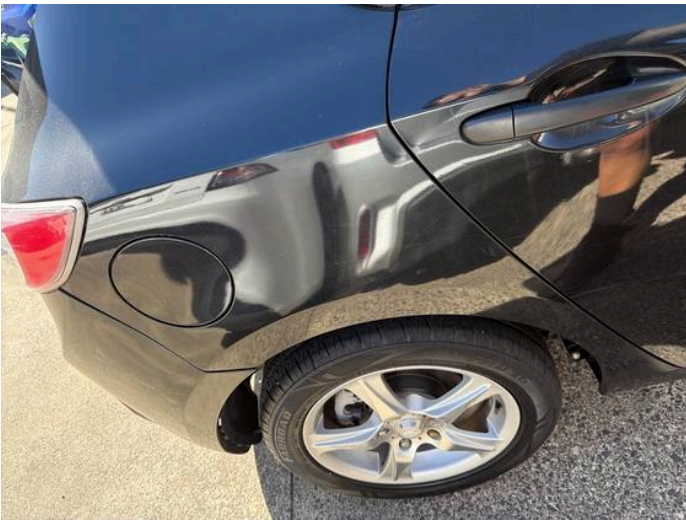
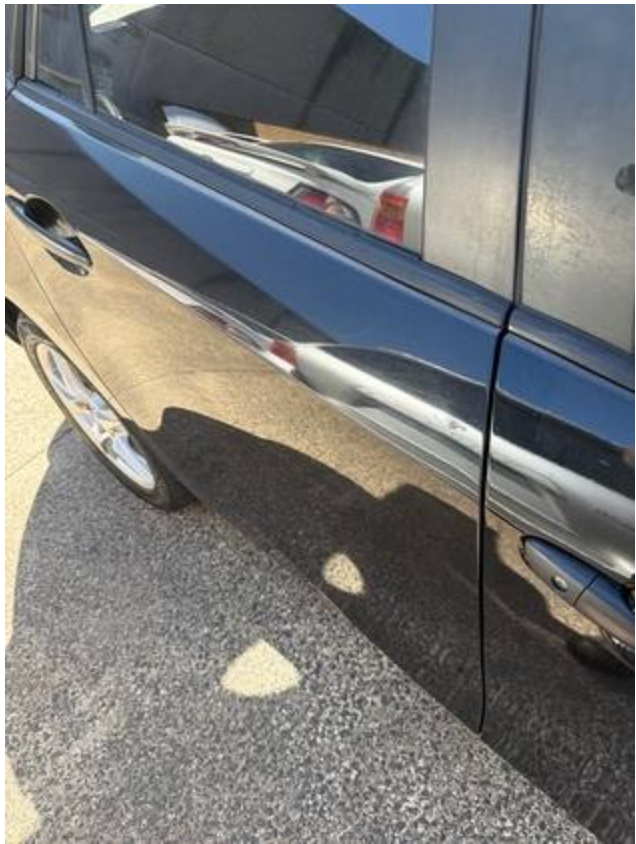
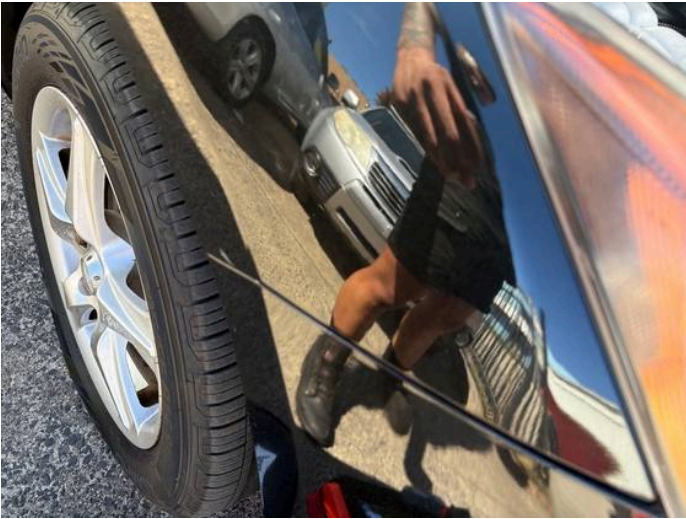
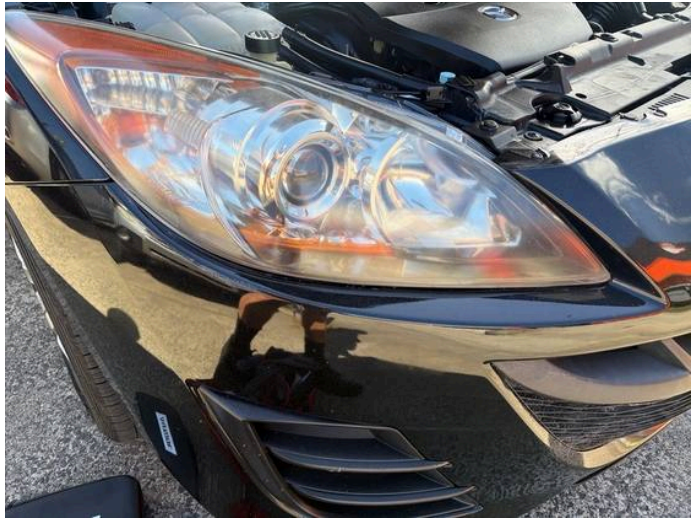
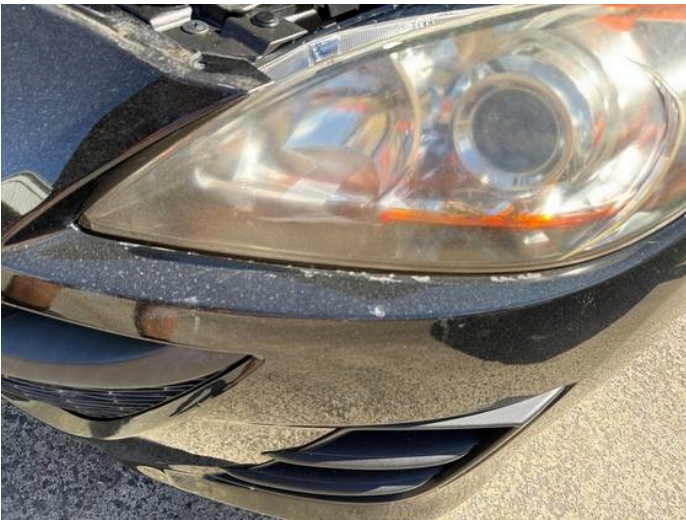
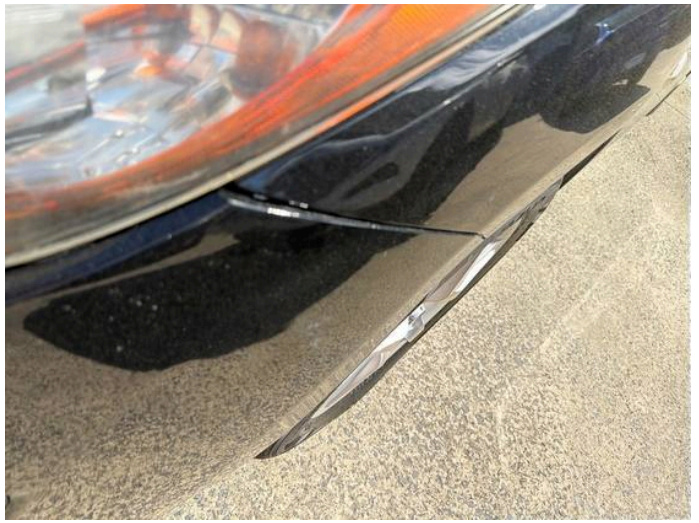
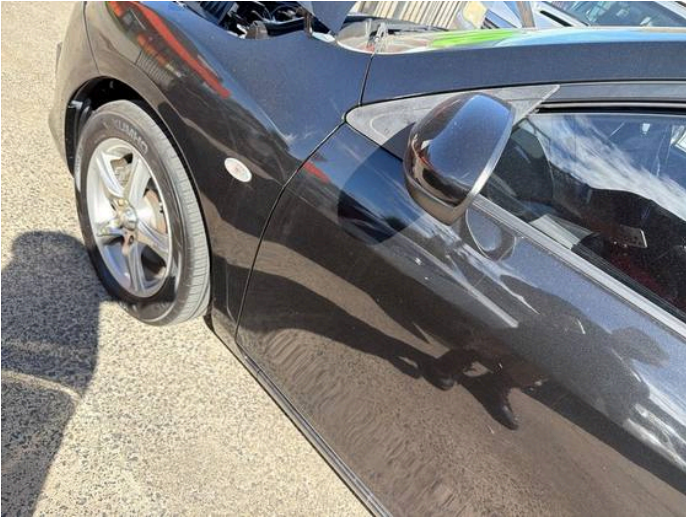
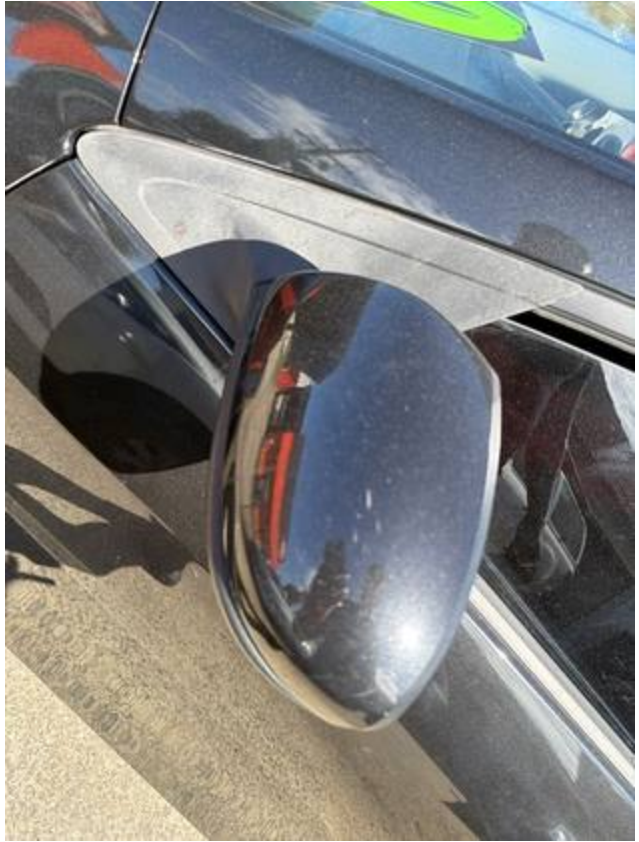
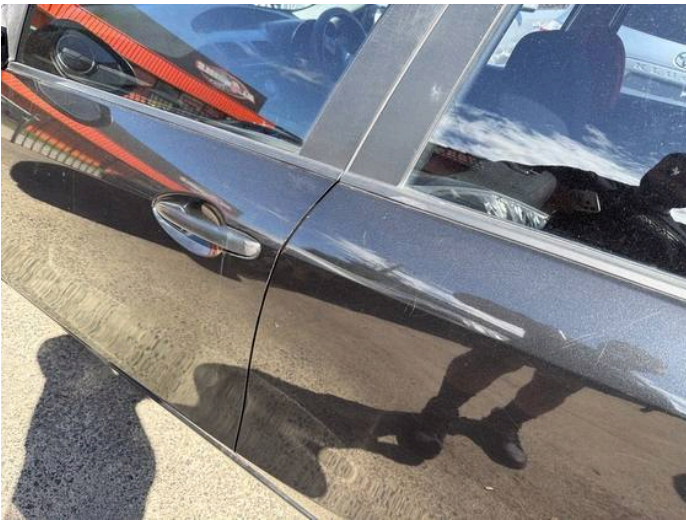
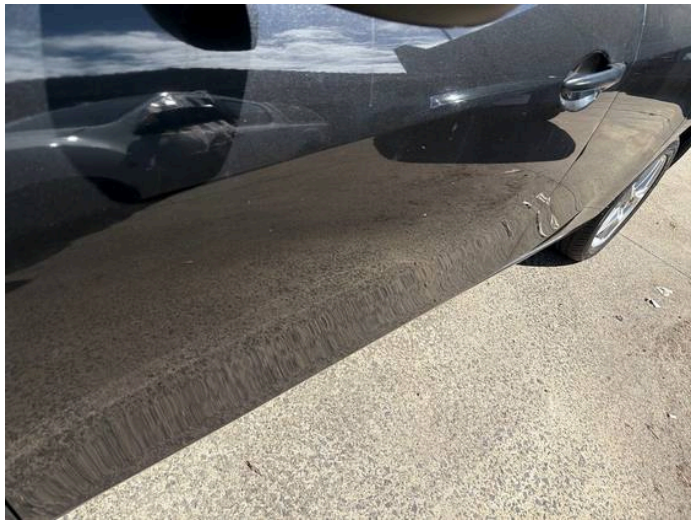
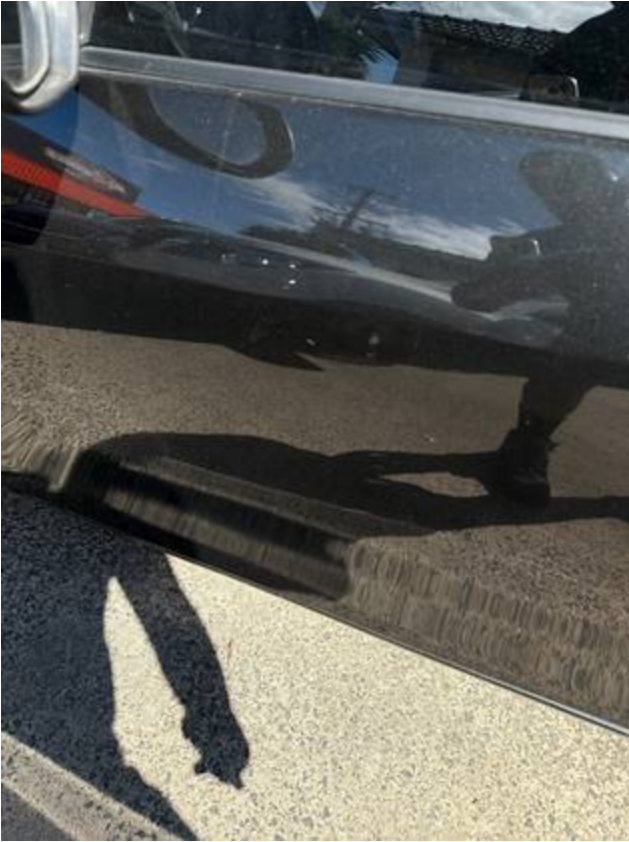
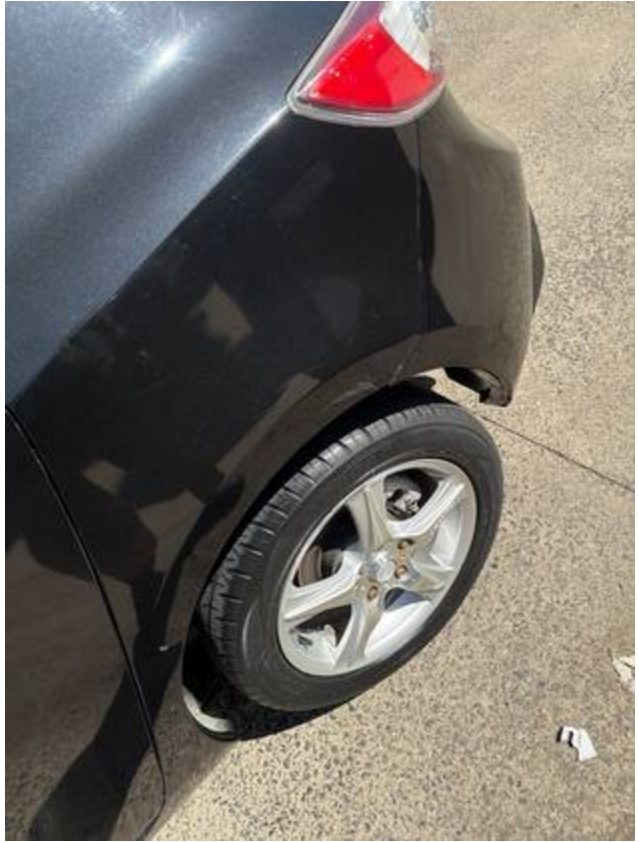
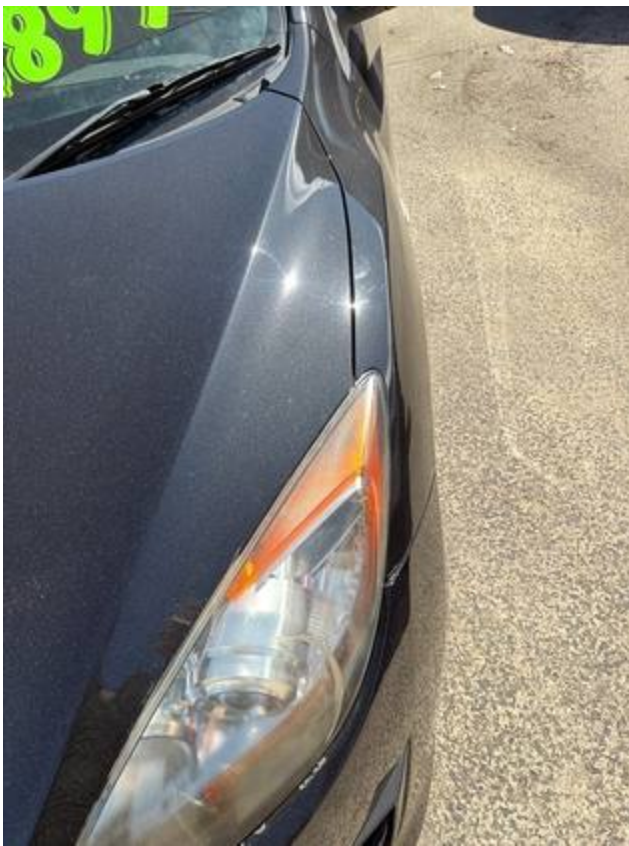
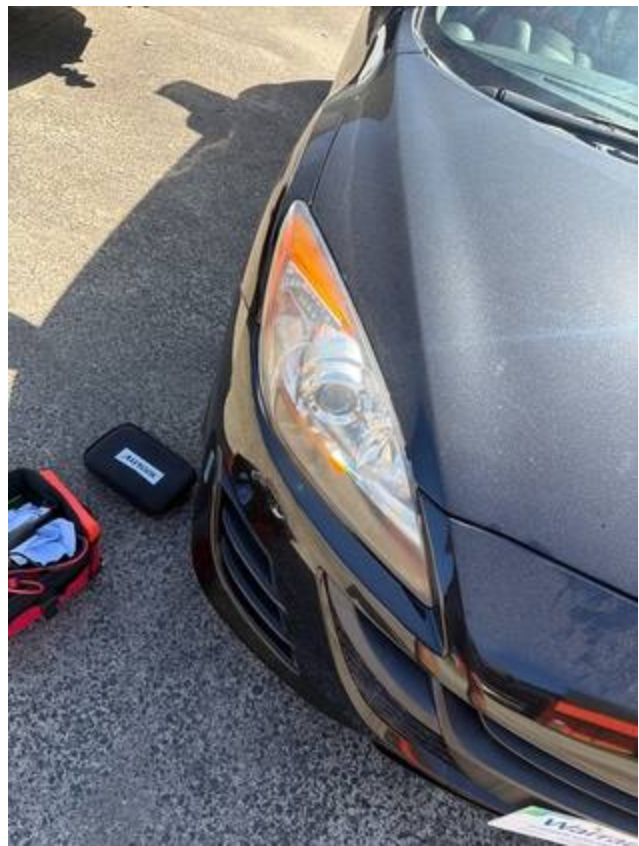
### Section photos – Exterior, Body & Paint

- \* Multiple scratches noted around the vehicle body.
- \* Several retaining clips were missing from the front and rear bumpers, indicating the bumpers had previously been removed.
- \* No obvious accident damage or repair work was detected during the visual inspection.
- \* PPSR check returned clear at the time of inspection.

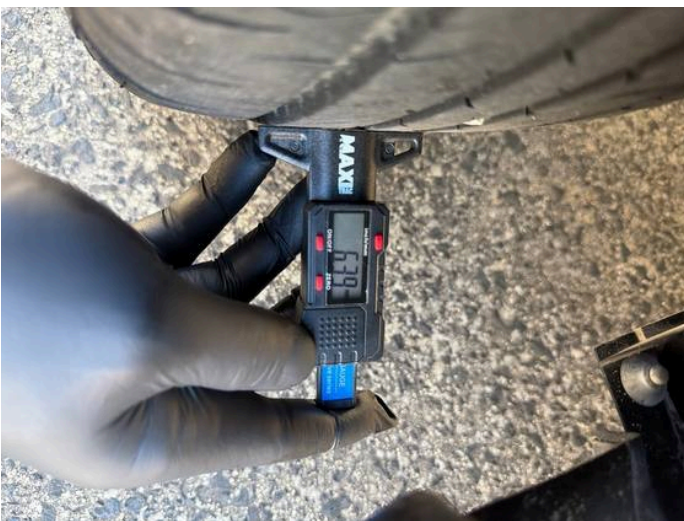
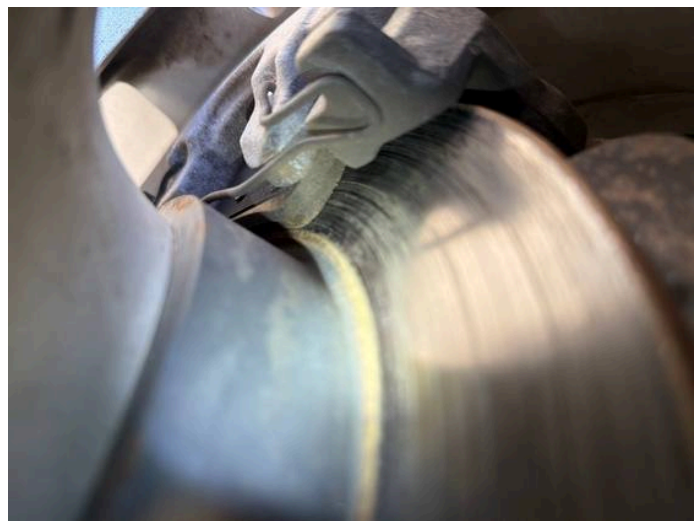
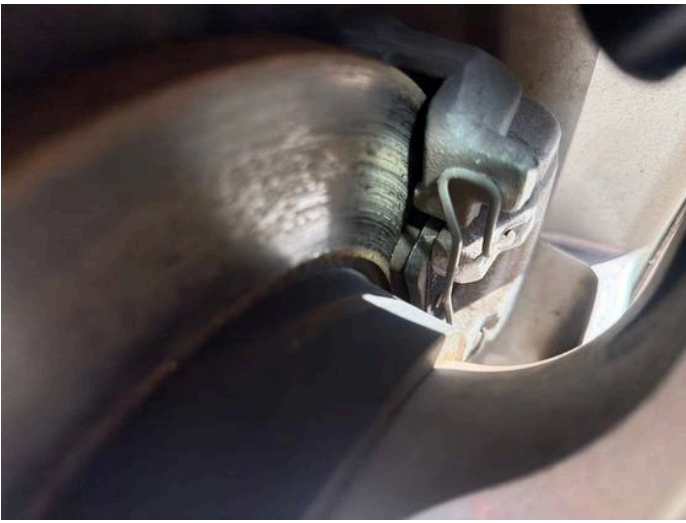
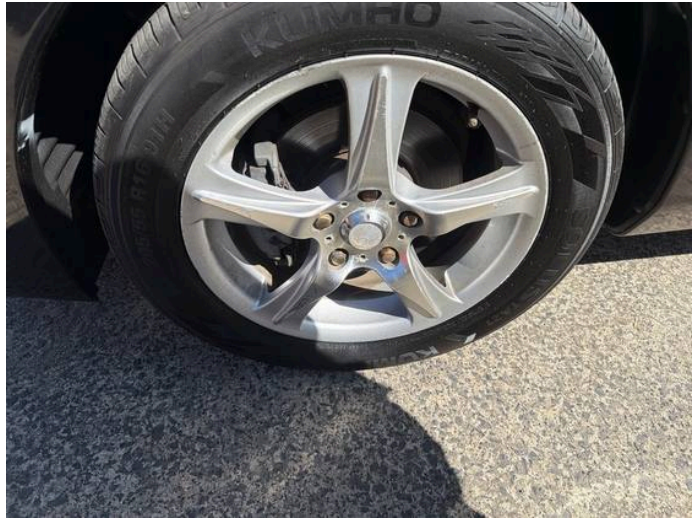
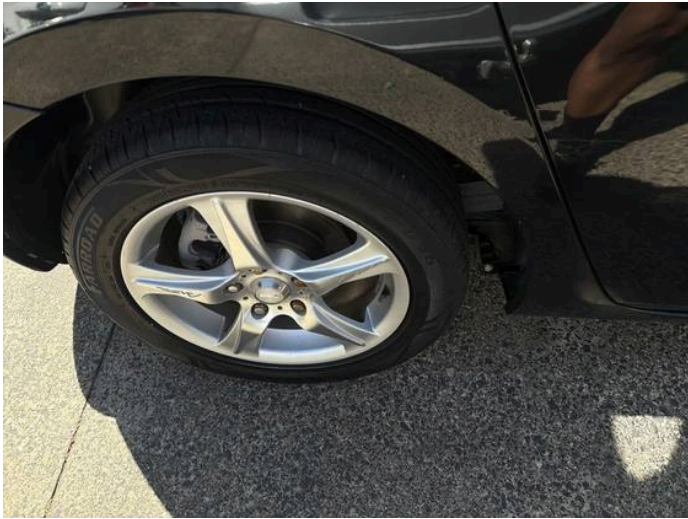
### Section photos – Wheels, Tyres & Visible Brakes

- \* Front tyres have around 90% tread remaining.
- \* Rear tyres have around 70% tread remaining and should still have good life left, depending on how much the vehicle is driven.
- \* Front brake pads are around 3.5 mm and may need replacing within the next few months.
- \* Rear brake pads are around 4 mm and are okay for now.
- \* All four wheels have some gutter rash, which is normal for the vehicle's age.
- \* Spare tyre was not secured properly and should be fastened correctly.
