# PRE-PURCHASE INSPECTION REPORT

Independent vehicle condition assessment by SMGLR Auto Checks

Mazda3

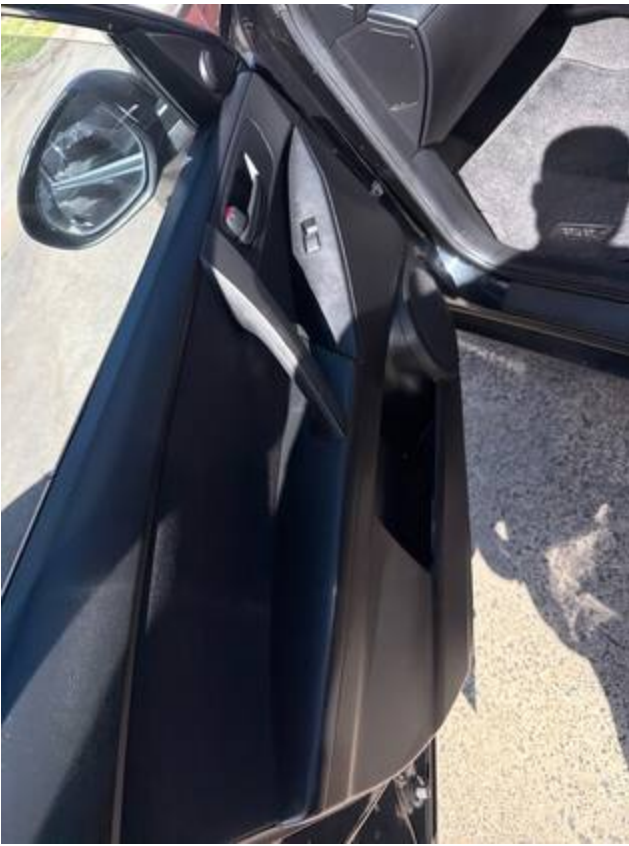
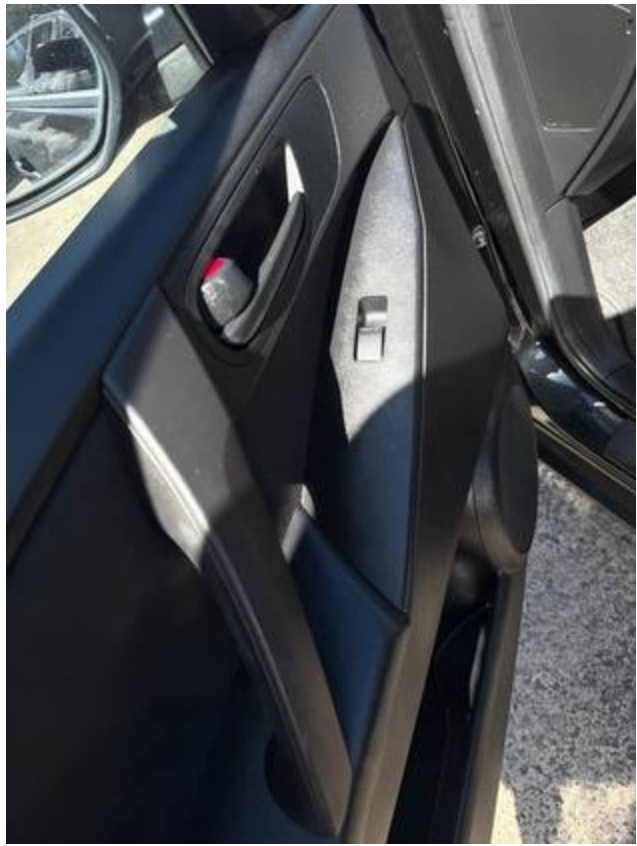
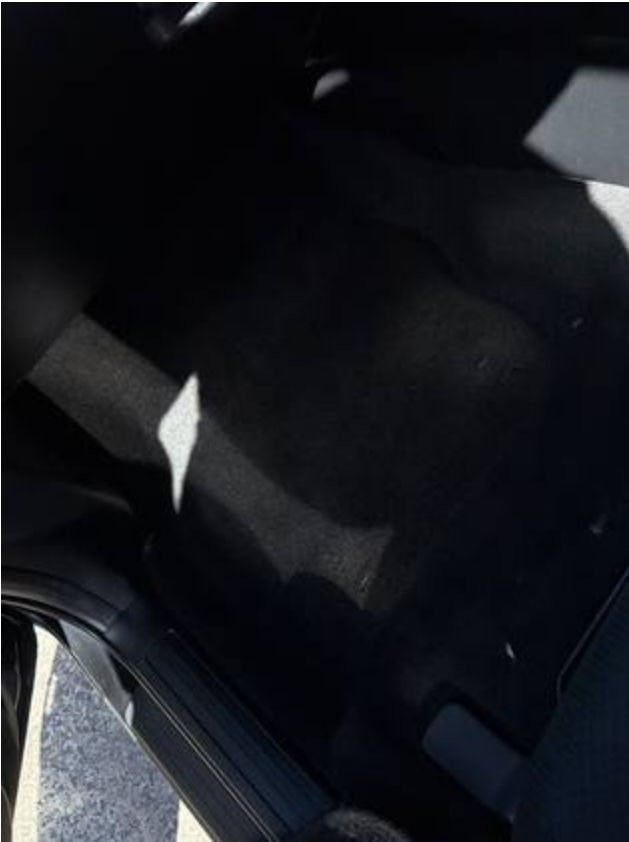
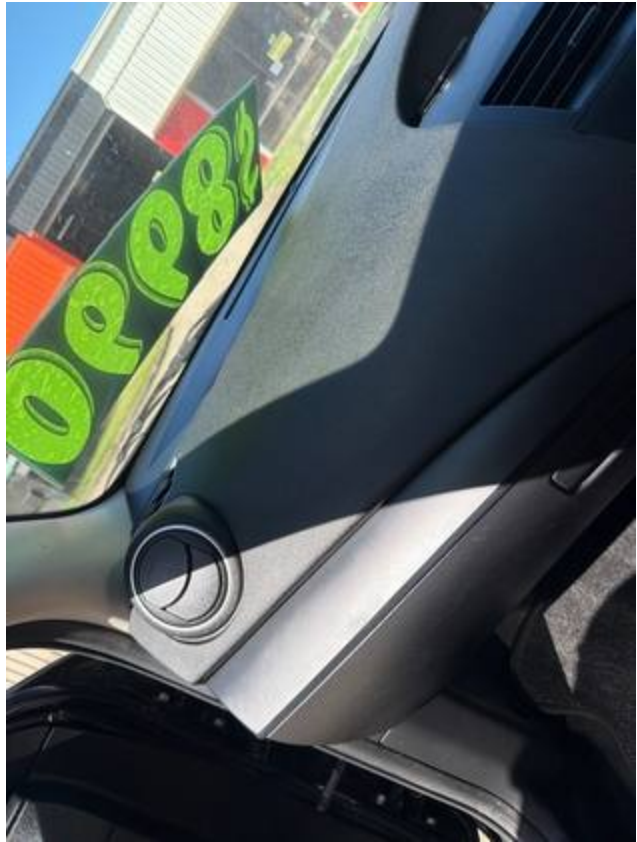
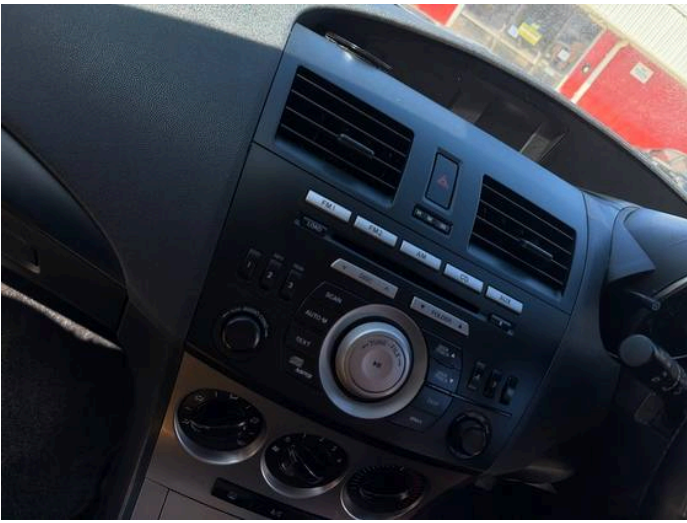
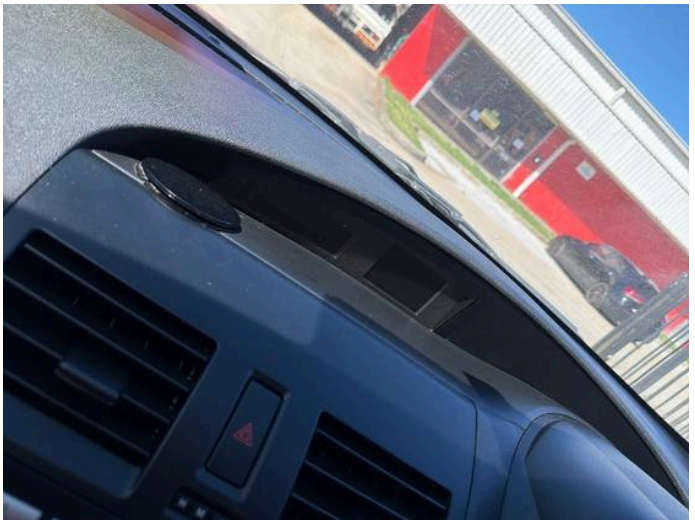
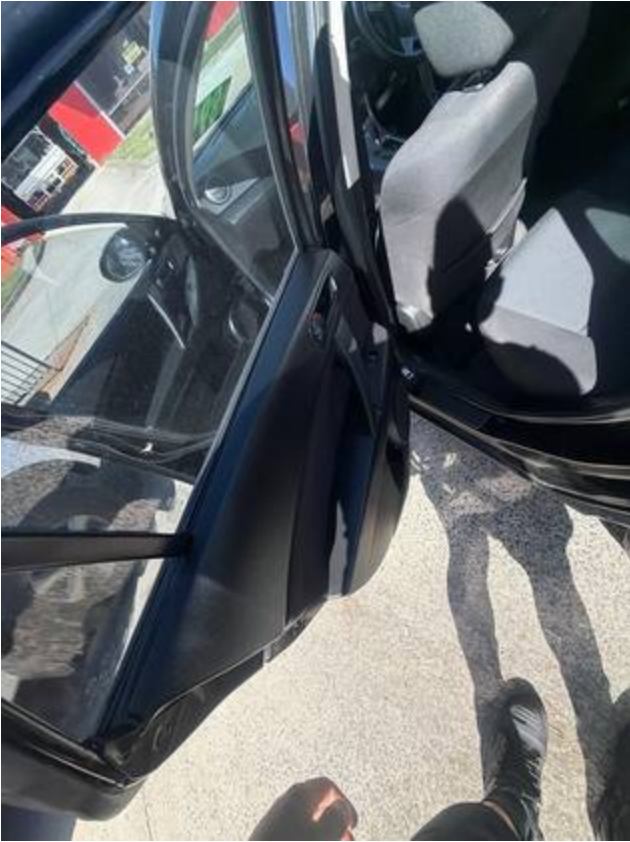
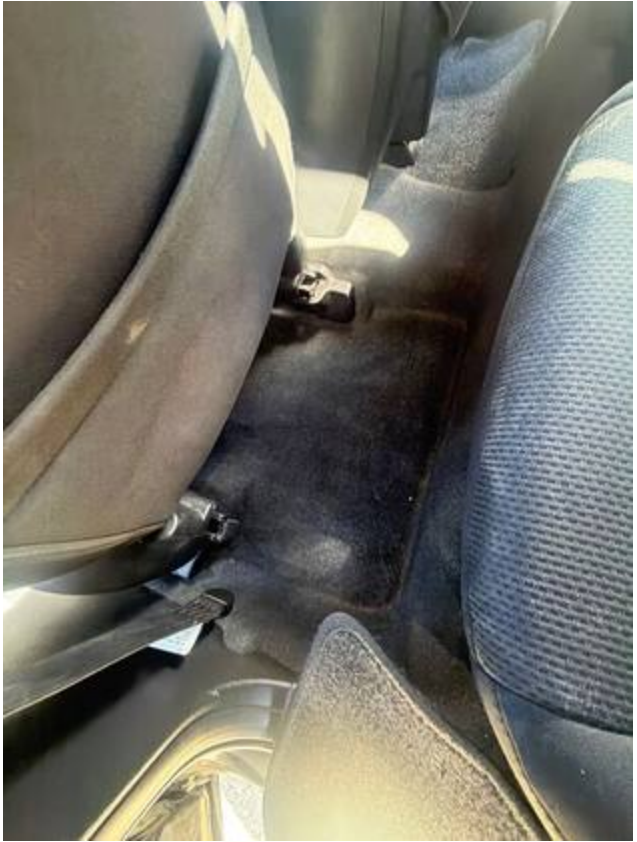
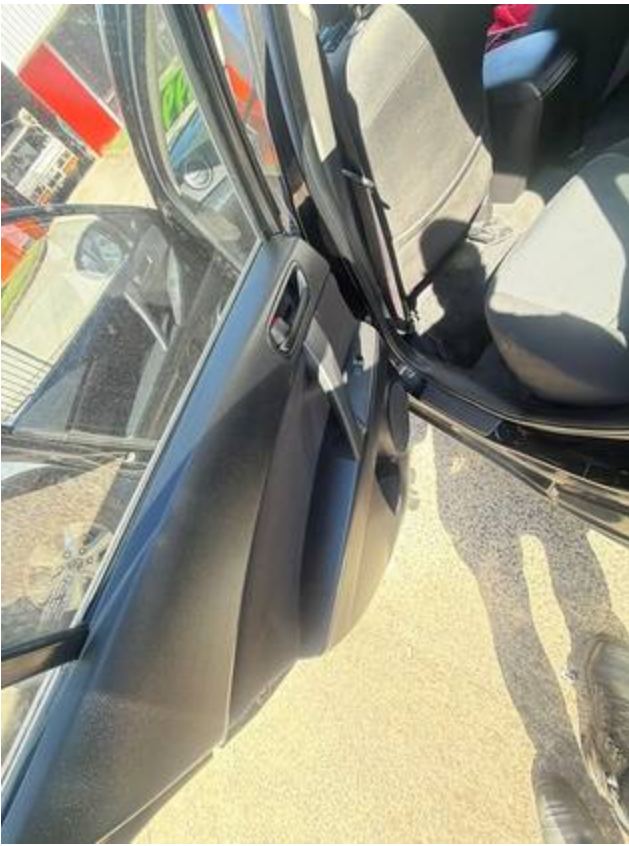
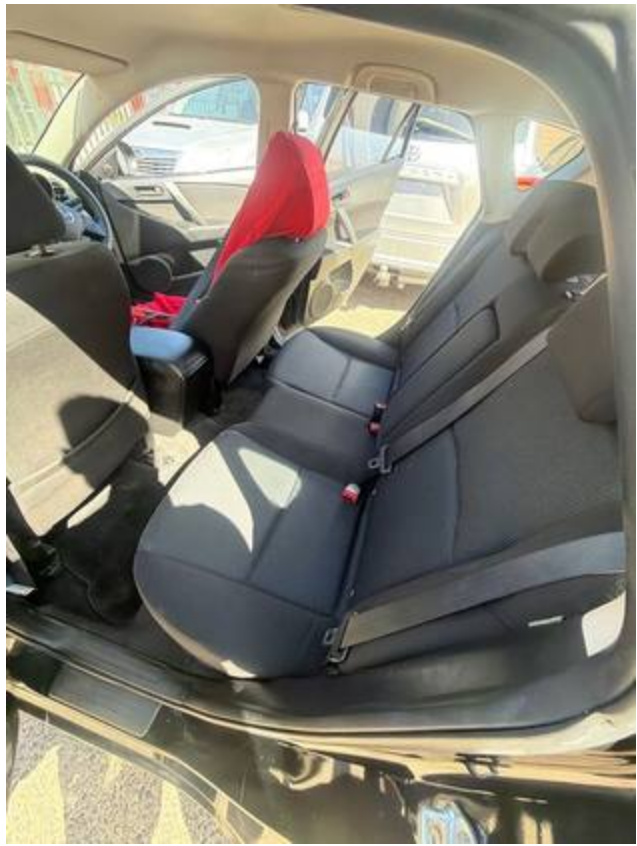
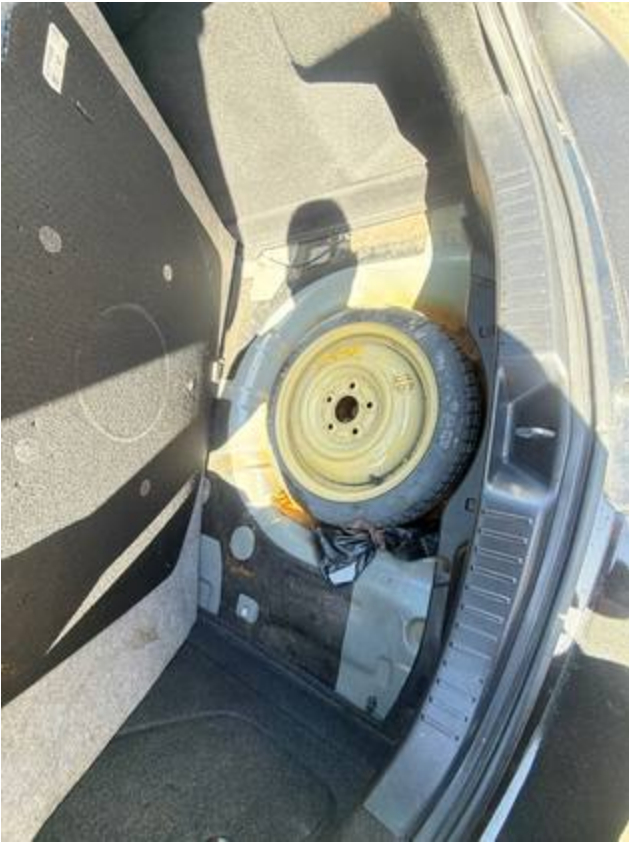
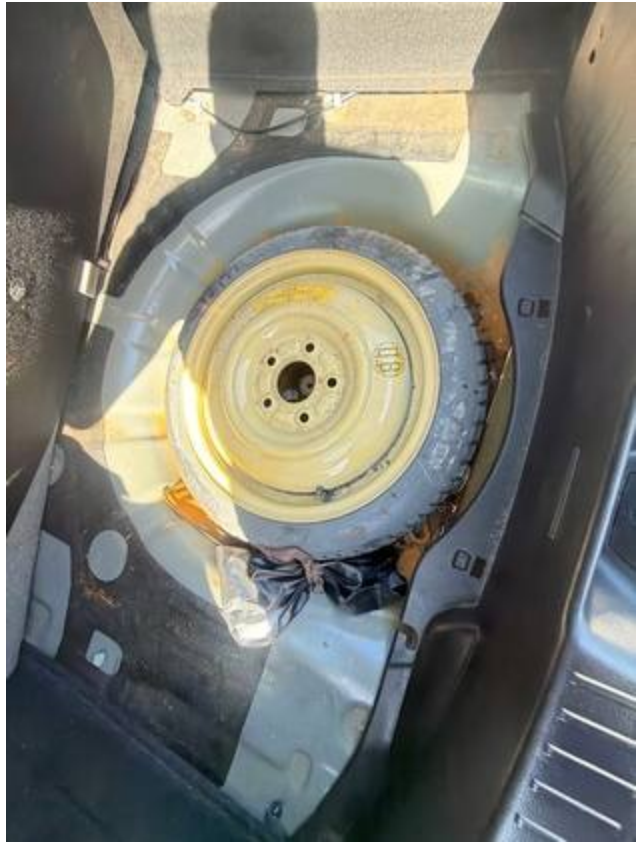
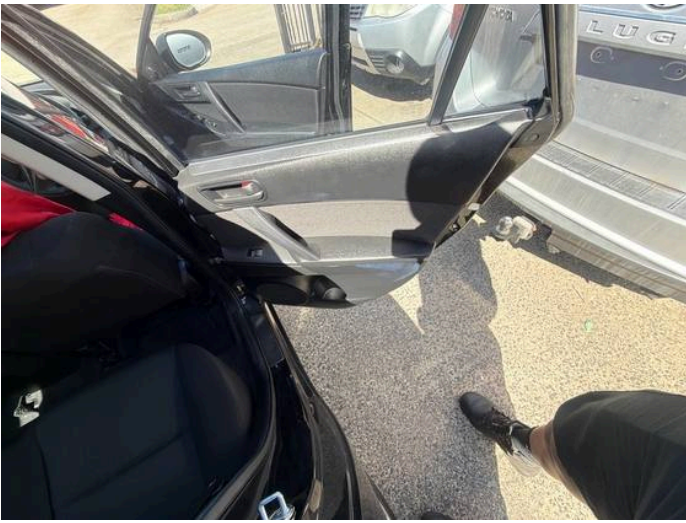
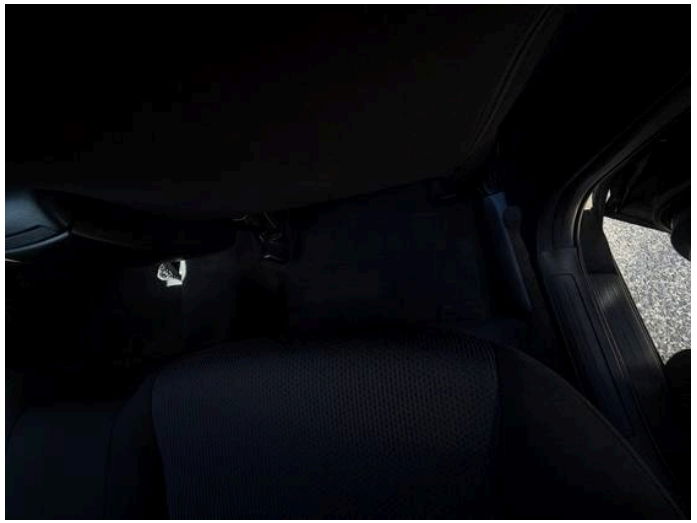
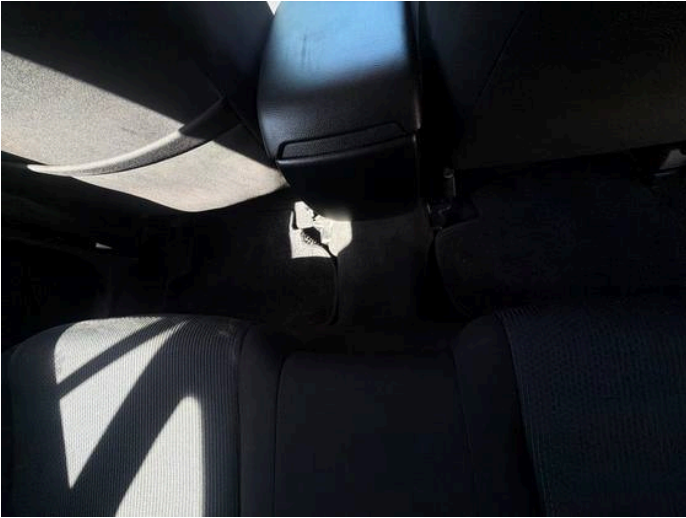
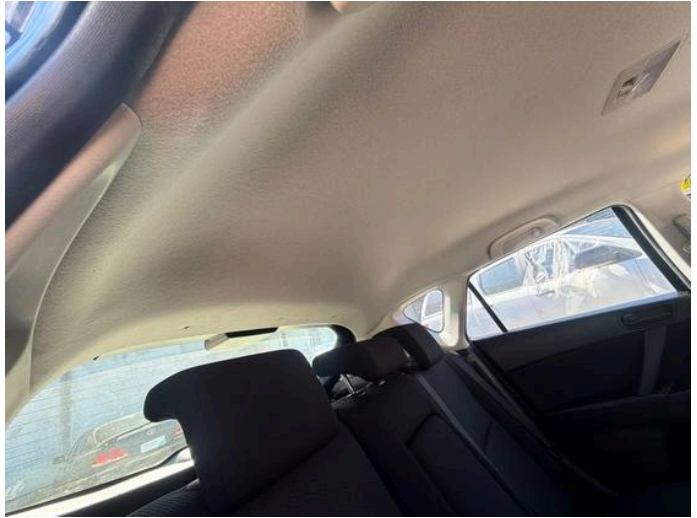
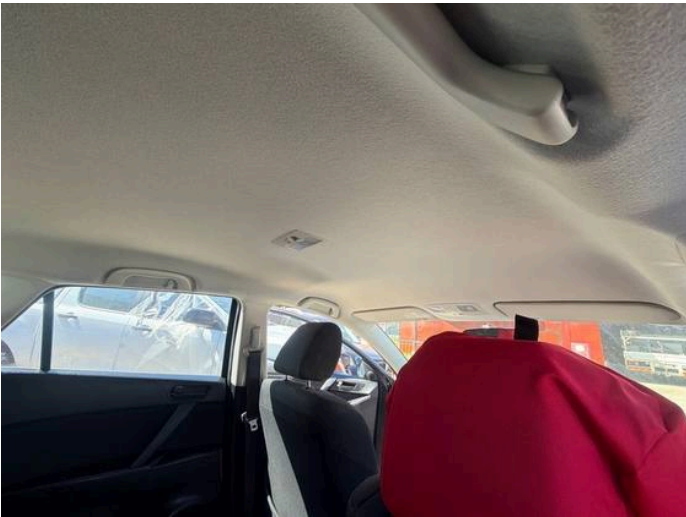
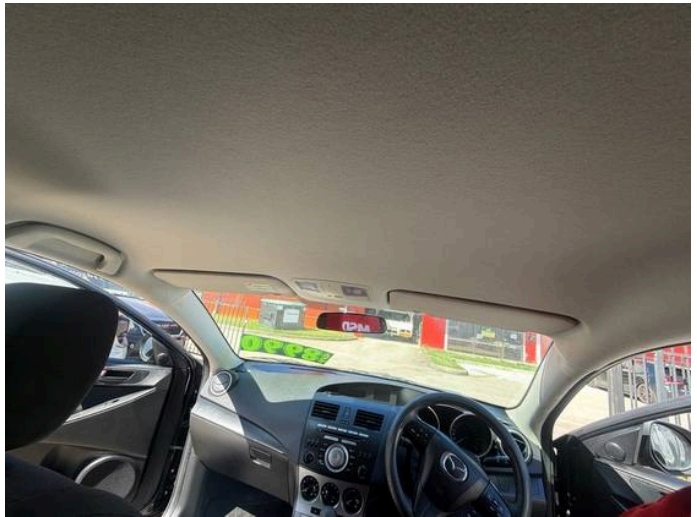
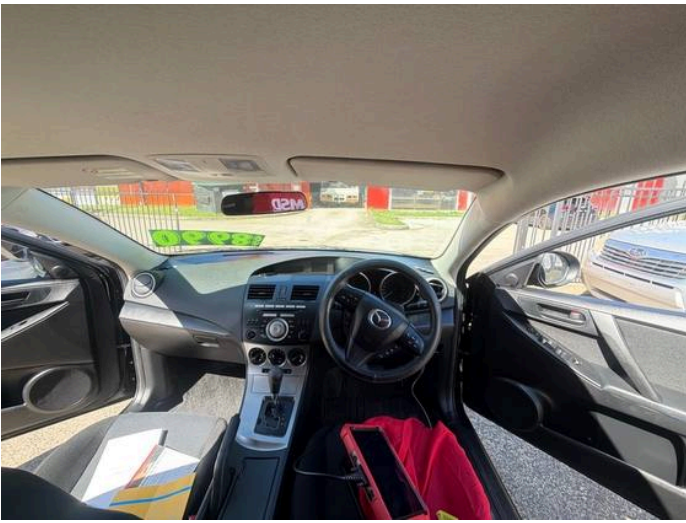
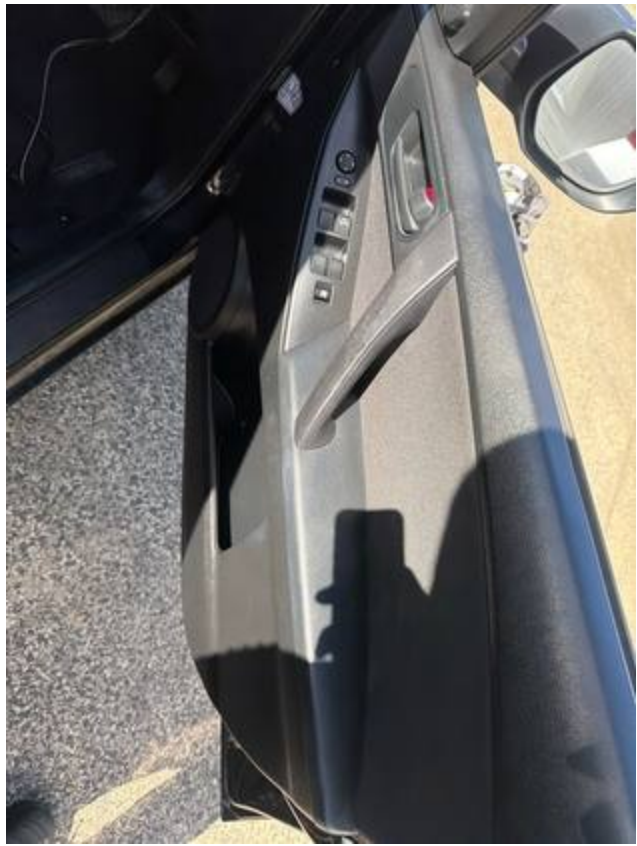
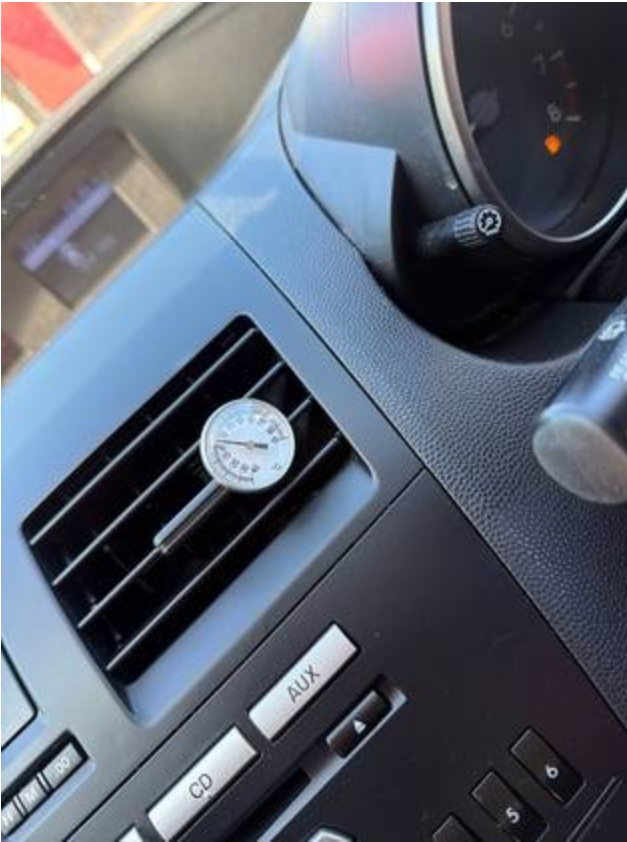
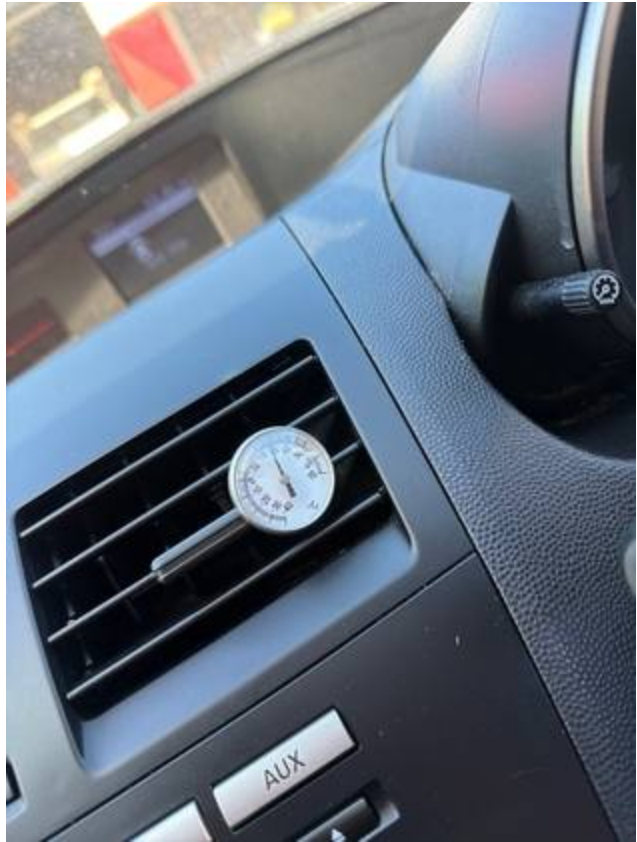
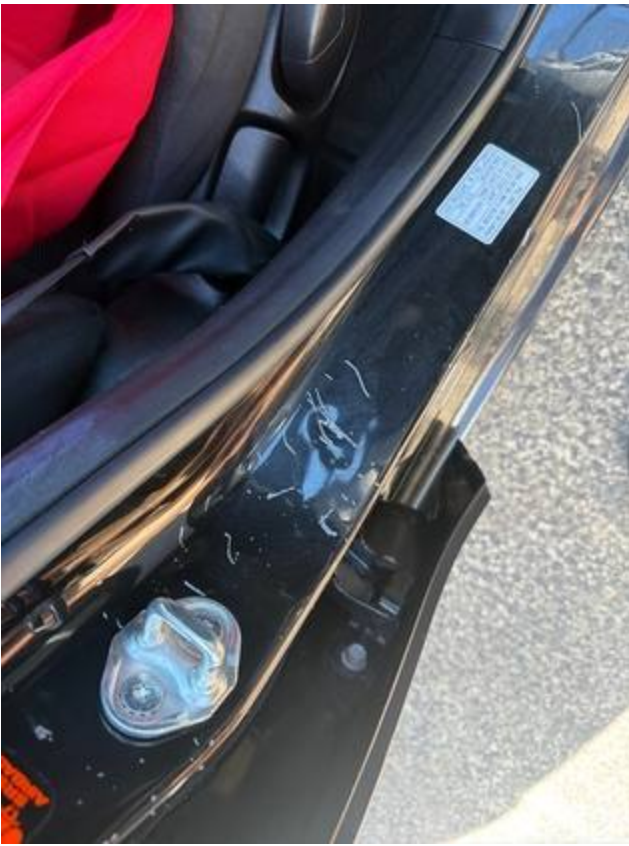
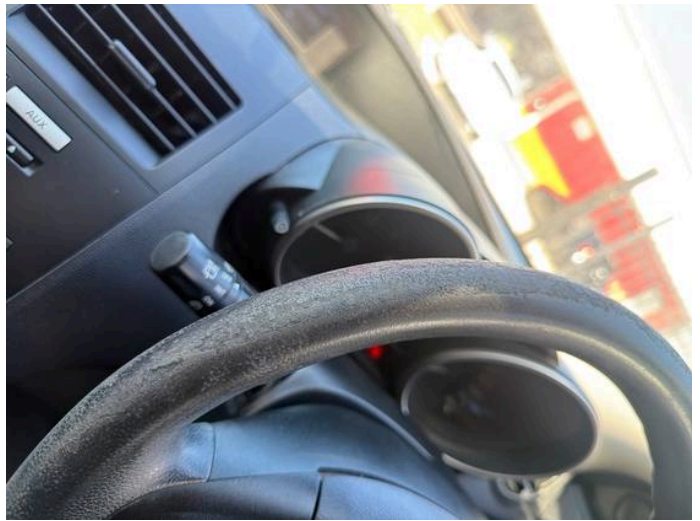
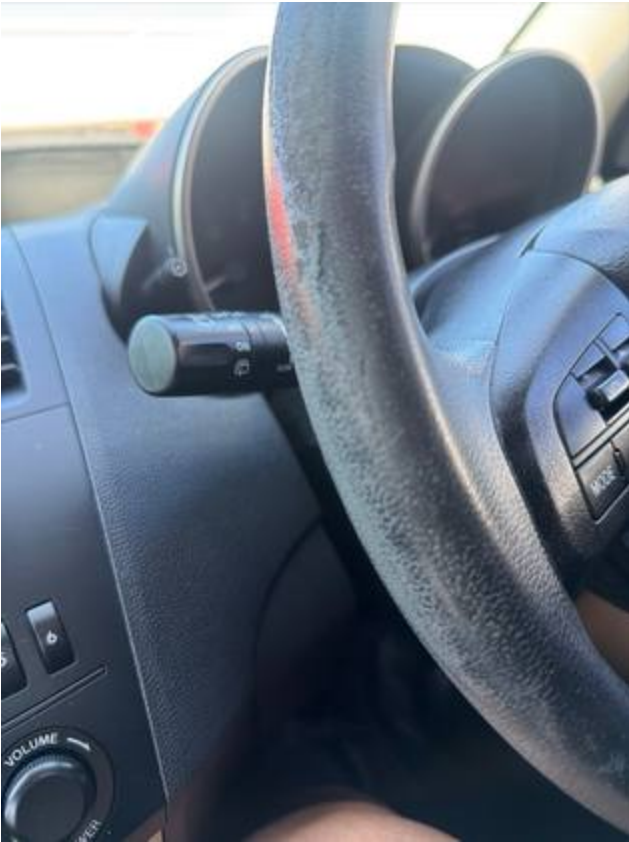
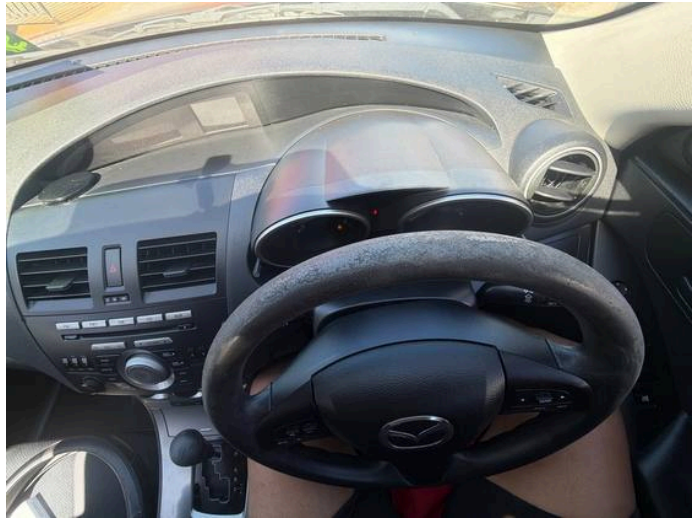
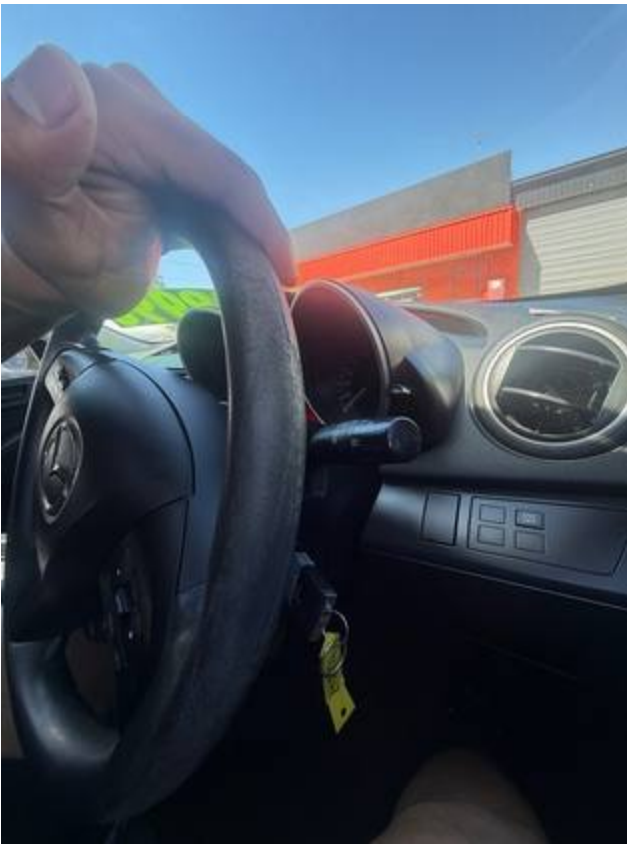
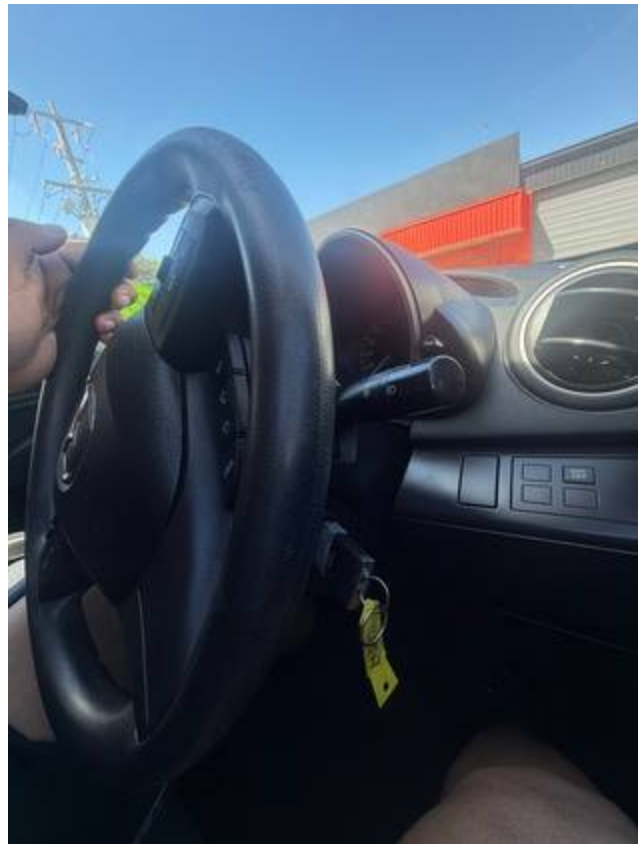
### Section photos – Interior & Convenience

- \* Overall interior condition was decent for the vehicle's age.
- \* All seatbelts retracted properly.
- \* No major seat or carpet damage was noted.
- \* Seat adjustments were working correctly.
- \* Heating and air conditioning operated correctly.
- \* All power windows were working at the time of inspection.

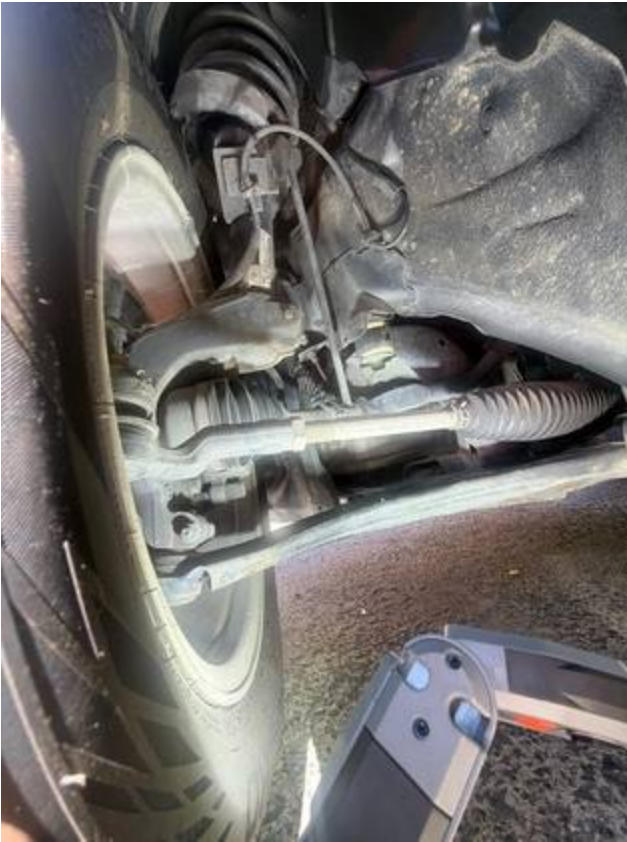
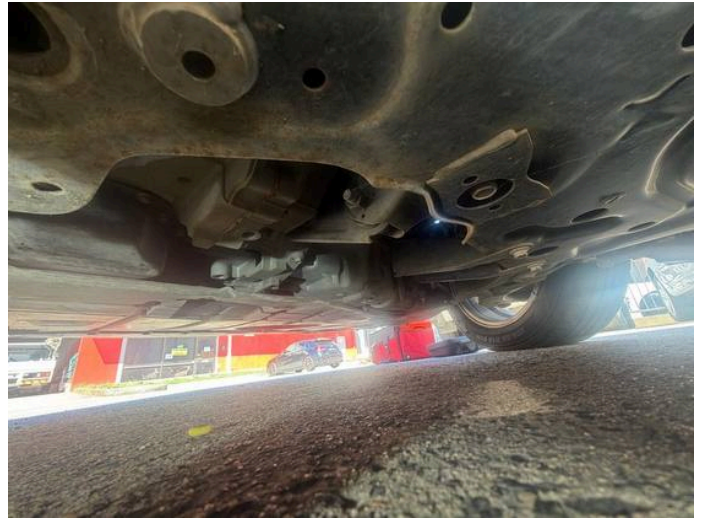
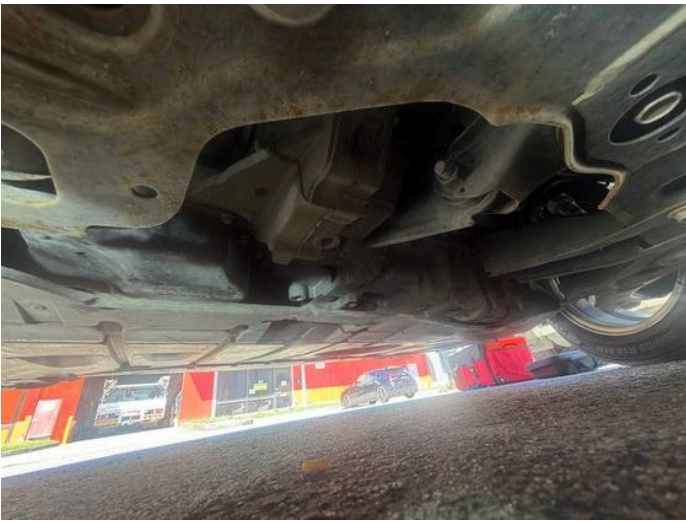
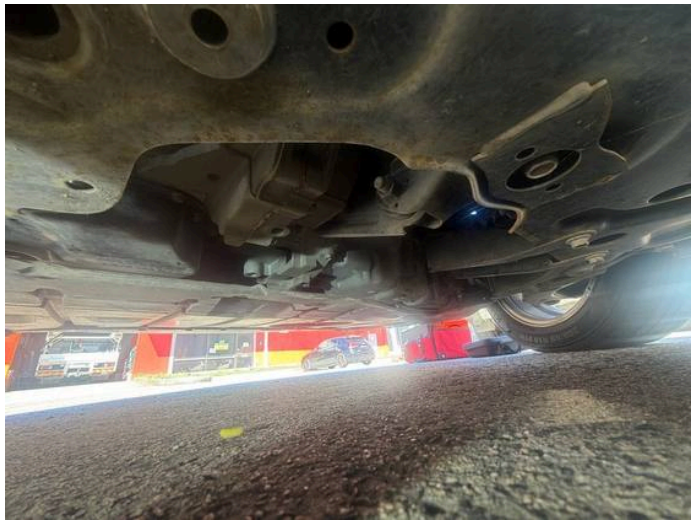
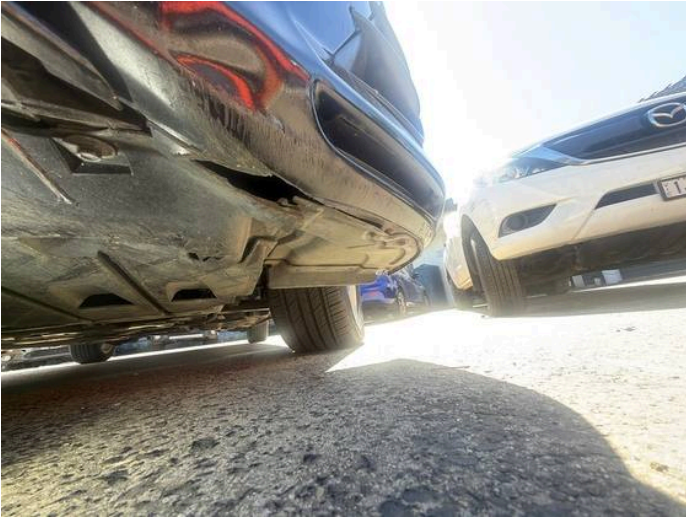
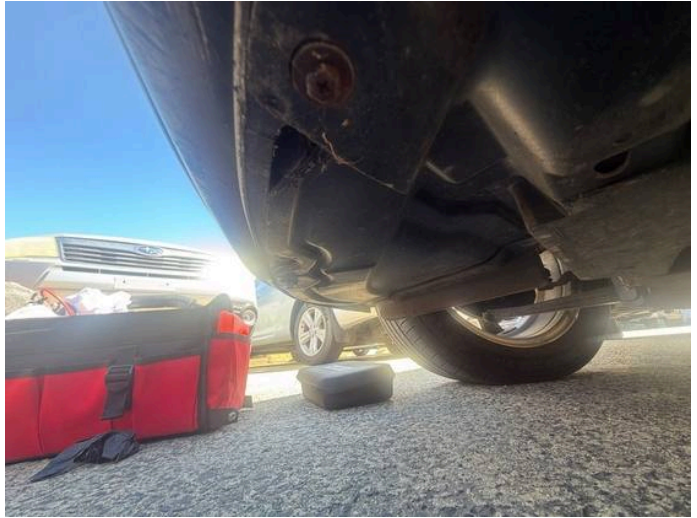
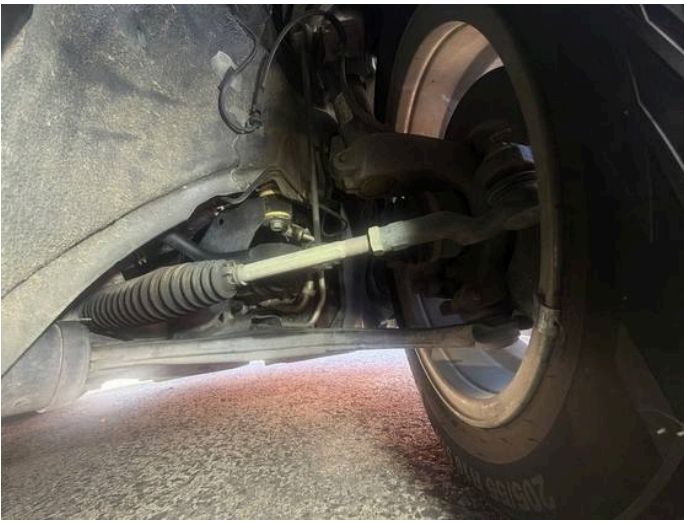
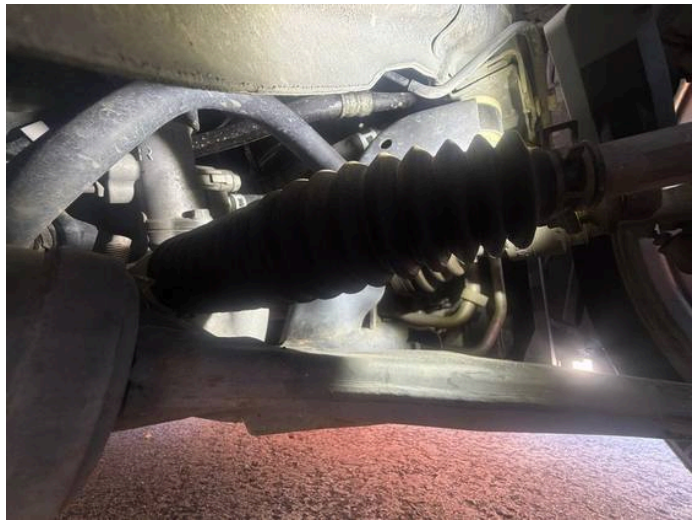
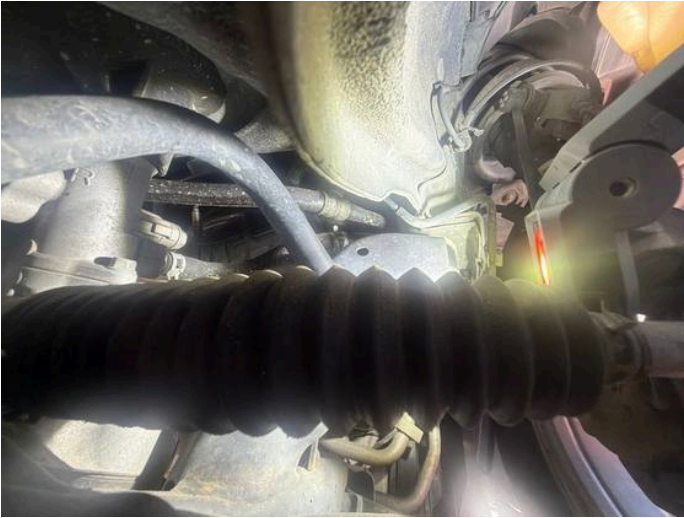
### Section photos – Underbody & Exhaust

| Engine lower-area leaks (underbody) | Fail |

- \* Overall underbody condition was satisfactory at the time of inspection.
- \* Suspension components appeared normal, with no obvious leaks or signs of excessive wear.
- \* No active leaks were detected around the engine or transmission area at the time of inspection.
- \* No radiator or coolant leaks were detected at the time of inspection.
- \* Oil residue was noted around the power steering hoses and should be investigated further.
